# **Site Inspection Summary**

## **Abandoned Oil Wells - Shoal Point**

### **Purpose of Inspection** Ongoing Monitoring of Abandoned Oil Wells at Shoal Point

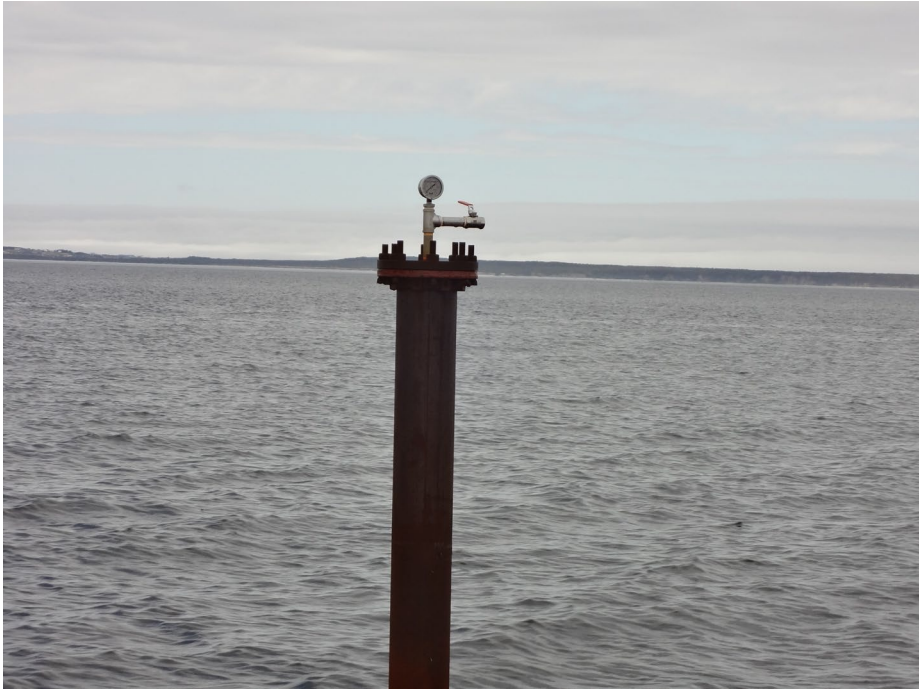
Photo 2 – Well Repair #1

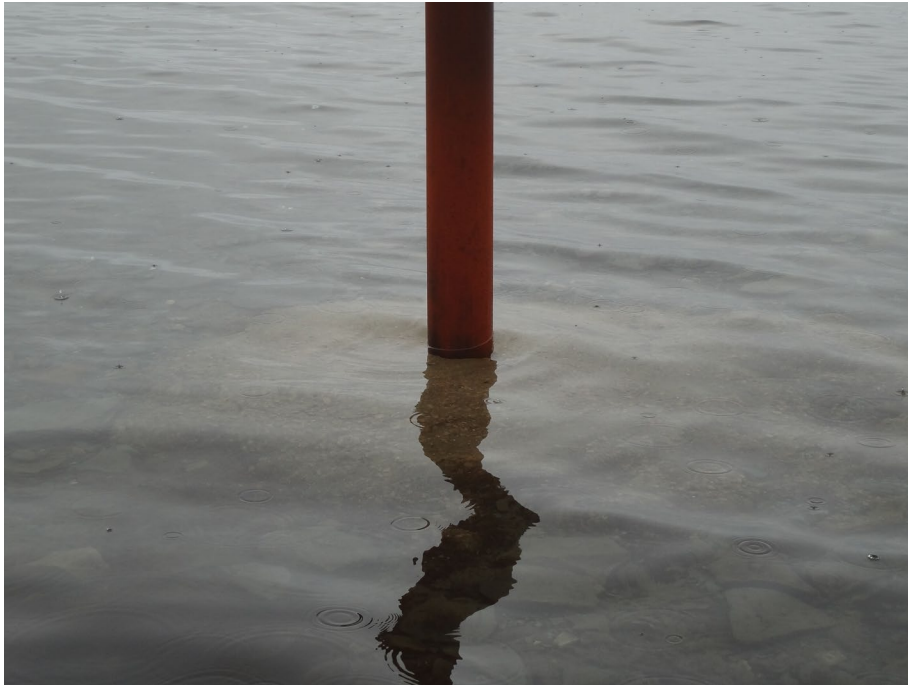
- Well #1 repair is still intact. I observed what I would estimate as individual oil drops being released in the vicinity of this well. The timing of the release varied from one drop every half a minute to one every 10 minutes. Oil sheens originated from the point of release and spread over the surface of the bay. The pressure reading on the gauge is zero. This corresponds to the reading observed when I last visited the site.

Photo 1 – Base of Well Repair #1

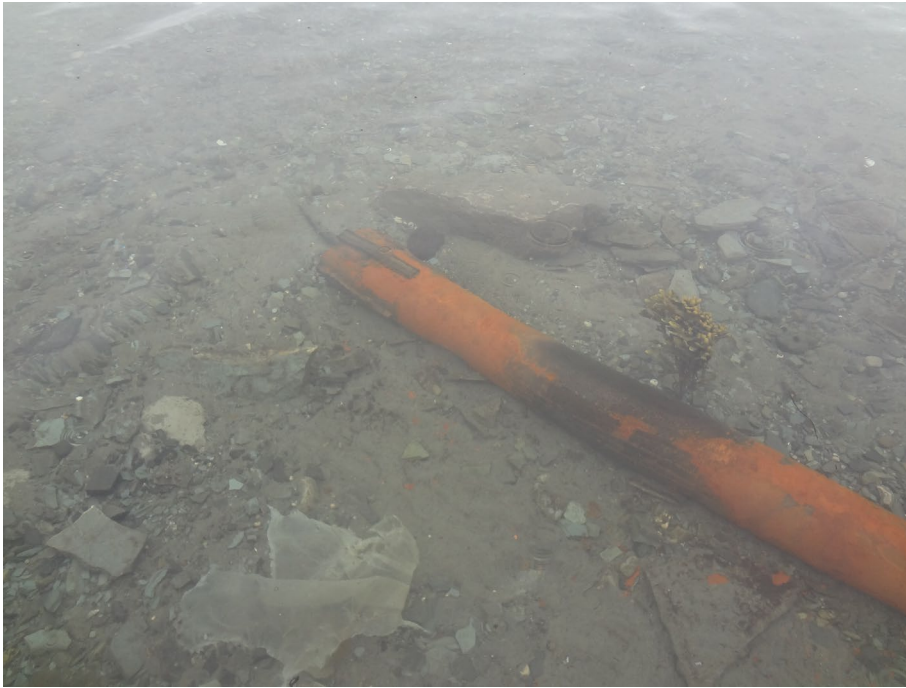
- The extension pipe associated with the repair of the second well has broken off from the original well casing. It appears to be broken at the weld. The extension pipe remains in the water. I was unable to locate the old well casing. It may be below the sea floor. I did not observe any oil release from this area.

Photo 2 – Casing from Well Repair #2

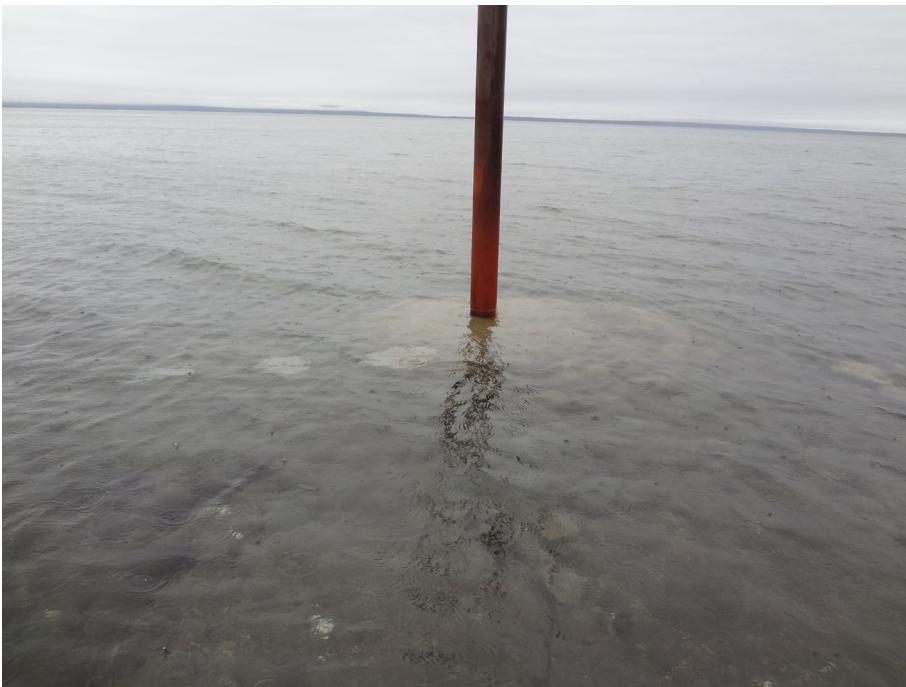
- A minor oil presence was observed on the beach in the general area adjacent to the repaired wells. As the tide came in, oil on the beach surface was released upon contact with the water creating a slight sheen on the surface.

Photo 3 – Visible oil in vicinity of Well Repair #1

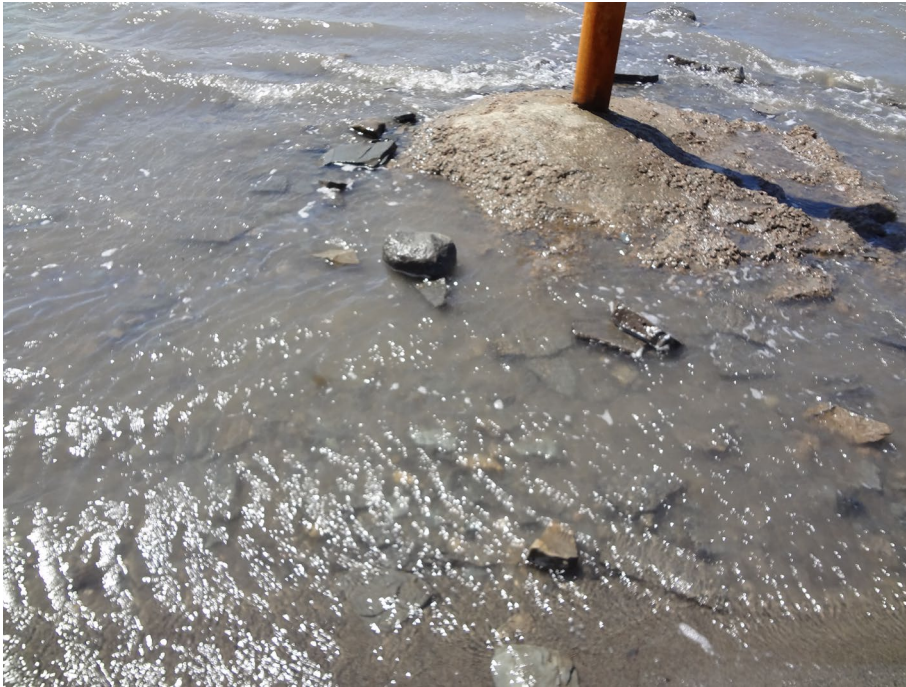
- As the tide lowered I noticed a small release of oil around the outer edge of the concrete around Well #1. The release is intermittent with a drop every few seconds then one every few minutes. The rate of oil seeping may be comparable to that observed prior to the repair. This is the only area I observed oil seepage. I suspect that the oil is leaking from the well casing and the oil is accumulating under the concrete and is eventually finding an escape route. The repair has not resolved the seepage.

Photo 1 – Concrete base around Well Repair #1

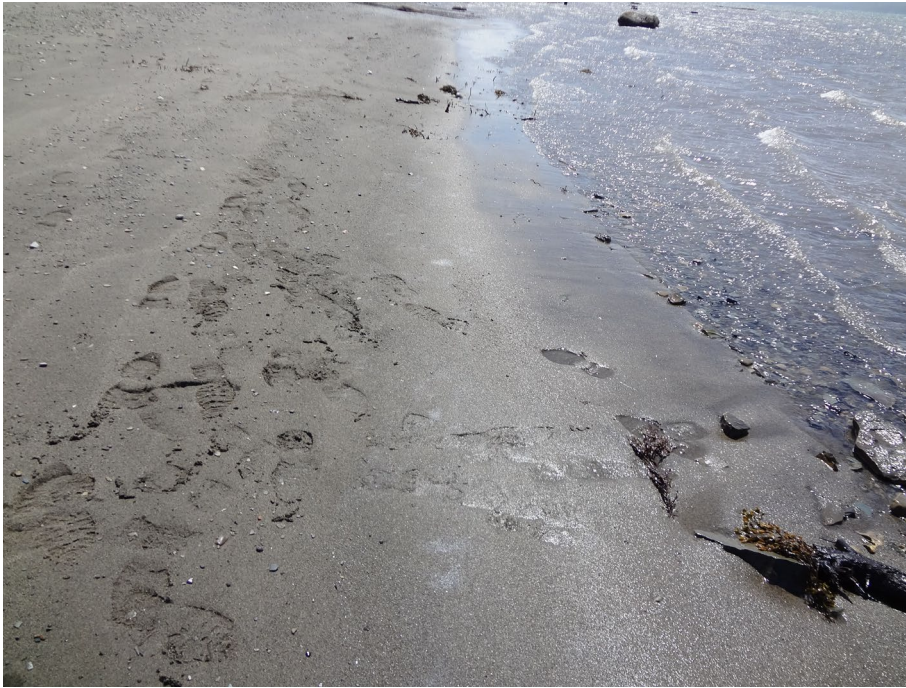
- The tide was still dropping when I arrived and was rising when I left the site. Winds were extreme causing considerable wave action in the bay. I did not observe any oil sheening in the water for the general area around the repaired wells. However any release would have been quickly dispersed with the waves. There is an oily odor and slight sheening along the beach just south of Well Repair #1.

Photo 2 – Oil sheening along shore

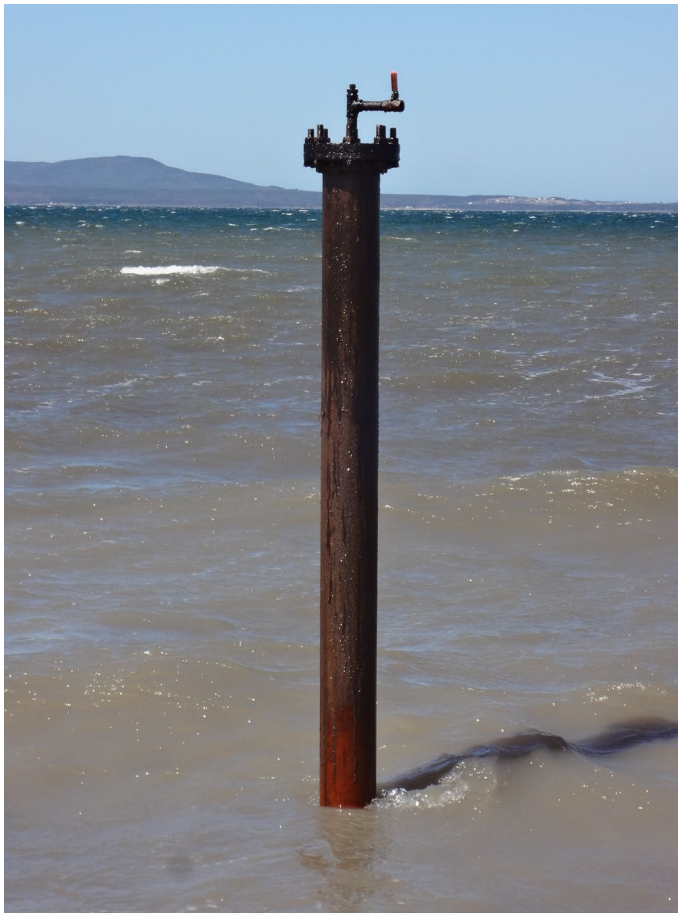
- Well Repair #1 was in the water. The pipe extension remains intact. The pressure gauge on top of the extension pipe is gone. Oil residue is present at the top of the pipe and along the exterior. No active oil seepage was observed from the well.
- No visible sign of oil was detected at any of the other well locations. The presence of oil in the water would not be evident as the wave action was significant and would quickly dissipate any oil seepage.
- A faint oil odour was evident in the area.

Photo 1 – Well Repair #1

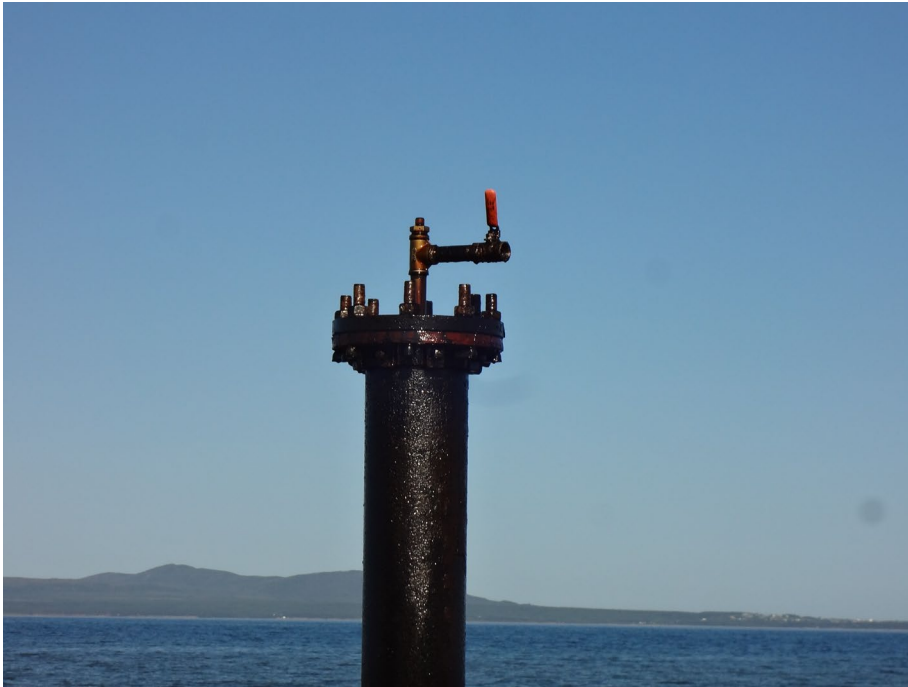
- The three visible well casings are in the water.
- The pipe extension associated with Well Repair #1 remains intact. Oil is observed leaking from the top of the pipe extension where the pressure gauge had previously been located. Oil release is consistent roughly estimated at 15-20 "bubbles" per minute. Released oil builds up on the top plate and drips into the water or on the casing below.
- A strong oil odor is evident near the leaking well.
- Slight oil sheening is evident along the beach surface as the tide recedes.
- No visible sign of oil or odor was detected at the other well locations.

Photo 1 – Area of Observed Oil Leakage from Extension Pipe of Well Repair #1

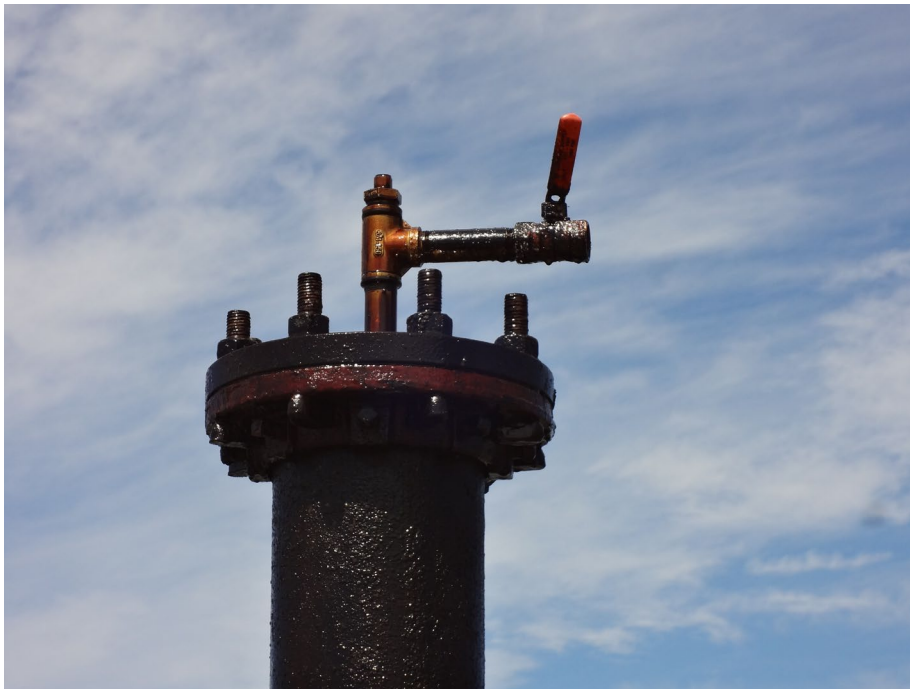
- The three visible well casings are in the water.
- The pipe extension associated with Well Repair #1 remains intact. Oil is observed leaking from the top of the pipe extension where the pressure gauge had previously been located. Oil release is intermittent but somewhat consistent.
- A strong oil odor is evident near the leaking well and along the shore.
- Slight oil sheening is evident on the sand/water interface along the beach downwind from the leaking well.
- No visible sign of oil or odor was detected at the other well locations.
- There is a posted DFO notice on the shore identifying the area as closed to shellfish. It is noted that shellfish are contaminated and unsafe for use as food.

Photo 1 – Oil Leakage from Extension Pipe of Well Repair #1

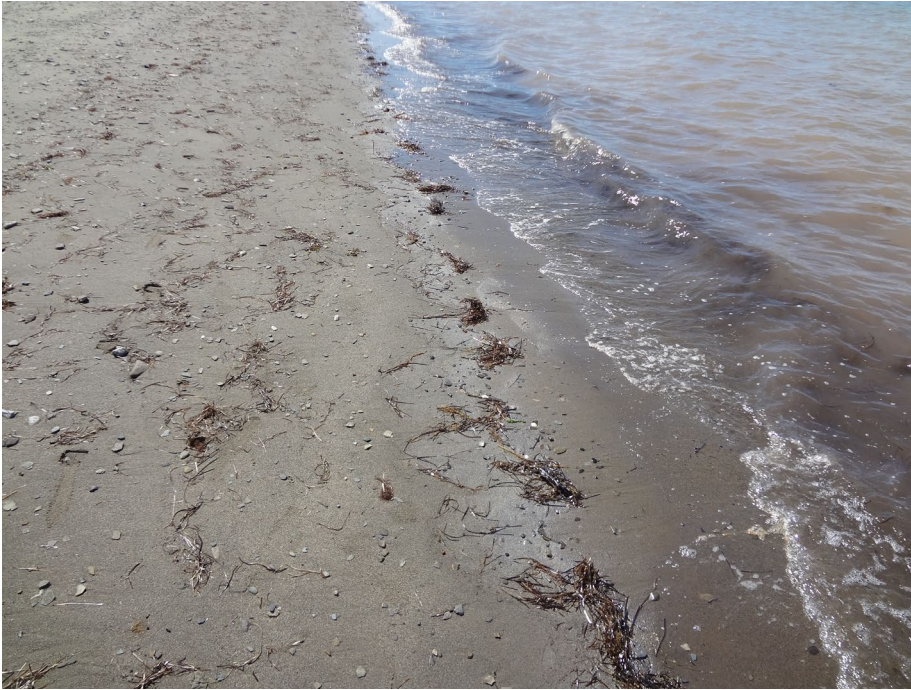
Photo 2 – Oil Sheening along Beach

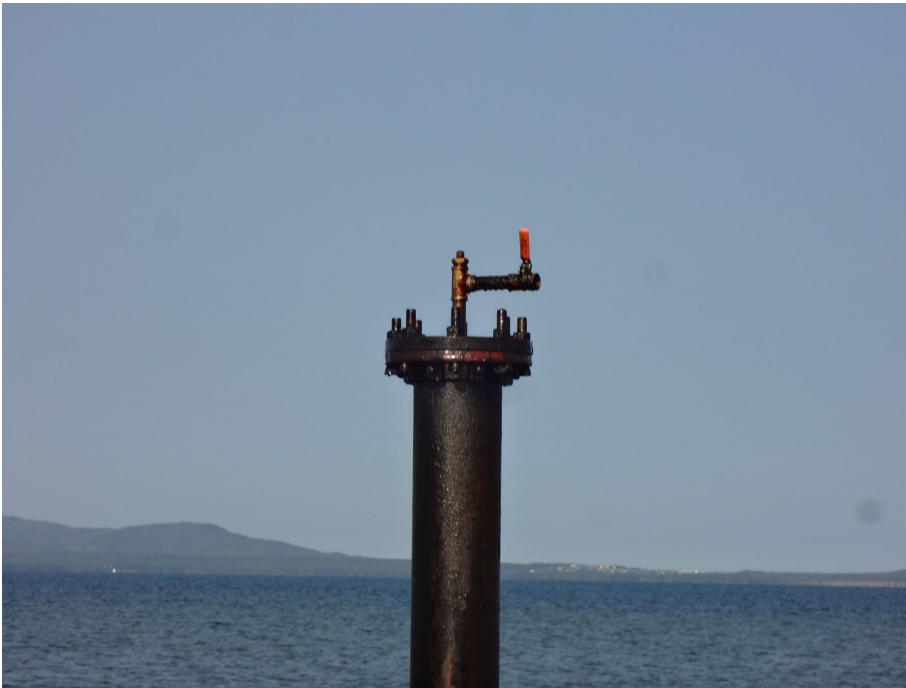
- The three visible well casings are in the water.
- The pipe extension associated with Well Repair #1 remains intact. Oil is observed leaking from the top of the pipe extension where the pressure gauge had previously been located. Oil release is intermittent but somewhat consistent.
- There was no oil odour in the area. Wind was offshore.
- There is significant oil sheening on the water surface which extends hundreds of meters out into the bay in the direction of the wind. The sheen originates at Well Repair #1 as oil droplets are released into the water from the top of the pipe extension.
- No visible sign of oil or odor was detected at the other well locations.

Photo 1 – Oil Leakage from Extension Pipe of Well Repair #1

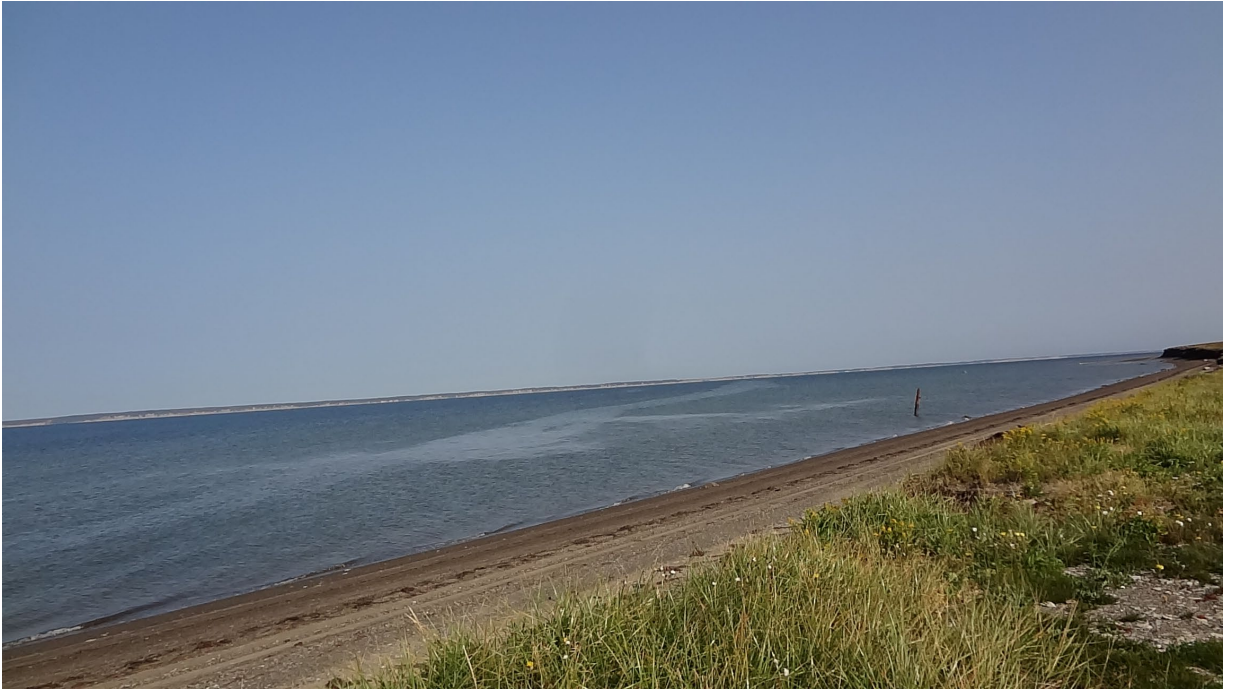
Photo 2 – Oil Sheening in the Bay (Downwind of Well Repair #1)

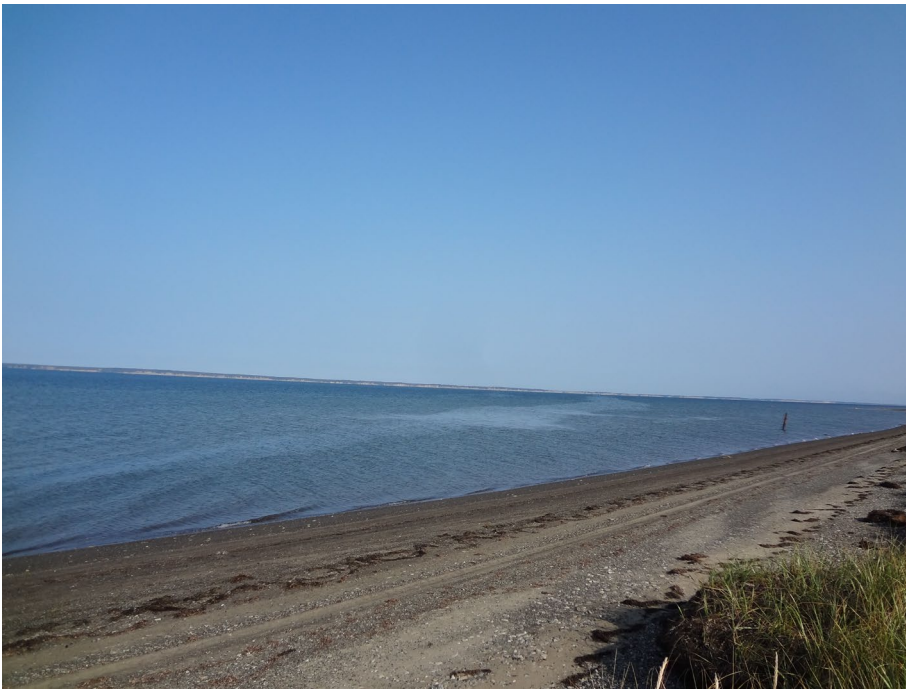
Photo 3 – Oil Sheening in the Bay (Downwind of Well Repair #1)

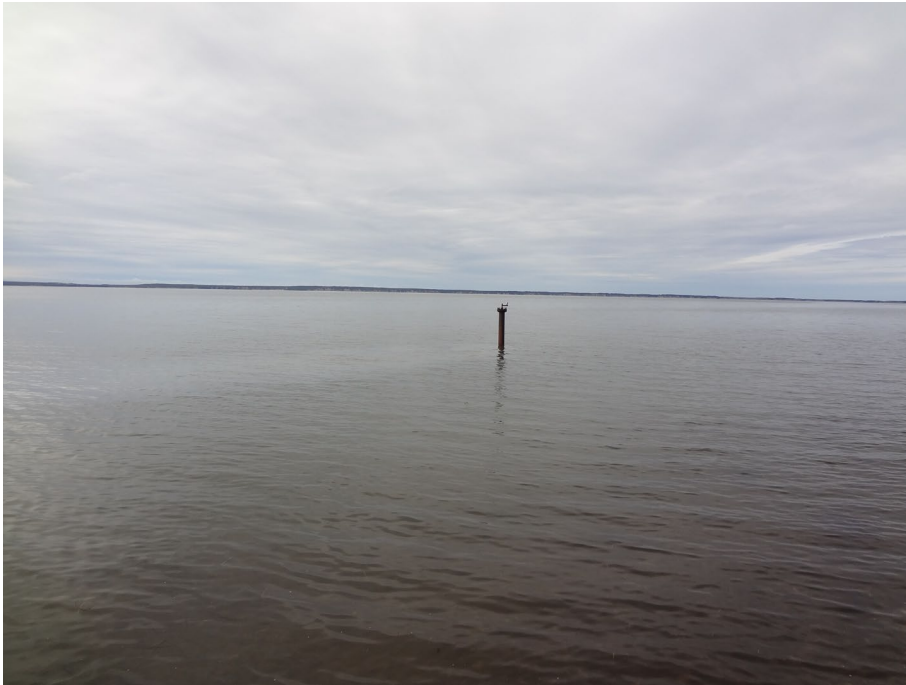
- The tide is high with only two well casings visible.
- There is oil sheening evident in the water in the vicinity of Well Repair #1.
- Oil sheening and odor is observed at the beach/water interface as the water level rises.
- No visible sign of oil or odor was detected at the other well locations.
- Arrangements were made to have a local contractor remove the damaged pressure gauge and install a threaded fitting in the top plate to seal the opening and to prevent oil seepage from this location. This work has been completed.
- Monitoring of the area for oil seepage will continue.

Photo 1 – Oil Sheening near Extension Pipe of Well Repair #1

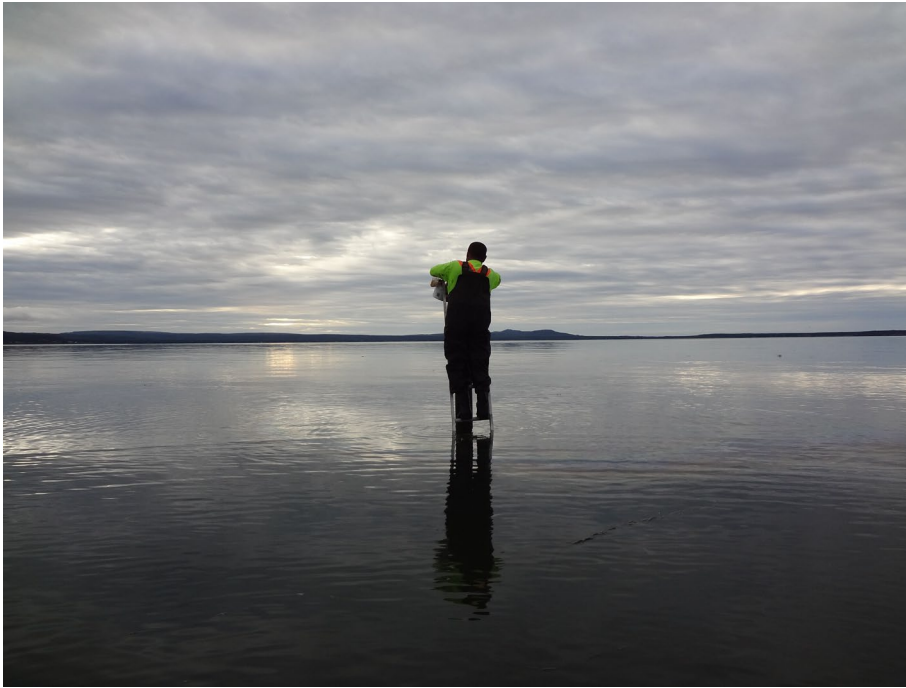
Photo 2 – Pressure Gauge Replacement Well Repair #1

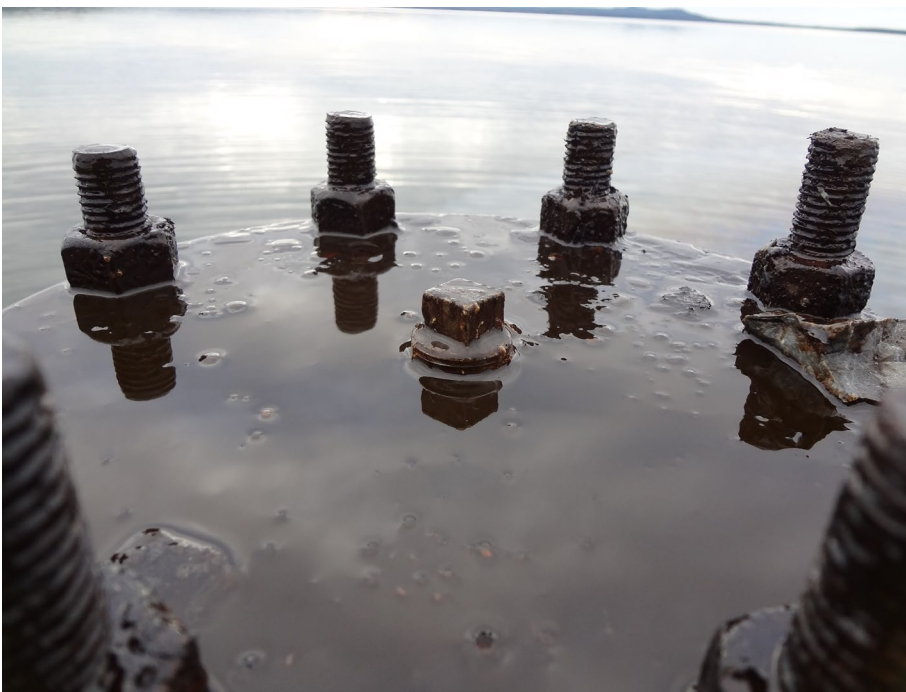
Photo 3 – Threaded Fitting in Top Plate of Well Repair #1

- There was no visible sign of oil in the vicinity of Well Repair #1. The plug placed in the top plate of the extension pipe has stopped the seepage of oil that had been occurring at this location.
- The wind was estimated to be 15-20 km/h SW (towards the shore). The water was relatively turbid and there was strong wave action.
- There was no visible sign of oil or oil odor detected in the area.
- Monitoring of the area for oil seepage will continue.

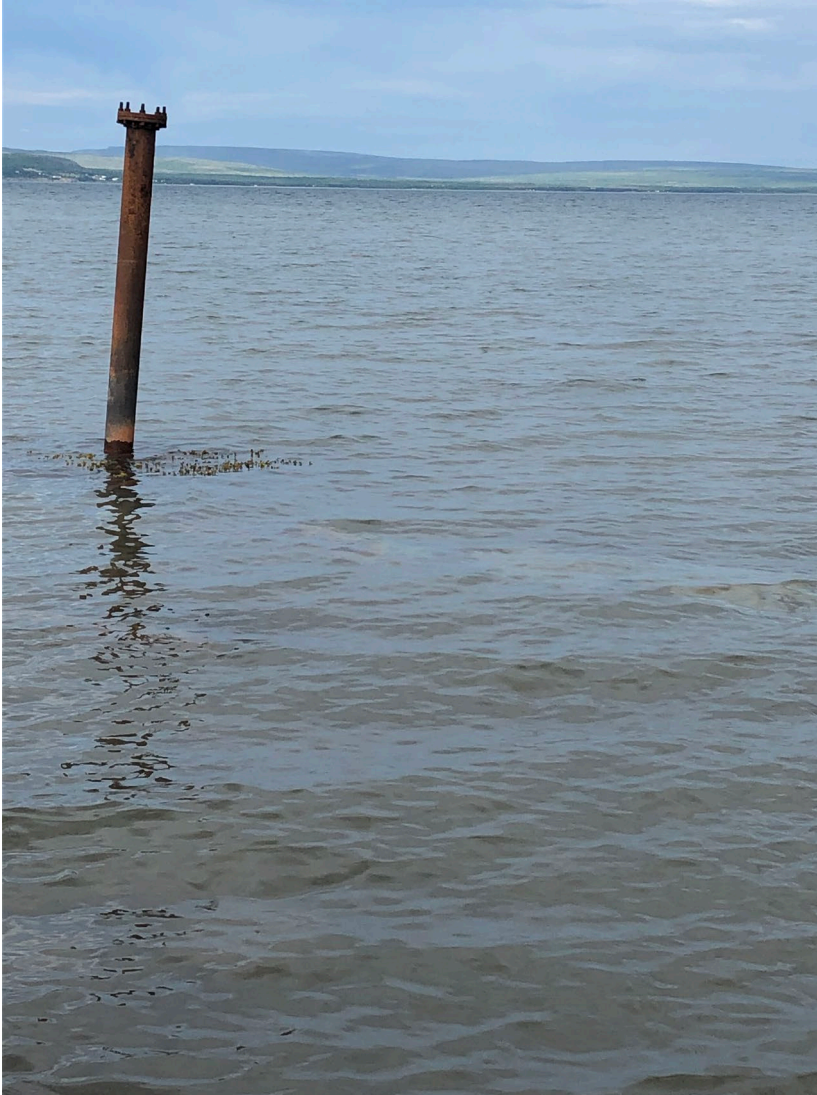
- Oil sheening was observed in the vicinity of Well Repair #1.
- Oil seepage was not observed at any of the other well locations.
- An oil odour was detected downwind from Well Repair #1.
- Oil sheening was visible along a section of beach at the water mark.
- Monitoring of the area will continue.

Photo 1 – Oil Sheening at Well Repair #1

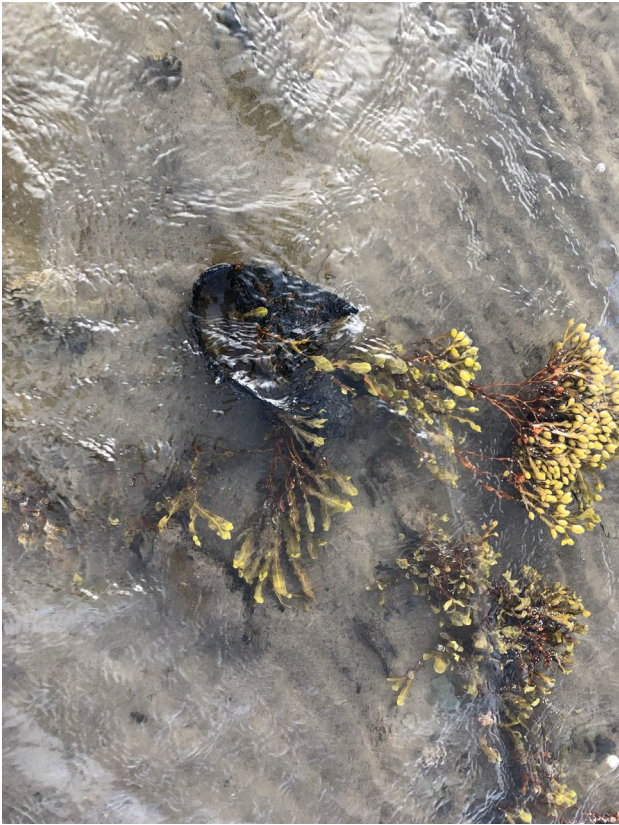
- Bubbling was observed on the surface of the pooled oil/water mixture which had accumulated within the pipe of Well Repair #1.
- Slight and intermittent oil sheening was observed in the vicinity of Oil Well #5. The sheening appeared to originate from within the well casing. The well casing extends about 0.5 m from the sea floor and was level with the water surface.
- A previously undetected abandoned oil well casing was discovered (labelled Well #6). The well is located to the north of Well #5. Slight and intermittent oil sheening was observed in the vicinity of Oil Well #6. The well casing extends about 0.5 m from the sea floor and was just beneath the water surface.
- The locations of the wells are provided on the attached map.
- Monitoring of the area will continue.

Photo 2 – Abandoned Oil Well #5

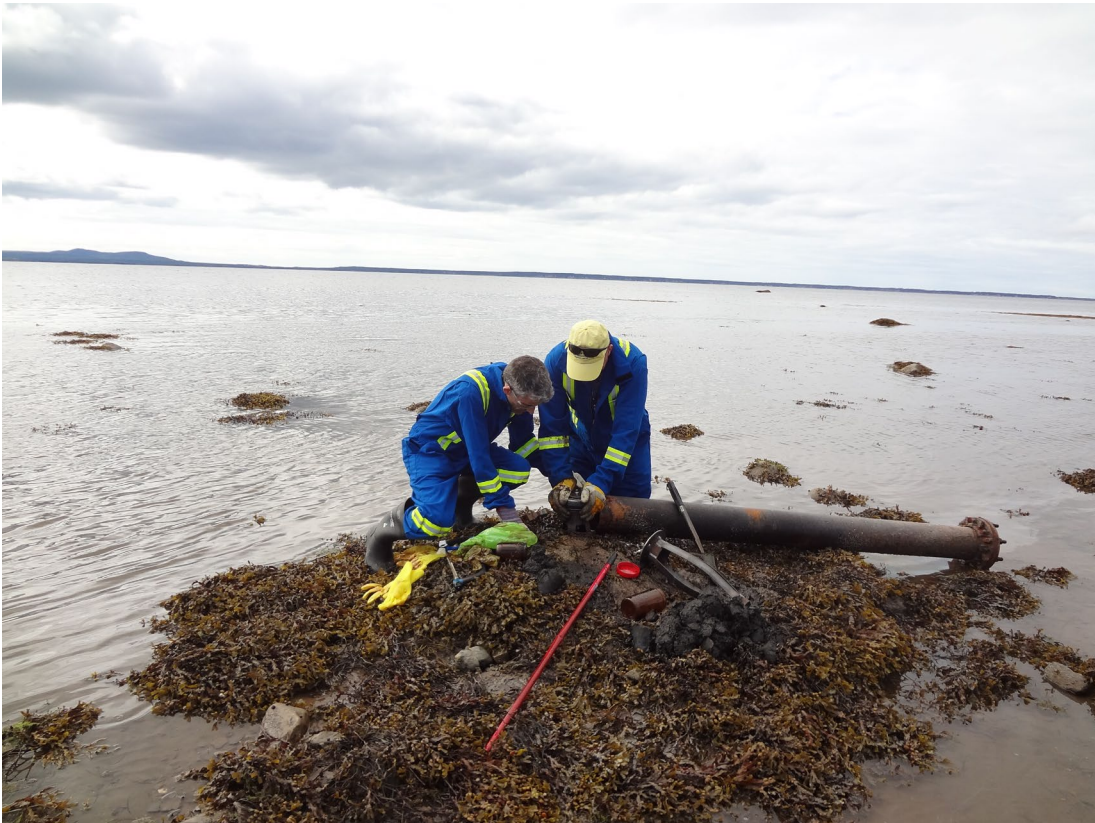
- Oil/water mixture continued to accumulate in the well casing after the installation of the plug. Active gas bubbles were observed on the surface within the well casing.

Photo 1 – Plug Installation Well #1

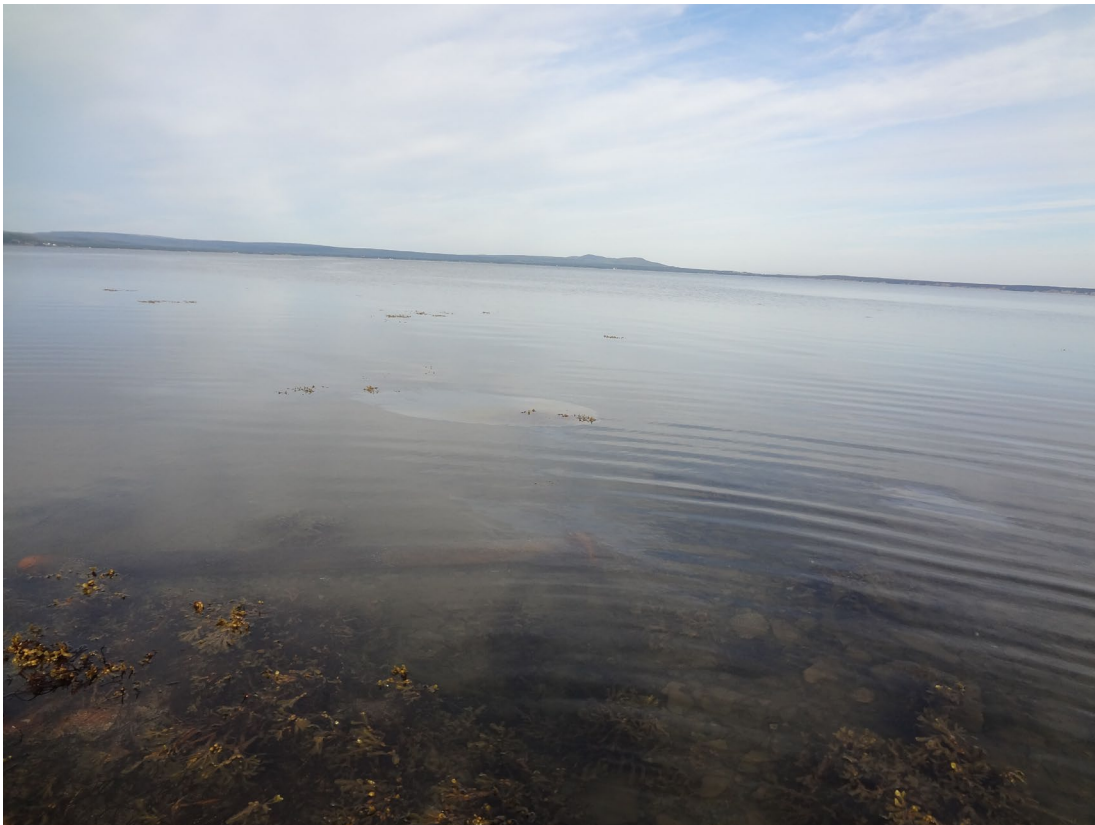
- The formation of intermittent oil sheens as small point sources was observed at random locations within the bay.
- The cap for Well #1 was removed. An oil presence was observed in the well pipe above the installed plug.
- Oil sheening was observed in the vicinity of Well #5 and Well #6.
- Monitoring of the area will continue.

Photo 1 – Random Oil Sheens forming in the Bay

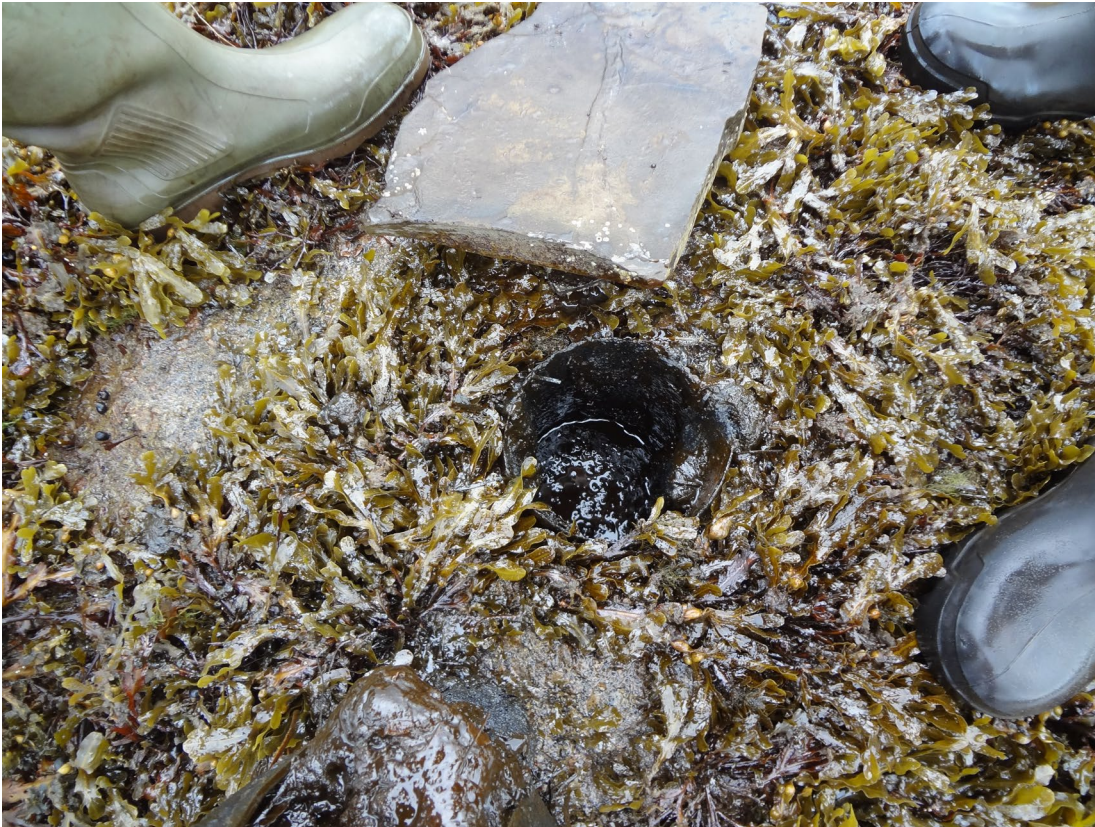
- Representatives from the Petroleum Engineering Section of the Department of Industry, Energy and Technology (IET) also visited the site. A main purpose of the visit was to inspect the well cap and plug system that was installed for Well #1 in August 2022.
- The cap for Well #1 was removed. A heavy oil/water mixture was observed in the well casing above the plug mechanism.
- Monitoring of the area will continue.

Photo 1 – Oil/Water Mixture in Casing Above Well Plug Mechanism

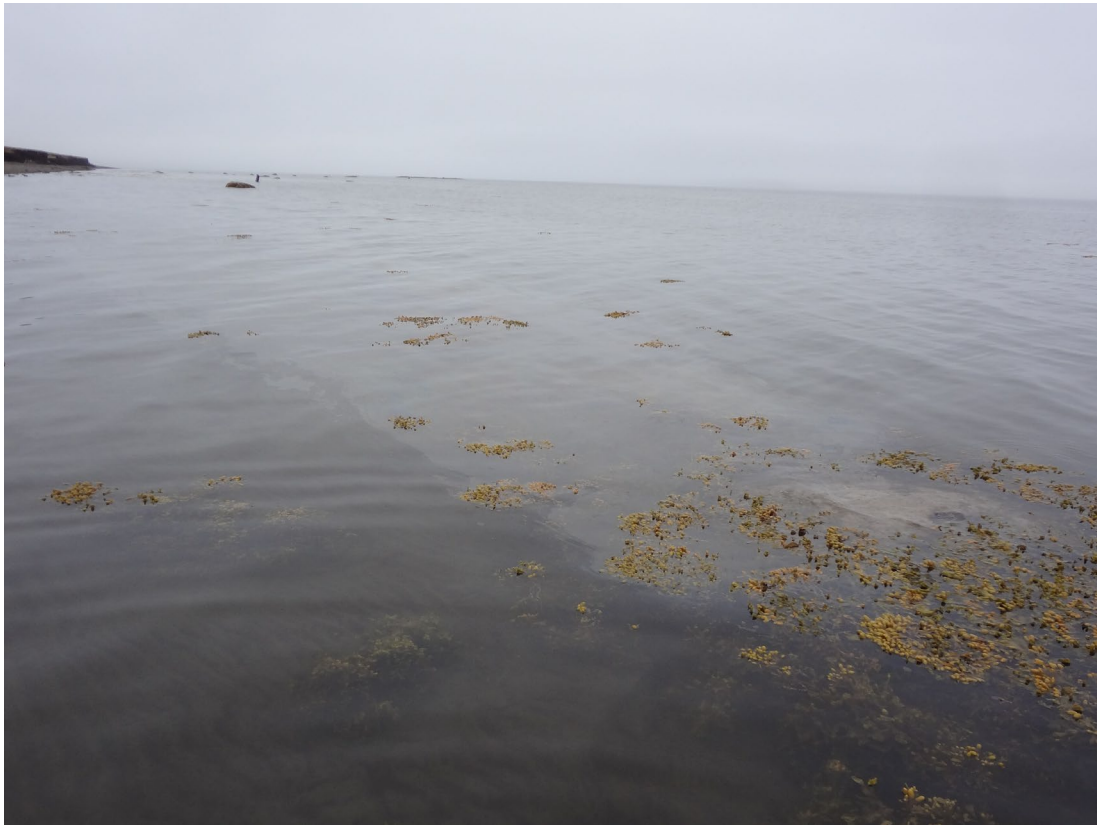
- Oil sheening was observed in the bay originating from the general area of Well #1.
- An oil odor was noted from the shore in the abandoned well(s) area.
- Monitoring of the area will continue.

Photo 1 – Oil Sheening Originating from Area of Well #1
