**Assessment of Oil Seepage at Shoal Point  
Port au Port Peninsula,  
Newfoundland and Labrador  
Summary Report**

**Department of Environment and Conservation**

7 August 2015

Amec Foster Wheeler Project #: TF1512739

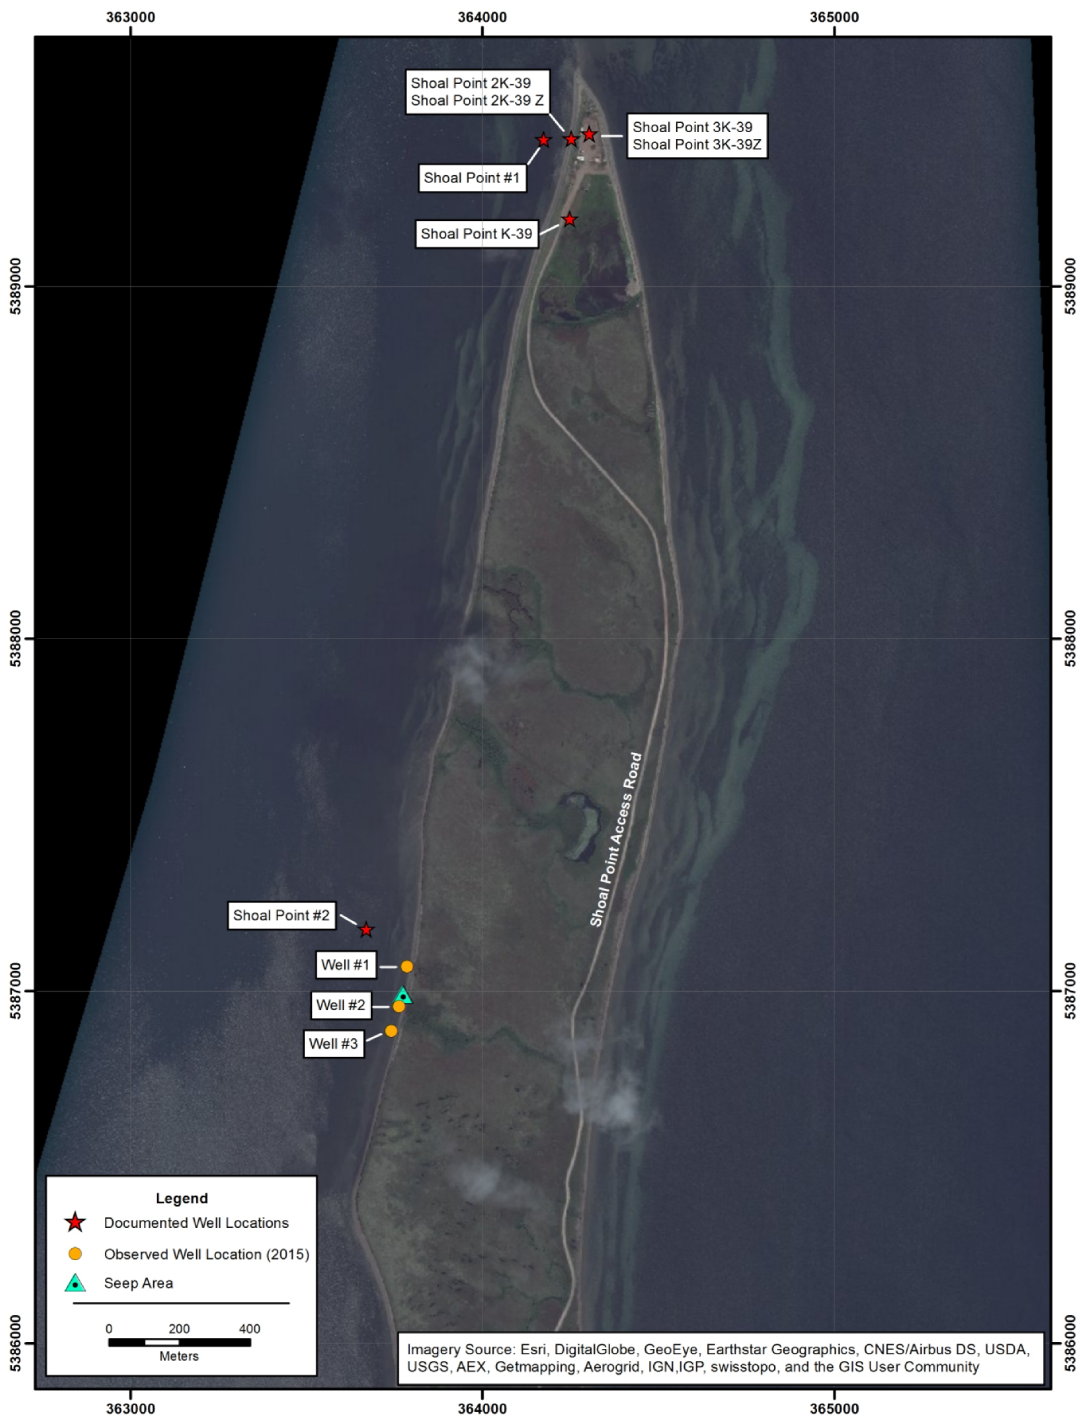
The visual inspection in this area identified three exposed well casings and the seep area, which is not located at a visible well casing location, as was previously observed by NLDEC. The locations of these items are identified on Figure 2 and the distance between each is provided in Table 2. The location of the Shoal Point No. 2 well drilled by Golden Eagle Refining Company of Canada Limited in 1965 was also indicated by the NLDEC representative, however, this well was neither specifically found nor inspected during the July 15, 2015 site visit.

**Figure 2: Location of Well Casings and Seep Identified during July 15, 2015 Site Visit.**

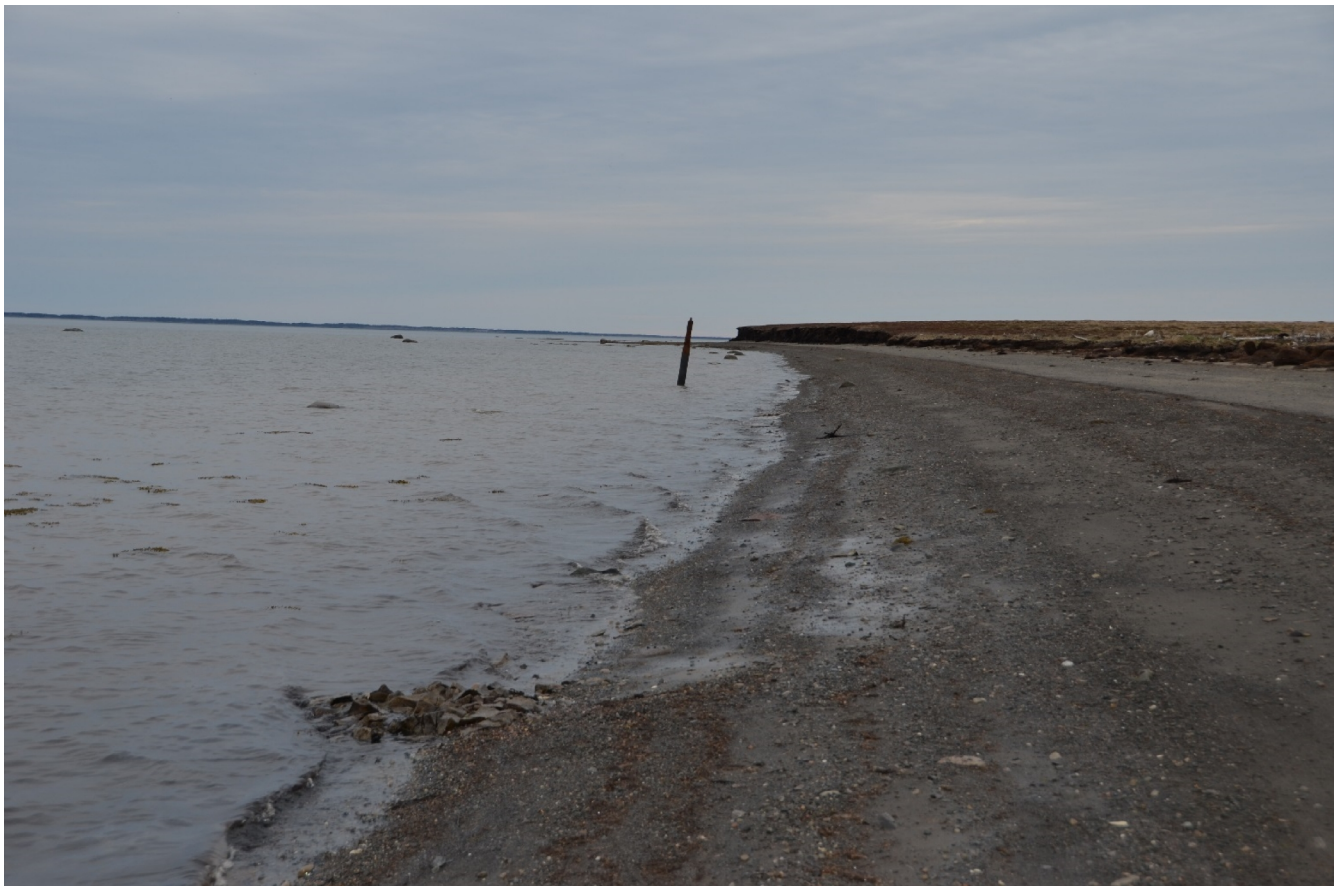
**Photo 1: July 15, 2015 Shoal Point Investigation - Well 1.**

| Well No. | Location | Outer Casing Diameter (cm) | Inner Casing Diameter (cm) | Comments |
|---|---|---|---|---|
| 1 | 48°37'18.7"N<br>58°50'54.2"W | 30 | 20 | <ul style="list-style-type: none"> <li>▶ Strong detection on metal detector from 7 m away;</li> <li>▶ Inner casing has cap with threaded coupling;</li> <li>▶ No odour and no artesian flow apparent;</li> <li>▶ Casing extends approximately 3 m out of the substrate and is fully out of the water at low tide;</li> <li>▶ The pipe enters the substrate at a 70° to 80° angle.</li> </ul> |

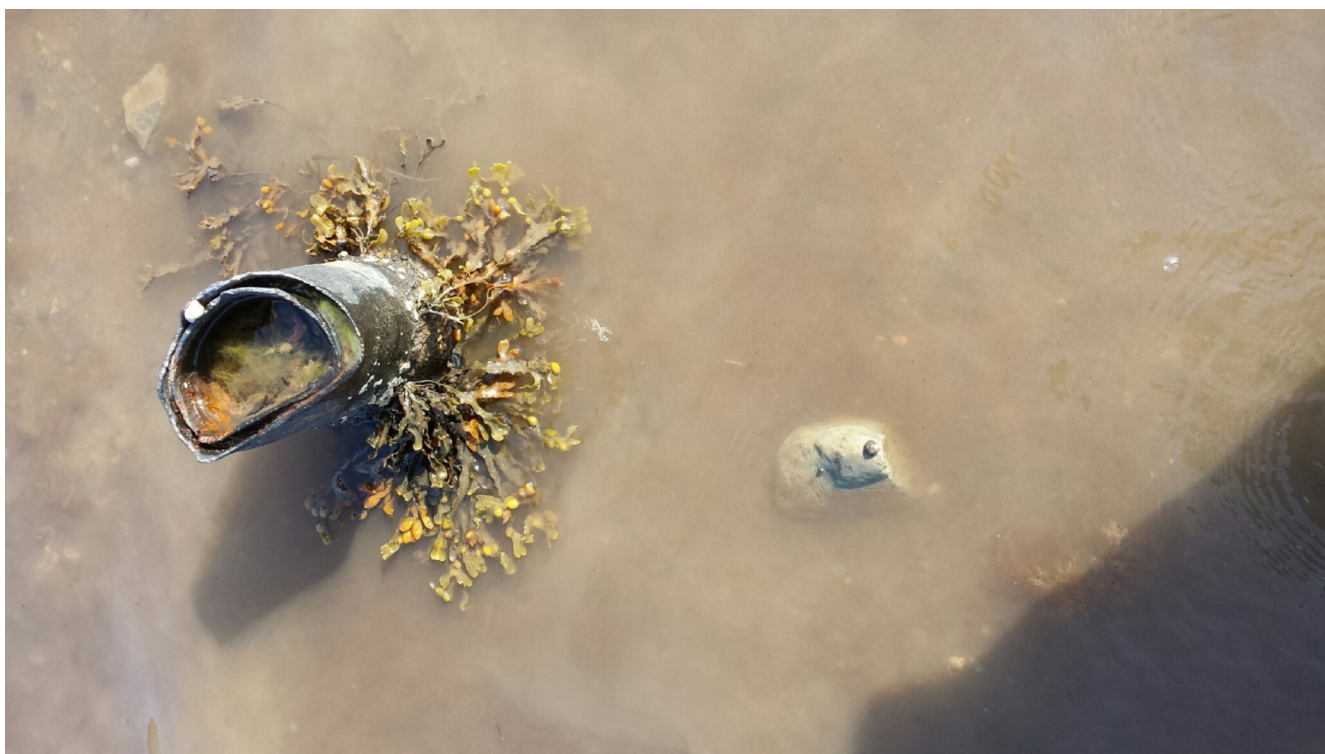
**Photo 2: July 15, 2015 Shoal Point Site Investigation – Well 2**

| Well No. | Location | Outer Casing Diameter (cm) | Inner Casing Diameter (cm) | Comments |
|---|---|---|---|---|
| 2 | 48°37'15.0"N<br>58°50'55.2"W | 20 | 15 | <ul style="list-style-type: none"> <li>▶ Strong detection on metal detector from 7 m away;</li> <li>▶ Evidence of slight artesian flow almost drying up before reaching the water approximately 20 cm below the top of the casing;</li> <li>▶ No visible hydrocarbon or odour;</li> <li>▶ The casing extends less than 0.5 m above the substrate, is exposed at low tide, but is fully submerged at high tide.</li> </ul> |

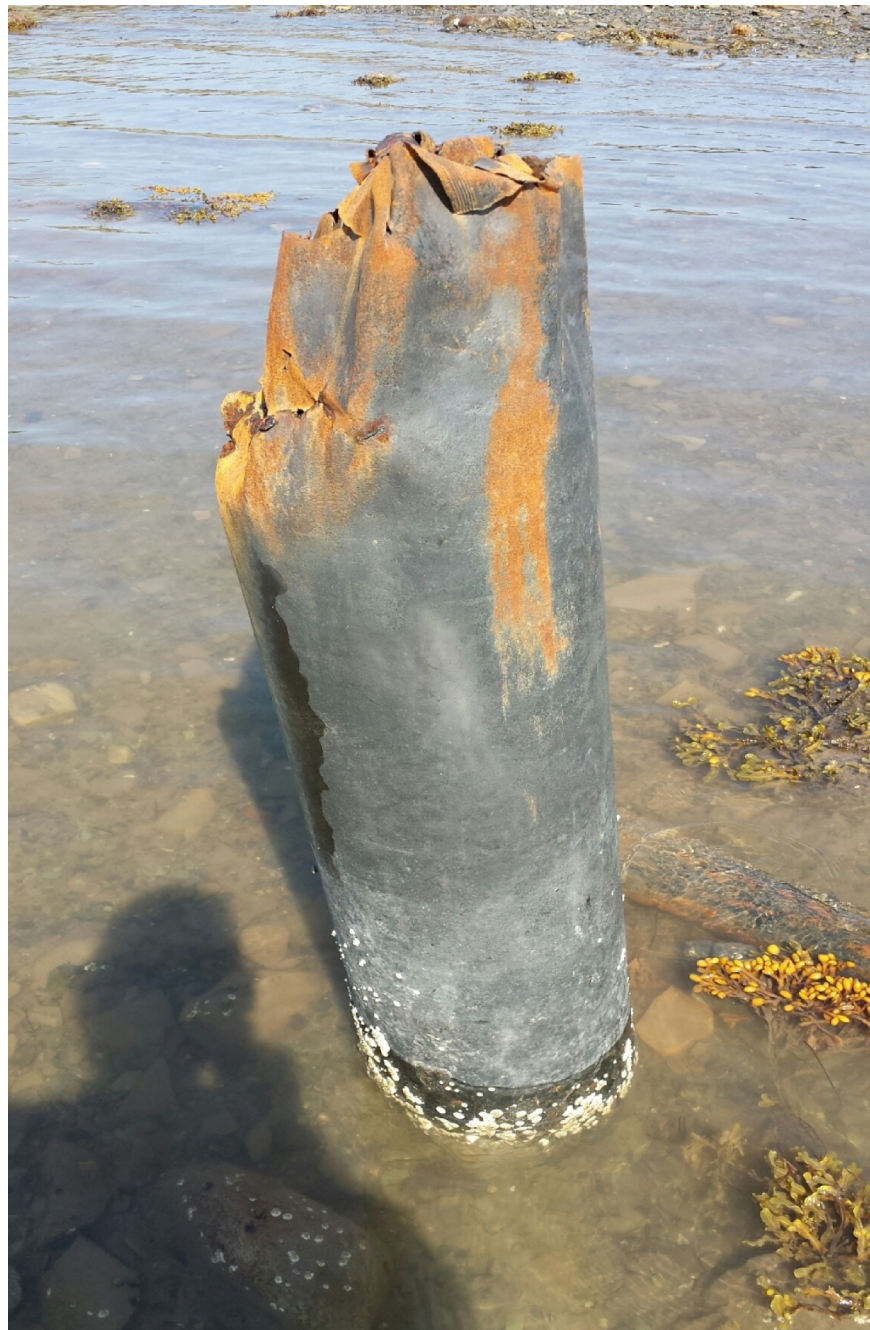
**Photo 3: July 15, 2015 Shoal Point Site Investigation – Well 3.**

| Well No. | Location | Outer Casing Diameter (cm) | Inner Casing Diameter (cm) | Comments |
|---|---|---|---|---|
| 3 | 48°37'12.7"N<br>58°50'56.2"W | 30 | 20 | <ul style="list-style-type: none"> <li>▶ Strong detection on metal detector from 7 m away;</li> <li>▶ Outer casing has a blackened coating;</li> <li>▶ No evidence of oil on or around piping;</li> <li>▶ No visible hydrocarbon or odour;</li> <li>▶ The casing extends less than 1 m above the substrate, is exposed at low tide, but is fully submerged at high tide.</li> </ul> |

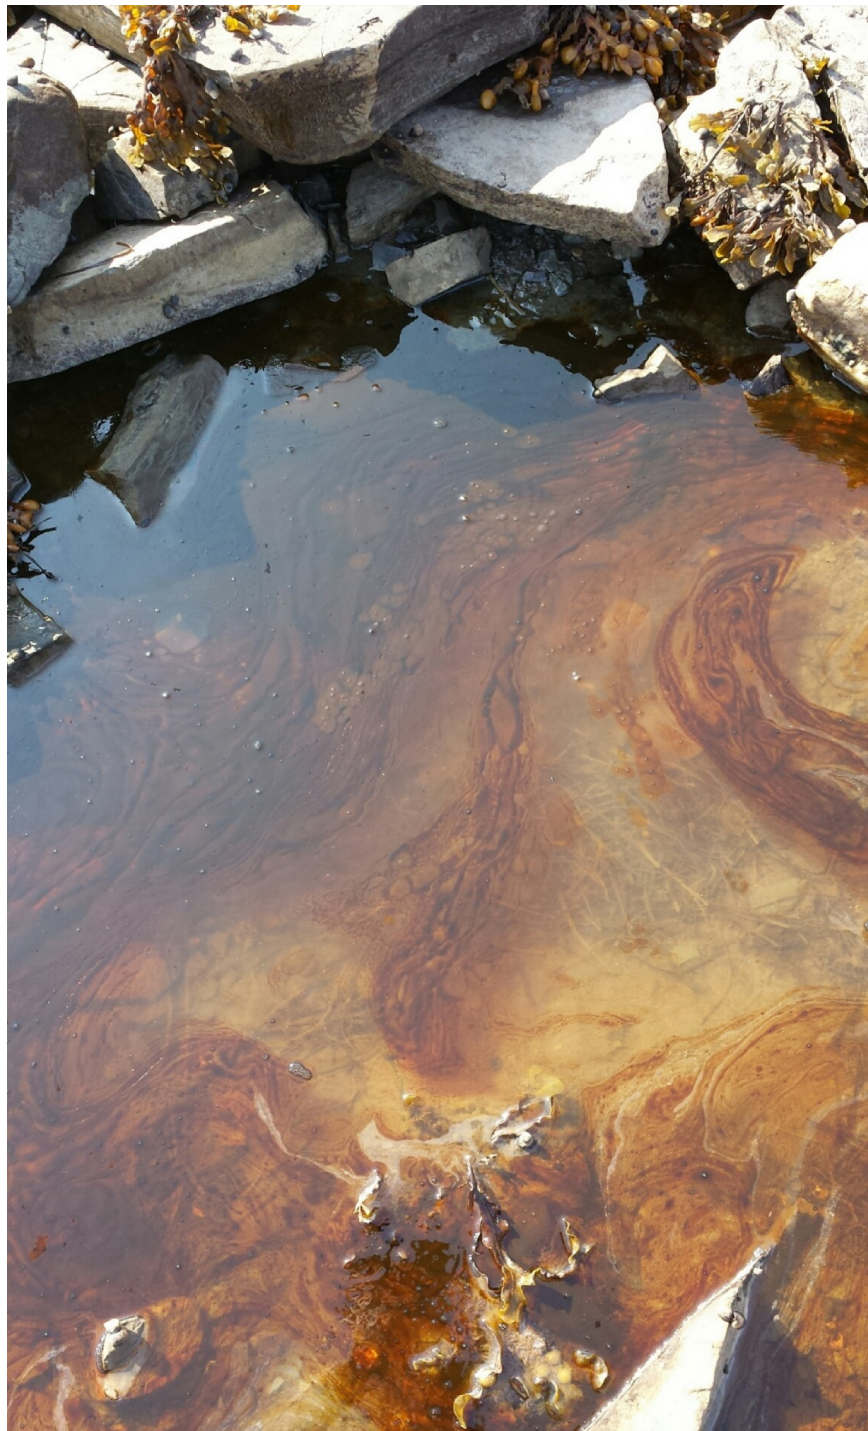
| Well No. | Location | Outer Casing Diameter (cm) | Inner Casing Diameter (cm) | Comments |
|---|---|---|---|---|
| Oil Seep Area | 48°37'16.1"N<br>58°50'54.8"W | Unknown | Unknown | <ul style="list-style-type: none"> <li>▶ Strong detection on metal detector from 7 m away;</li> <li>▶ Bubbles coming up from several locations in the immediate area of a small rock dammed pool surrounding a shallow pool of oil water mixture;</li> <li>▶ Is exposed at low tide, but is fully submerged at high tide; observed oil flow estimated on the order of 1.0 litre per hour.</li> </ul> |

The immediate area of the oil seepage was found to be surrounded by a small rock dam in which a shallow pool of water remained at low tide. Intermittent bubbling occurred within this pool during the time of inspection and oil accumulated on the surface of the water in the pool over that period. The quantity of oil seepage was sufficient to cover the pool in an hour and was roughly estimated by comparison of visible coverage at initial inspection and visible coverage at the end of the inspection period to be on the order of one litre per hour at that time. It is not known if the rate of seepage is constant over time or how the tide and groundwater fluctuations may affect the rate. Further monitoring would be required to appropriately evaluate potential variability in the seepage rate.

This sheen is emanating from an area located between two of the wells casings, where oil is seeping through soil comprising of clay, silt, sand, gravel and some cobble and small boulders. This seepage appears to be isolated to a single location in the intertidal zone. Bubbling is evident throughout the small pool where this seepage is occurring, indicating the presence of gas release. The signal received by the metal detector at the seepage area indicates there is strong potential that the oil is originating from, or

near, a fourth well casing that has broken off, or was terminated at the time of drilling, below the surface at this location.

**Photo 4: July 15, 2015 Shoal Point Site Investigation – Shoreline Oil Seep.**

Assessment of the condition of the evident subsurface well casing, and remediation of the leakage, cannot be undertaken without first removing the surrounding overburden and rocky materials to reveal the casing. In order to safely excavate in this area, and to provide protection to the surrounding environment against the continued release of hydrocarbon, it is necessary to isolate the seepage area and the associated excavation from flooding during high tide. Once the area has been isolated and the casing uncovered, the condition of the casing and the appropriate means of repairing the leakage can be assessed.

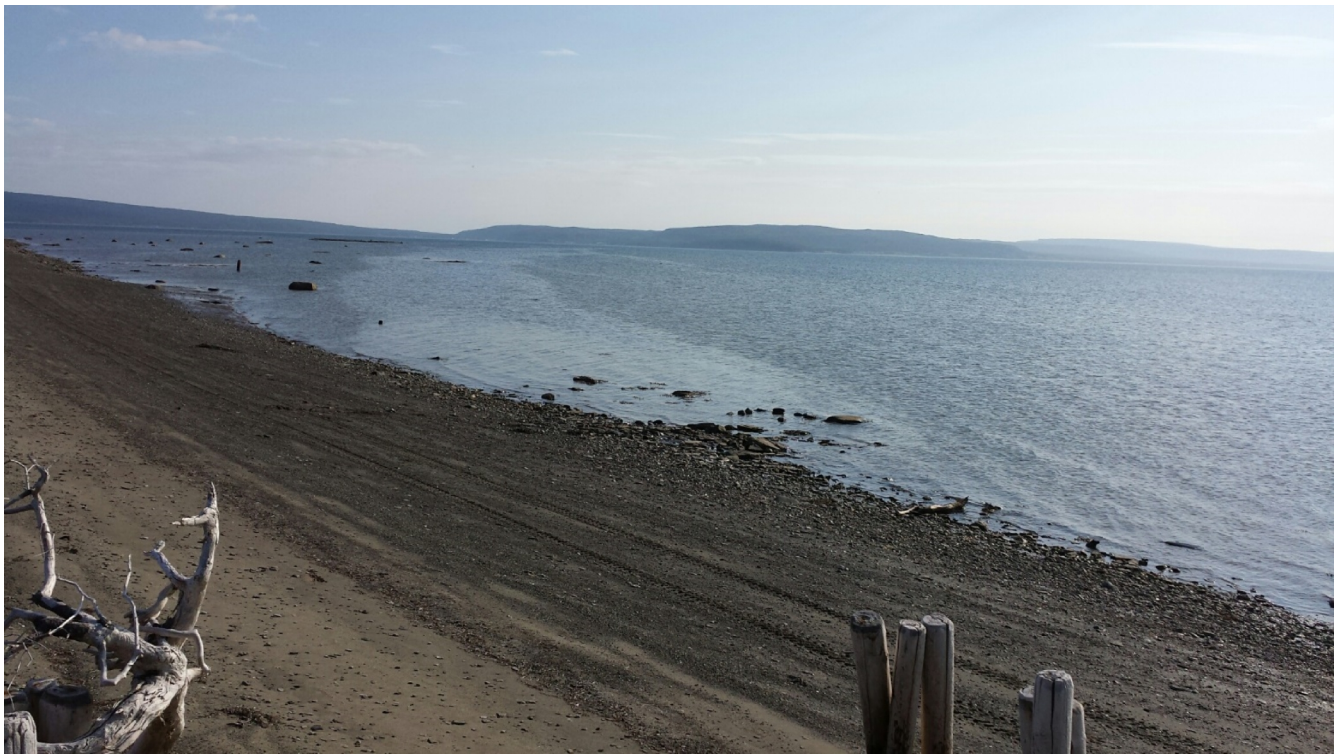
Each of the three visible well casings and the identified seep area are located in the intertidal zone of the shoreline and within a metre of the low water mark at the time of the investigation. The investigators accessed the area during the low tide period and remained in the area for about two hours as the tide returned to the seepage site and the visible well pipes. This allowed the investigators to visually locate any sheen of oil on the water surface as the tidal water submerged these locations. It was apparent that an oily sheen was emanating from the seepage site and that no other source of sheen was apparent.

**Photo 5: July 15, 2015 Shoal Point Site Investigation – Oil Sheen Emanating from Shoreline Seep.**
