Investigation and Mitigation of Leaking Abandoned Underground Oil Well Casing Completion Report (Final)

Shoal Point, NL – ENVC-SP-2015-1

## Investigation and Mitigation of Leaking Abandoned Underground Oil Well Casing, Shoal Point, NL Completion Report

18 December 2015 Amec Foster Wheeler Project #: TF1512740

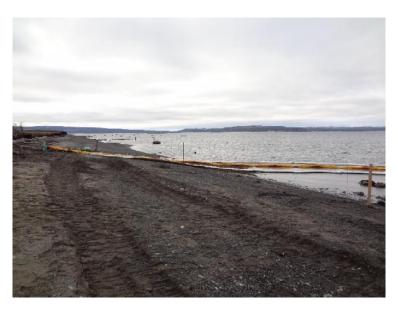
Photo 7 – View south of second leaking oil well casing beyond oil absorbent booms and turbidity curtain.

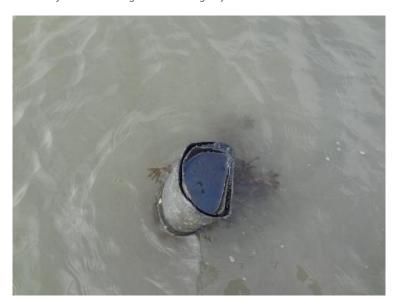
Photo 8 – Close-up view of leaking oil well casing No. 2 to the south of the main well casing.

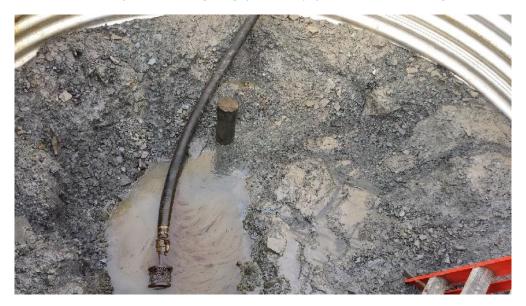
Photo 2 – Exposed well casing No.1 with existing threaded coupling attached.

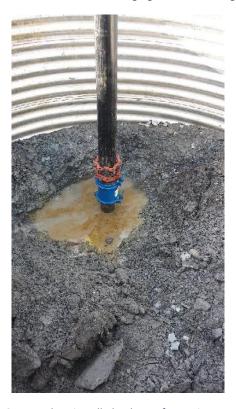
Photo 6 – Megalugs installed at base of new pipe extension.

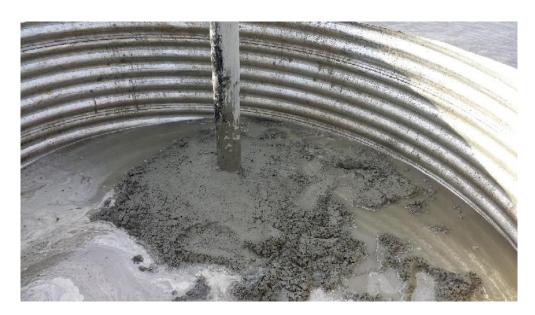
Photo 7 – Concrete fill placed around coupling and megalugs.

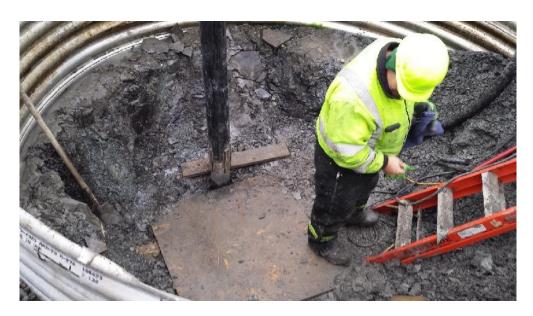
Photo 5 – View of completed extension pipe connection to existing casing.

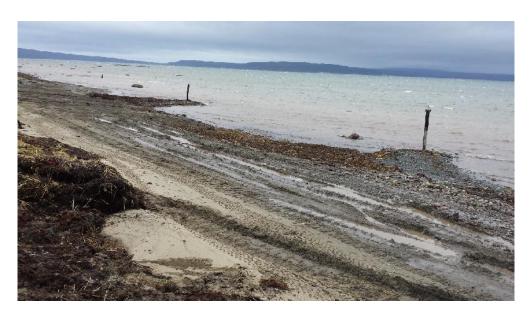
Photo 3 – View of extended well casing Nos. 1 & 2 at end of project.

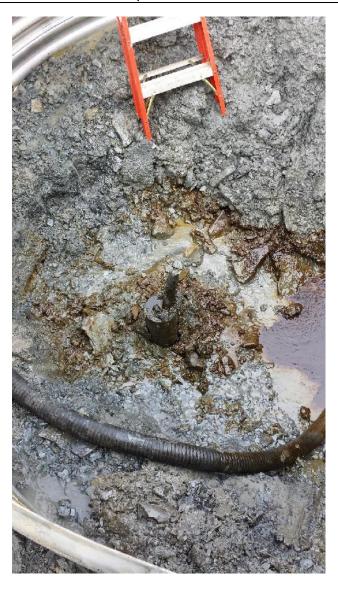
Uncovered Well Casing at about 12:30 PM.

A 2" Diameter pipe was lodged in the 6" casing. It was about 10' long and was removed by hand. A portion of the pipe broke off and remains in the casing. Probing with a steel bar showed that the casing was filled with apparent sand and gravel.

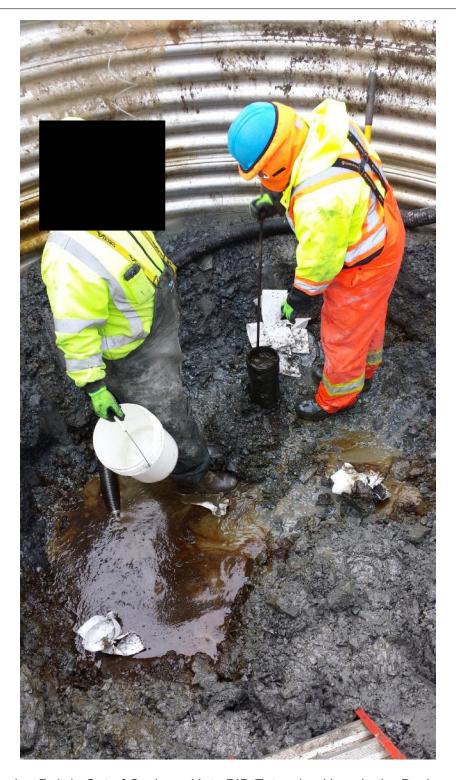
Cleaning Debris Out of Casing - Note PID Extension Hose in the Background

The original drilling mud and cuttings were visible immediate adjacent to the casing. The men are standing on broken shale bedrock.

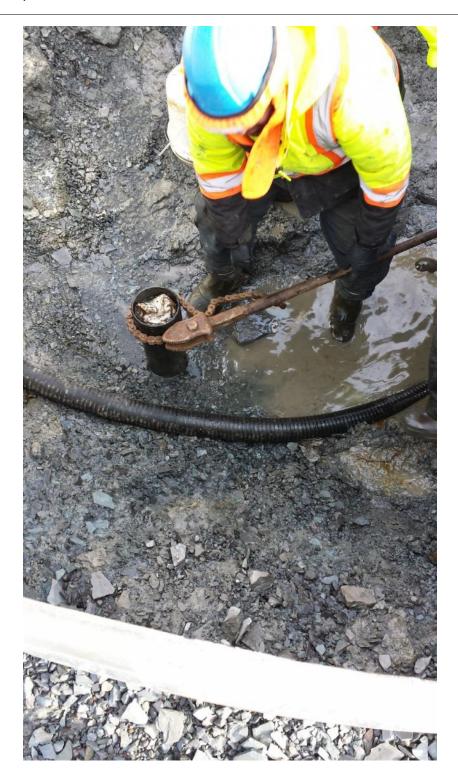
Tightening Coupling on Casing ~1/2 Turn

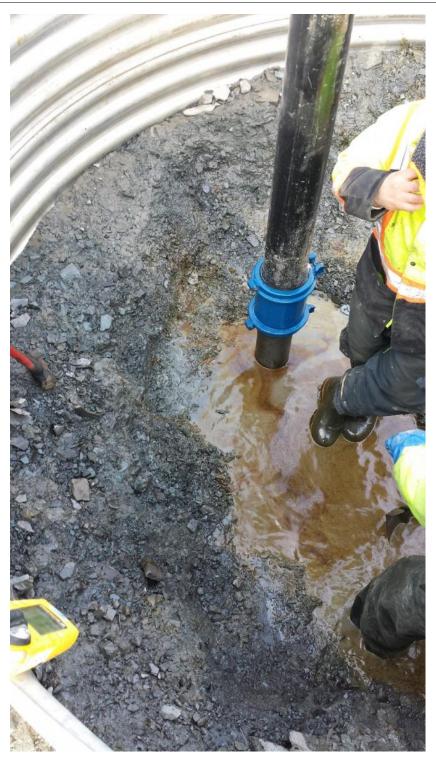
Dresser Coupling and Riser (workers had just cleaned the soil and loose bedrock down to solid bedrock. Note the oil on the water and oozing out from pockets in the rock).

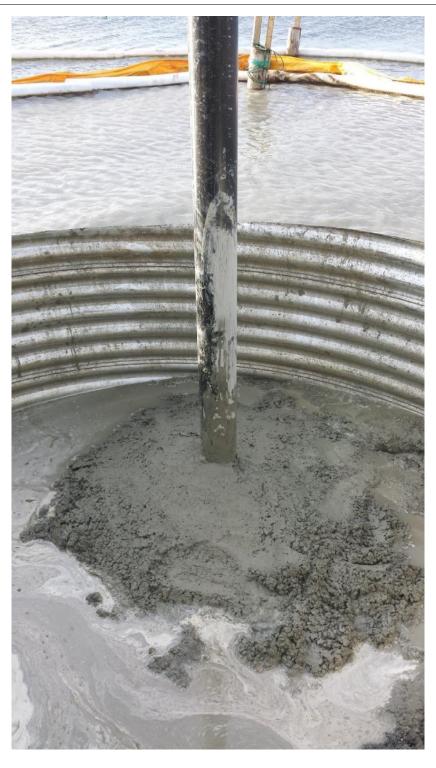
35 MPa concrete placed

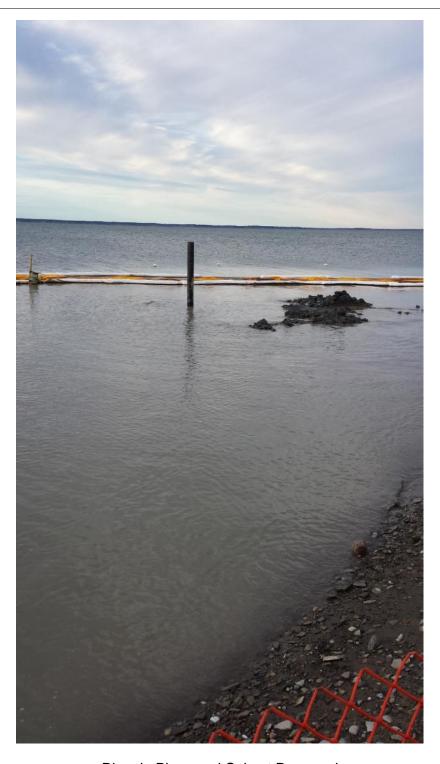
Riser in Place and Culvert Removed

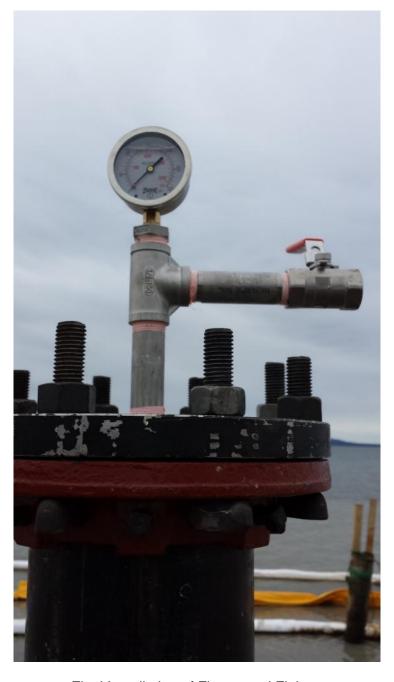
Final Installation of Flange and Fittings

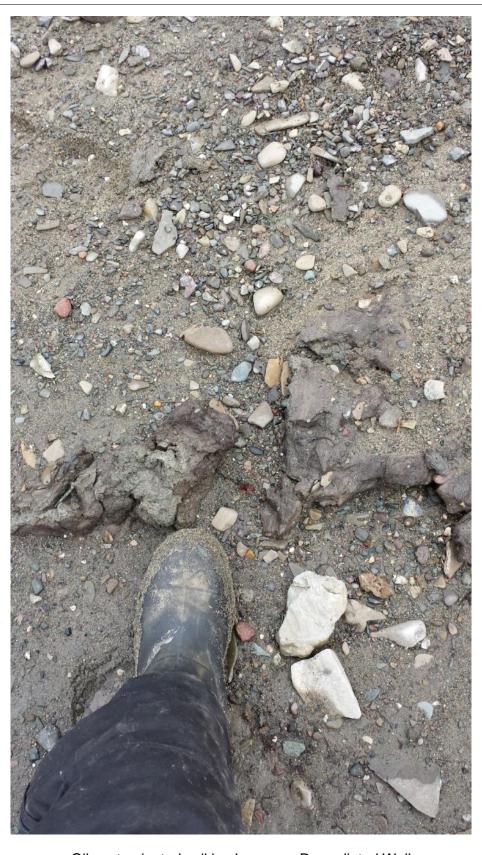
Oil contaminated soil in place near Remediated Well

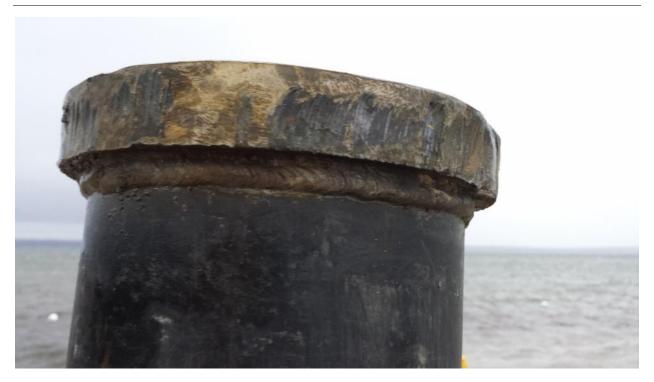
Modified 200 mm flange welded to Well #2 Riser

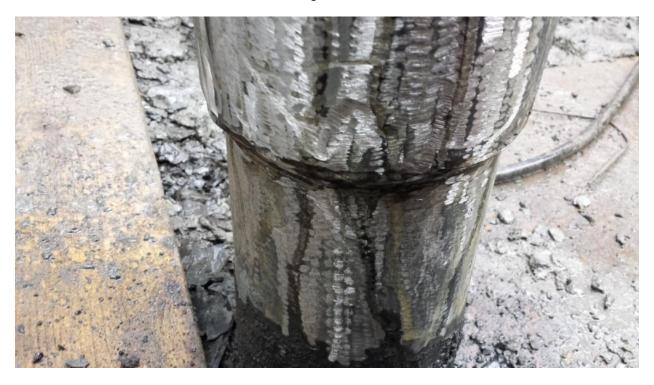
- We had to bring the articulated truck back out to the site to deliver the welder. It was difficult going.
- When we were placing the new riser on the existing casing we found that the new could slide down over the existing and fit snugly. It appears that the old pipe is 6" OD while the new is 6" ID. We held it at 125 mm overlap due to restricted working space and welded at that location. Five reinforcement straps were used instead of the four specified (we had the material at hand). With this we felt that we had a significantly stronger connection than at the first well. No concrete was available on Sunday. With this in mind along with the poor condition of our beach road and pending forecast strong winds NW for later Monday into Tuesday we decided (with consultation with the designer and project manager) that the addition of concrete at this particular site was both not needed nor practical at this time.

New 6" ID riser pipe welded onto old 6" OD casing (5" overlap)

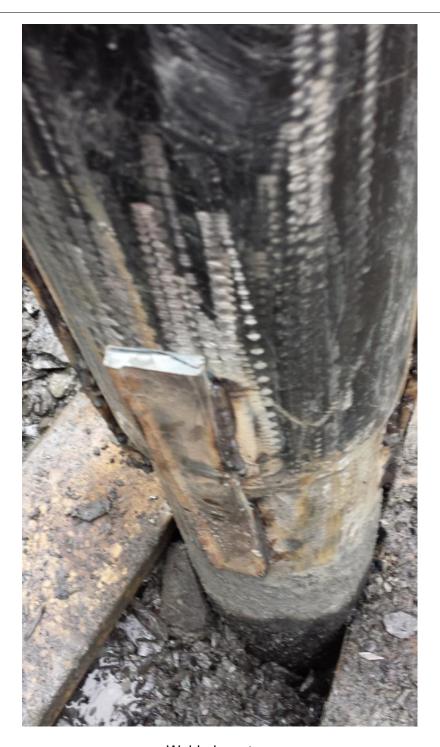
Welded on strap
