# **Site Inspection Summary**

## **Abandoned Oil Wells - Shoal Point**

### **Purpose of Inspection** Ongoing Monitoring of Abandoned Oil Wells at Shoal Point

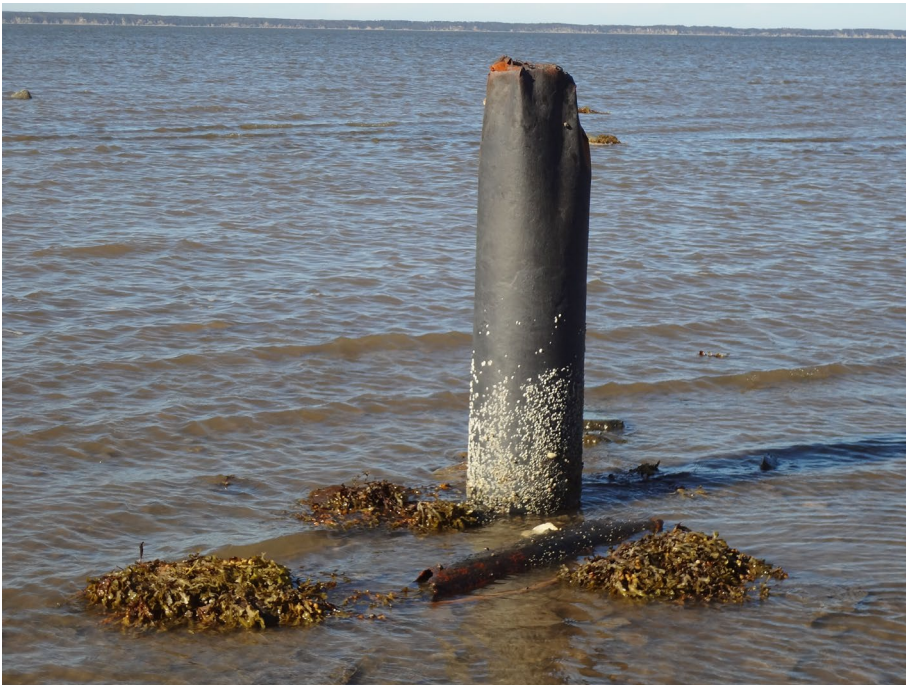
Photo 3 - Abandoned Well Casing

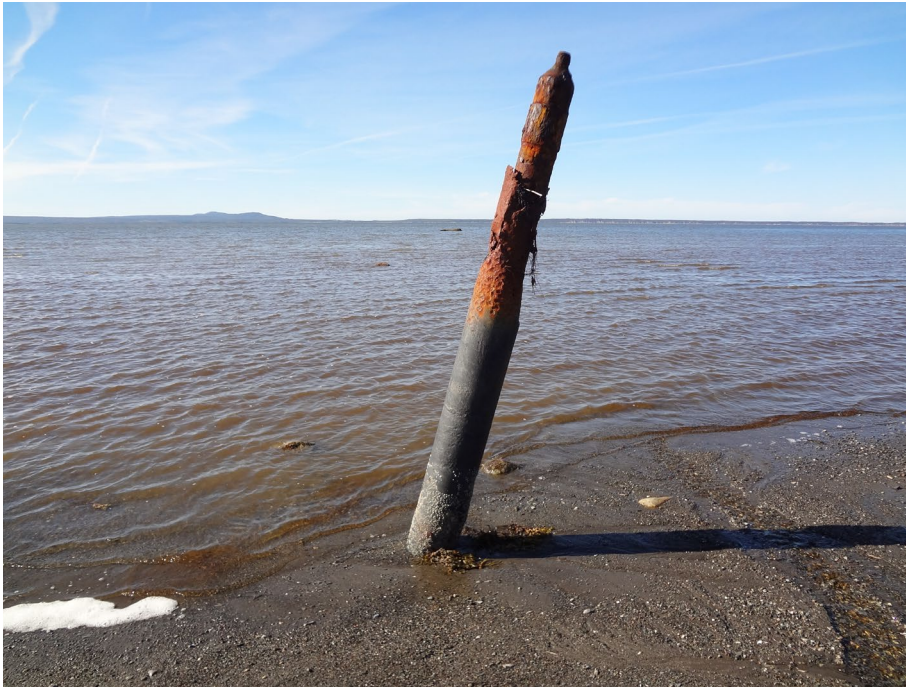
Photo 4 - Abandoned Well Casing

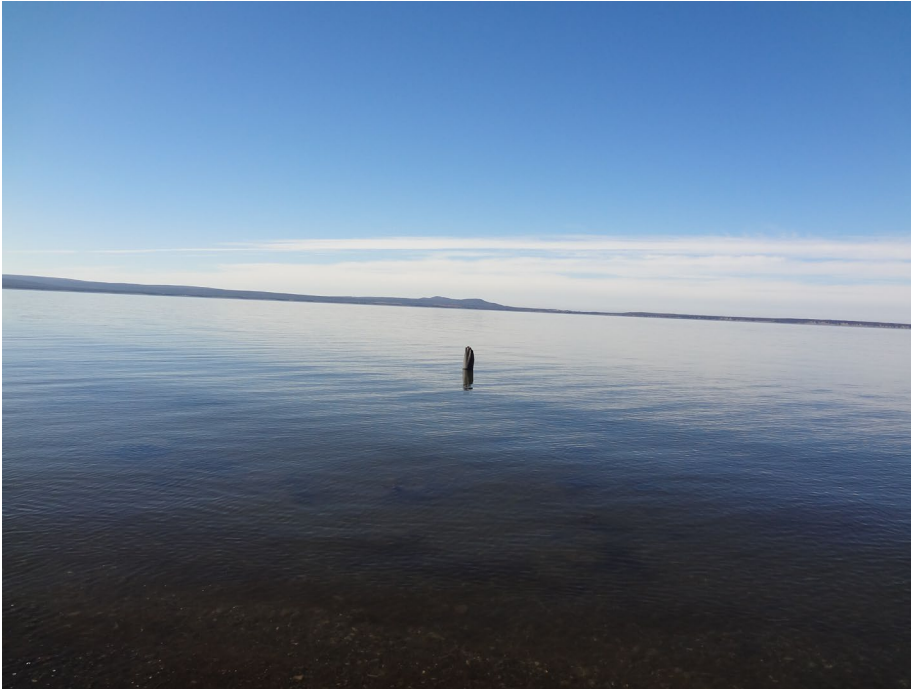
Photo 2 – Abandoned Well Casing

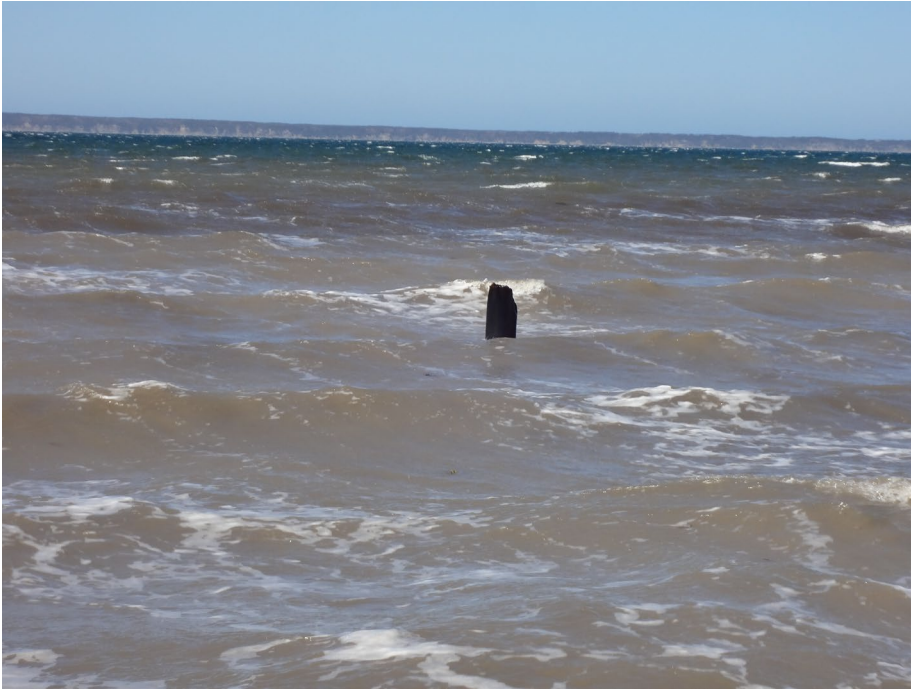
Photo 2 – Abandoned Well Casing

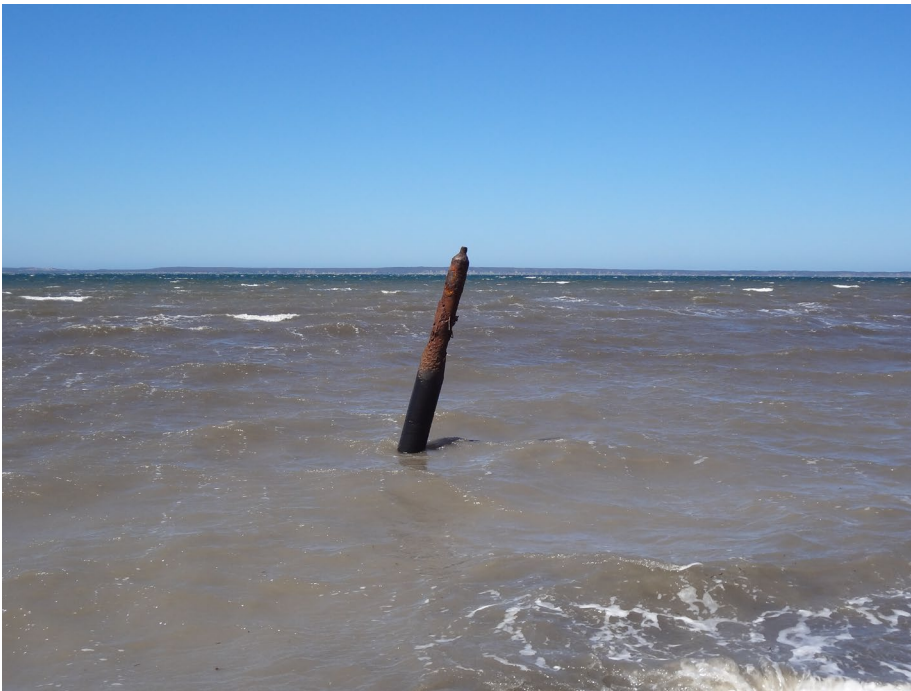
Photo 3 - Abandoned Well Casing

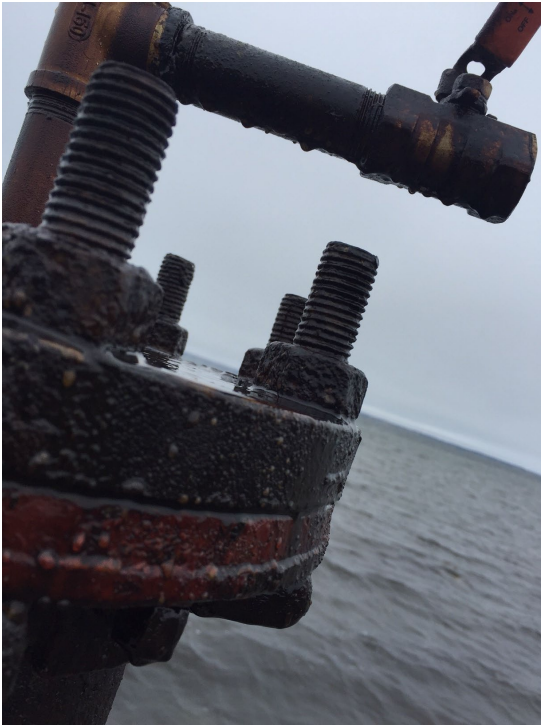
- The pipe extension associated with Well Repair #1 remains intact. The concrete base in the water is also intact.
- Oil residue is present at the top of the pipe and along the exterior of the casing.
- Oil seepage was observed in the vicinity of the well. The exact location of the seepage could not be pinpointed. Seepage appeared to originate at various locations within the water and consisted of sporadic oil releases.
- No visible sign of oil or odor was detected at the other well locations.
- An oil odour was evident along the shore downwind of Well Repair #1.

Photo 2 – Top of Extension Pipe of Well Repair #1

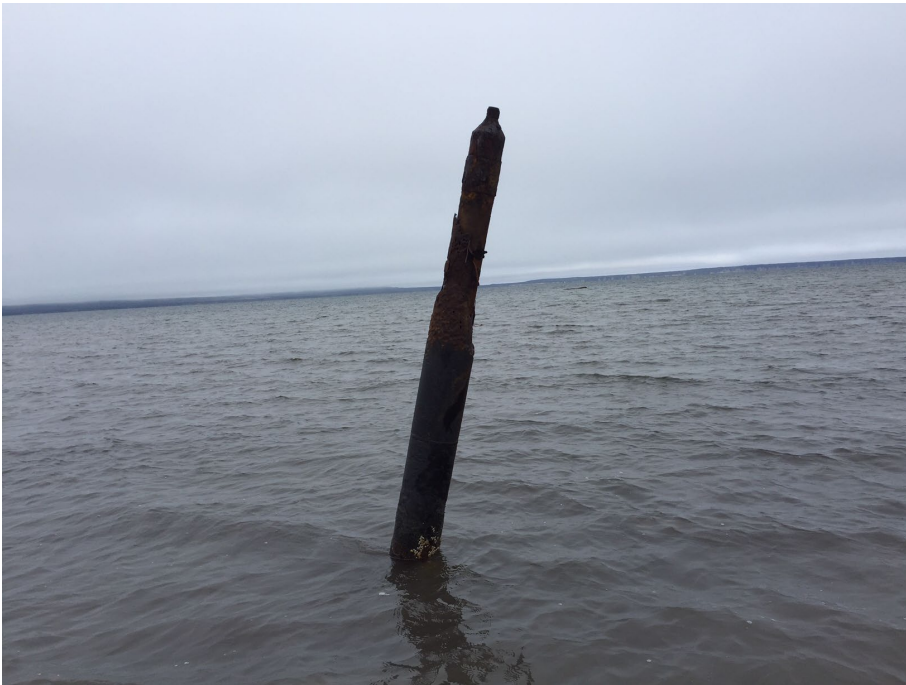
Photo 5 – Abandoned Well Casing

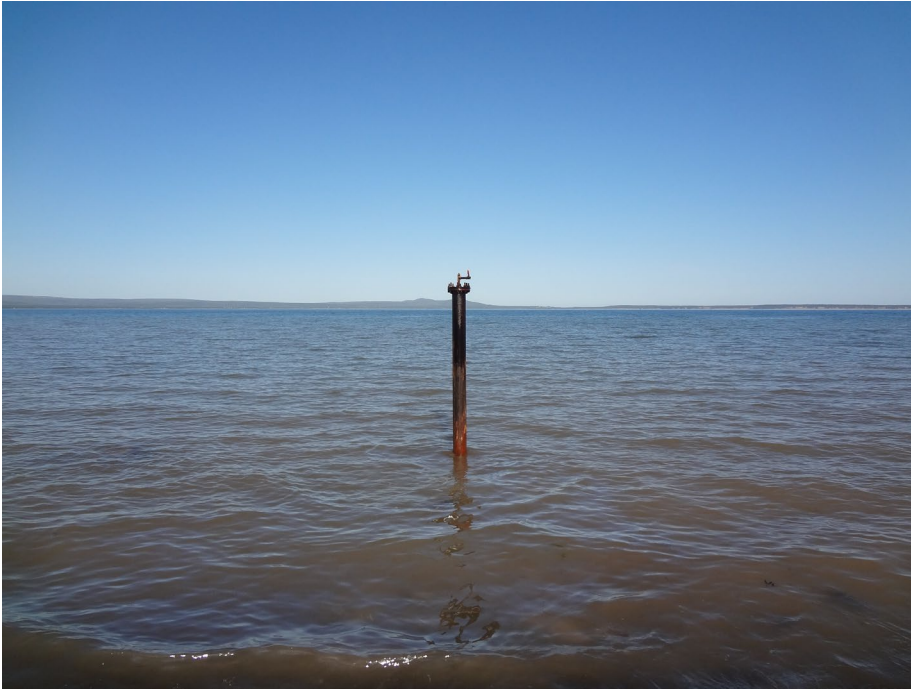
- The three visible well casings are in the water.
- The pipe extension associated with Well Repair #1 remains intact. Oil is observed leaking from the top of the pipe extension where the pressure gauge had previously been located. Oil release is consistent roughly estimated at 15-20 "bubbles" per minute. Released oil builds up on the top plate and drips into the water or on the casing below.
- A strong oil odor is evident near the leaking well.
- Slight oil sheening is evident along the beach surface as the tide recedes.
- No visible sign of oil or odor was detected at the other well locations.

Photo 2 – Extension Pipe of Well Repair #1

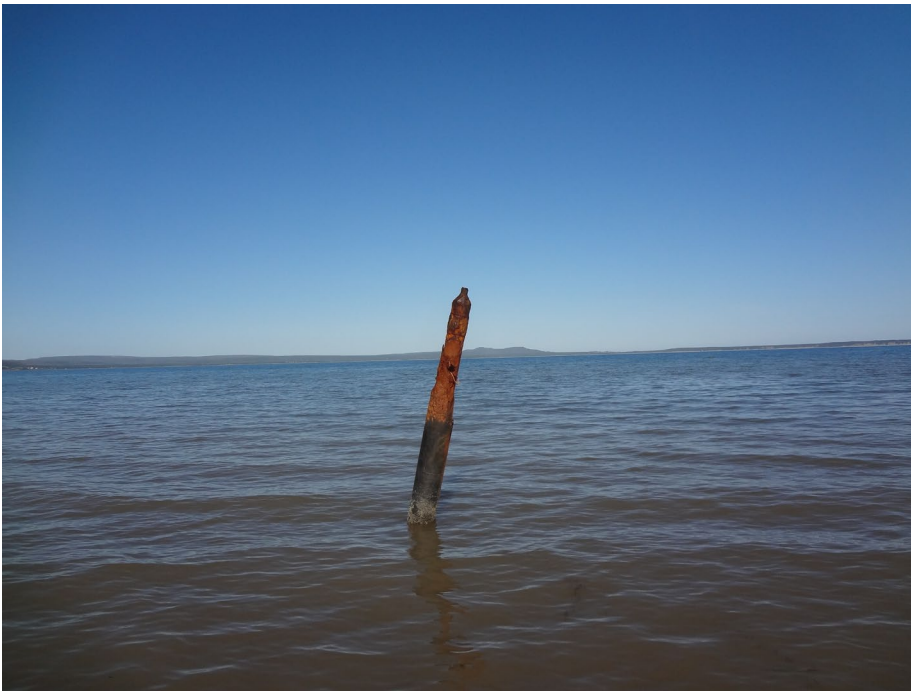
Photo 3 – Abandoned Well Casing

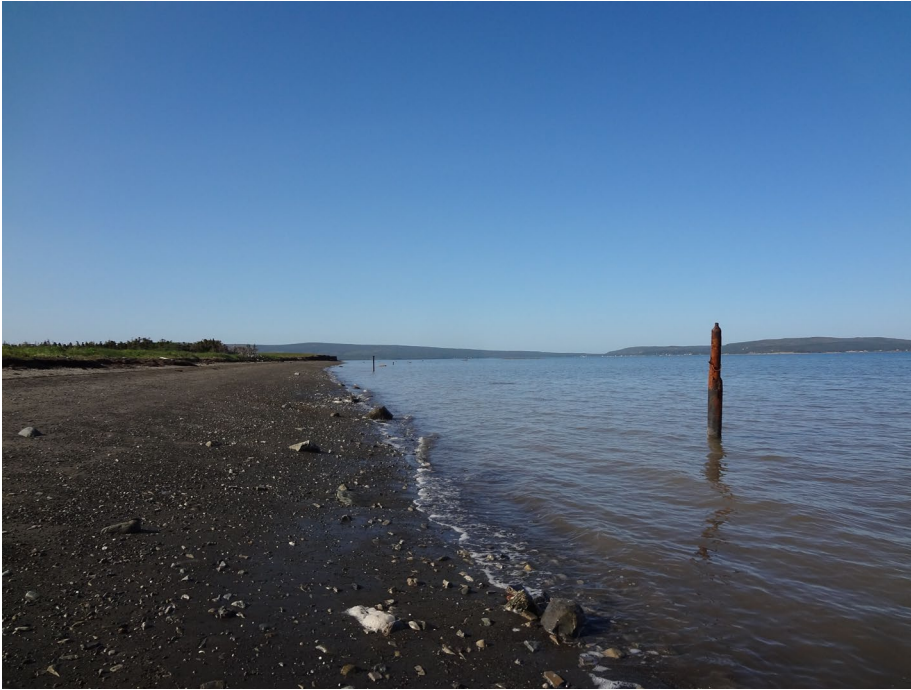
Photo 6 – Three Visible Abandoned Wells

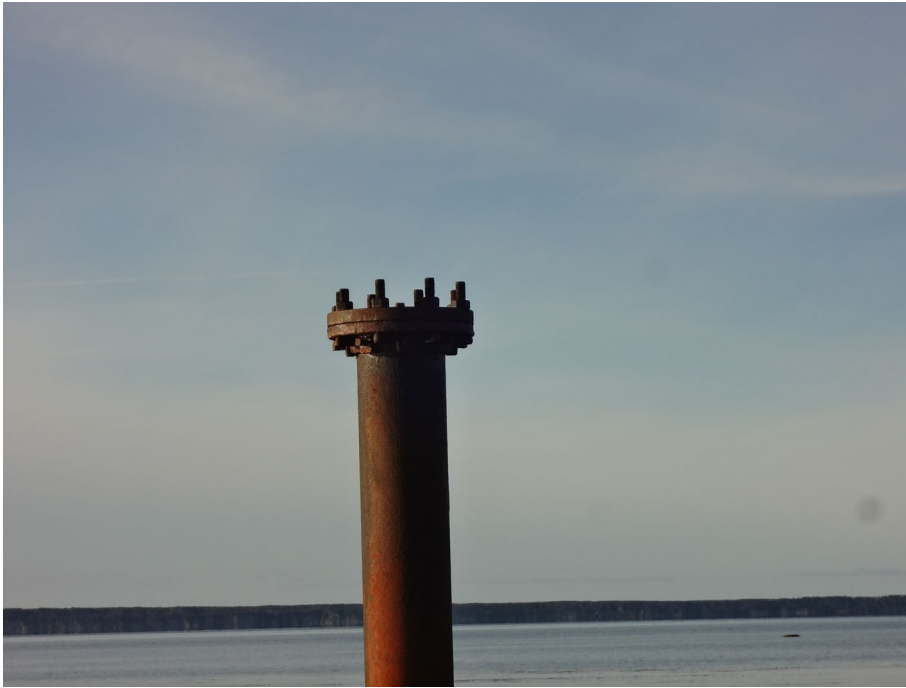
- Oil sheening is noted on the water surface in the general vicinity of Well Repair #1. Oil sheens are formed as small circular patterns originating at random locations within a 3 metre radius of the well casing.
- Oil sheens are quickly dispersed and there is no major sheening observed in the bay.
- Oil sheen patterns are forming at an average rate of one every 20 to 30 seconds.
- There is a faint oil odor downwind of the well.
- Oil sheening is not occurring at any other of the well locations associated with the site.

Photo 2 – Cap Casing of Well Repair #1

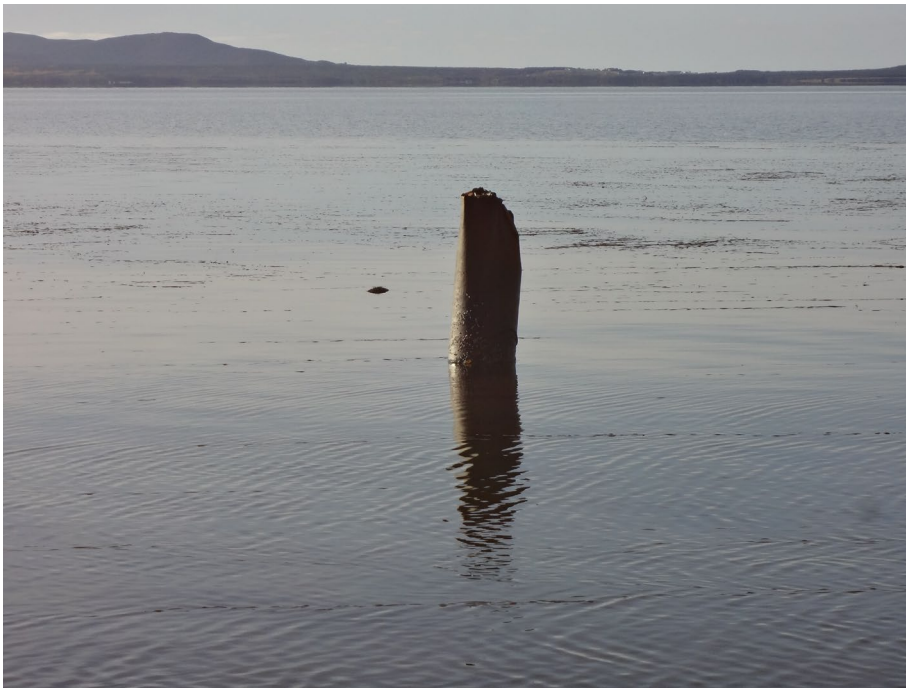
Photo 3 – Abandoned Oil Well Casing

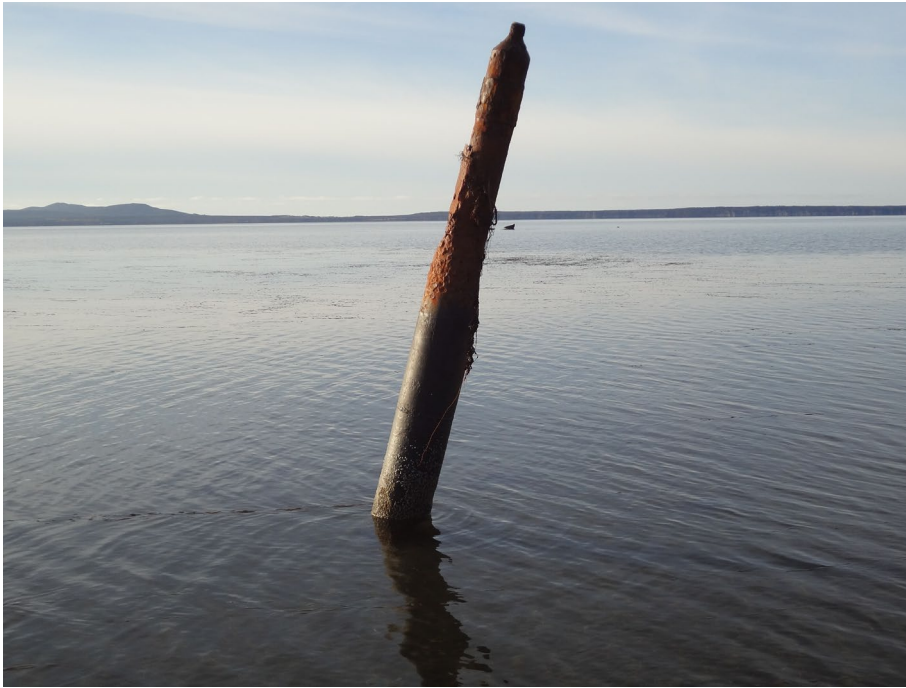
Photo 4 – Abandoned Oil Well Casing

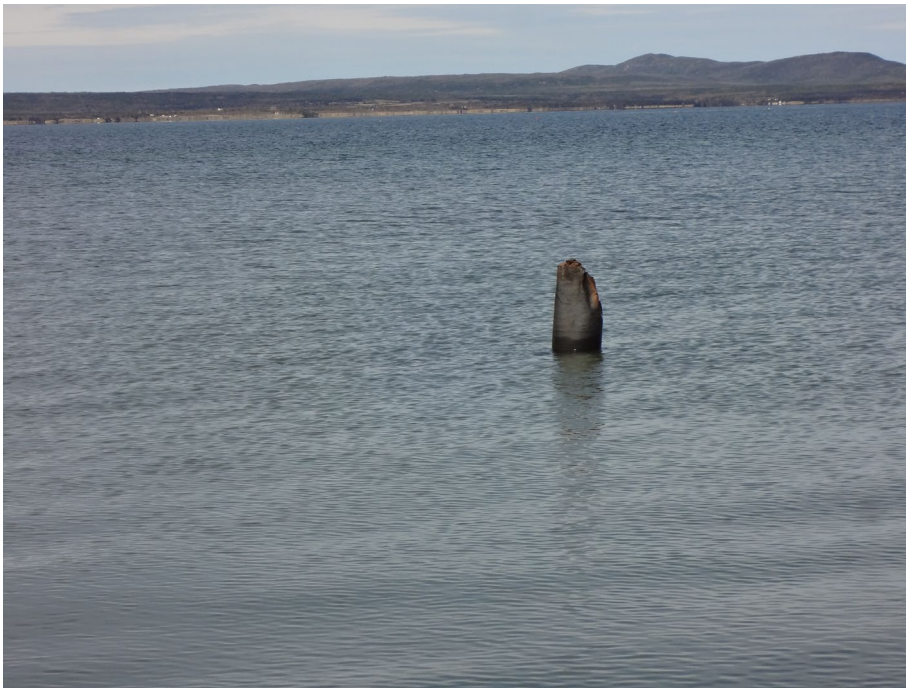
Photo 3 – Abandoned Oil Well Casing (Furthest from the Shoal Point Tip)

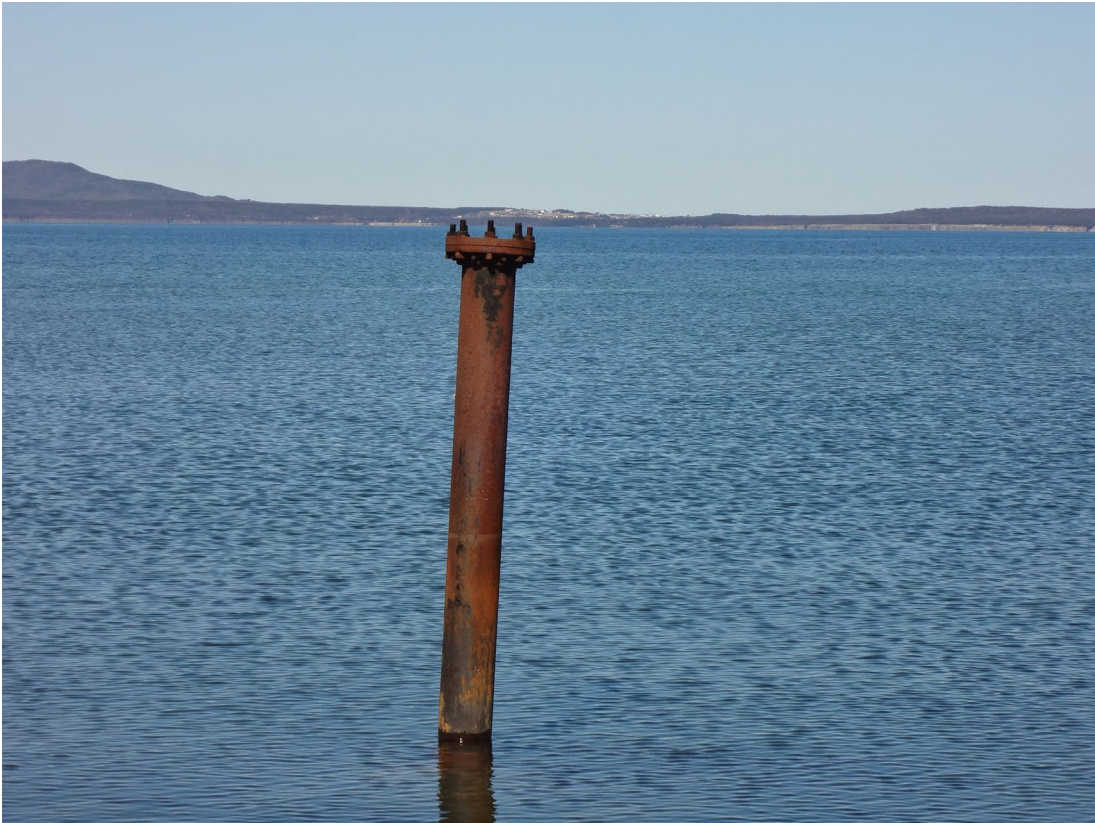
- The water level was high and as a result the wells were not accessible without use of waders/boat.
- This was the first visit to the site since September 2018. There had been a significant buildup of pack ice in the bay for a considerable period over the past winter. The abandoned well casings do not appear to have been impacted by ice movement/force as they remain intact.
- There was no obvious sign of oil release/seepage associated with Well Repair #1 or with any of the other abandoned wells in the area.
- Oil odor was not detected in the area.
- Monitoring of the area for oil seepage will continue.
- The shoreline along this section of Shoal Point continues to display significant signs of erosion. Large sections of shore bank have broken off and have been deposited in the water.
- Seals (3-4) were observed in the bay.

Photo 1 – Abandoned Well Repair #1

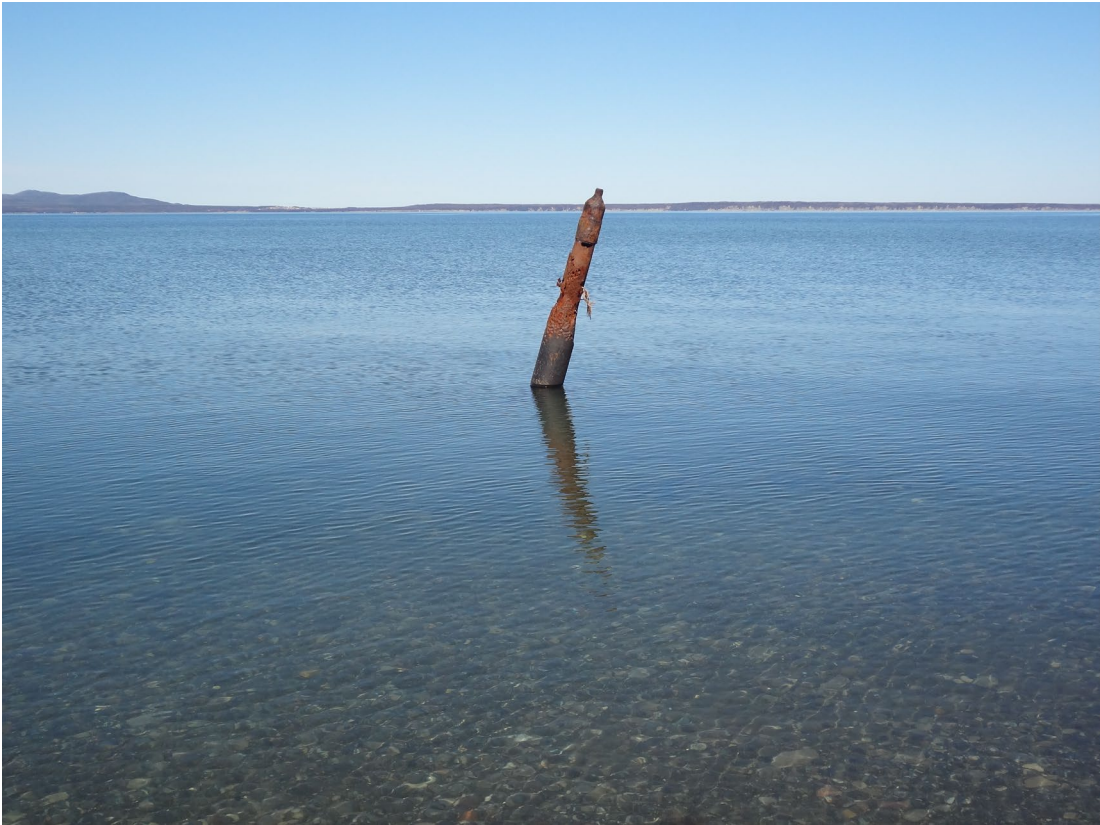
Photo 2 – Abandoned Oil Well Casing (Closest to the Shoal Point Tip)

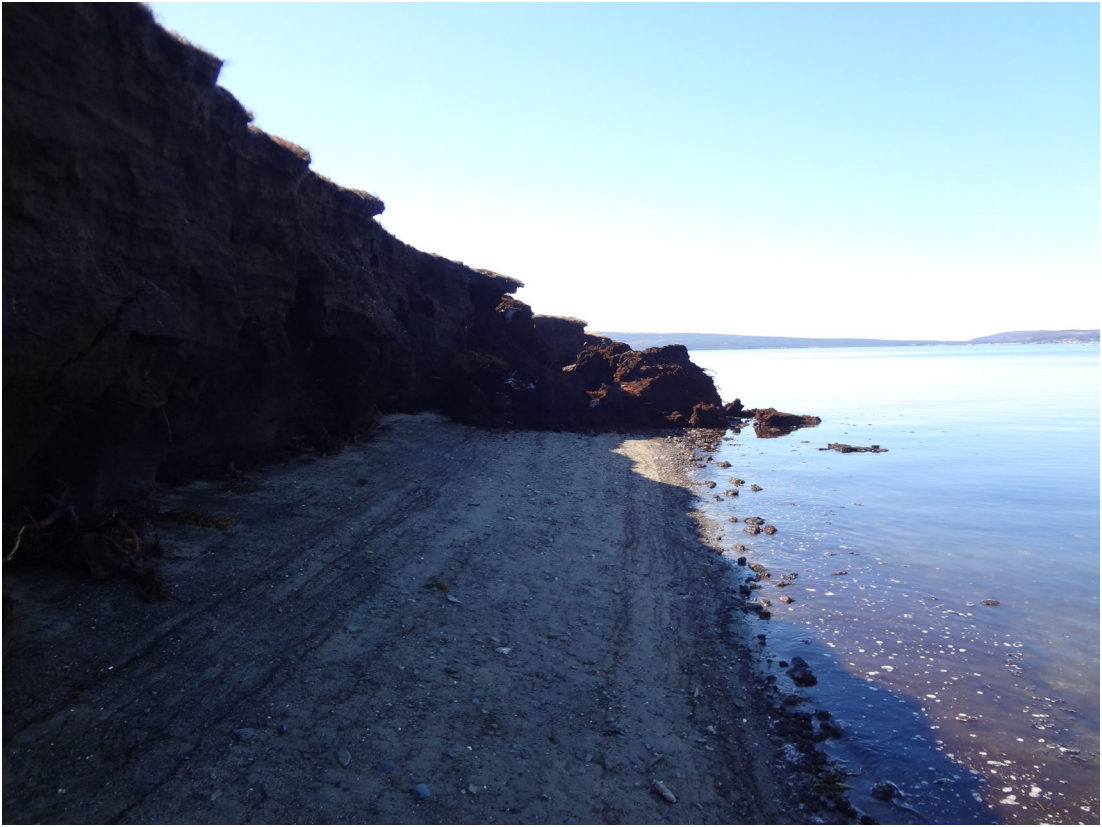
Photo 4 – Erosion of Shoreline at Shoal Point

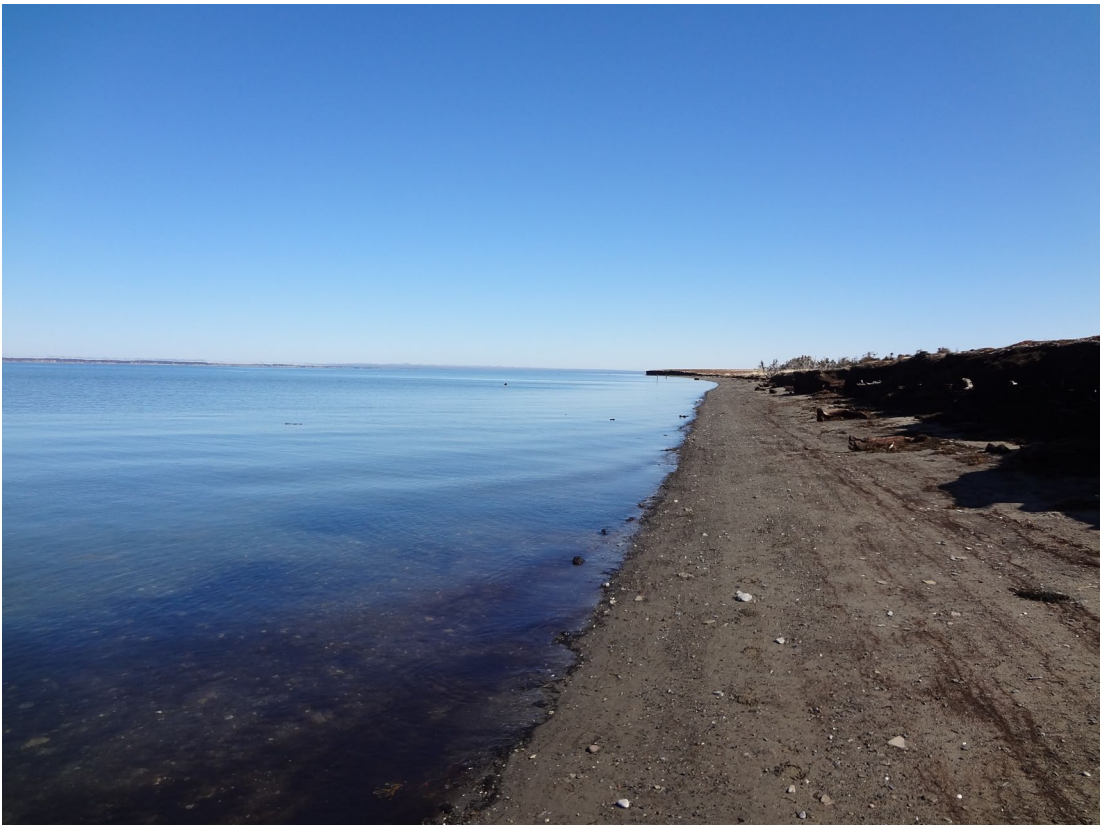
Photo 5 – Abandoned Well(s) Area

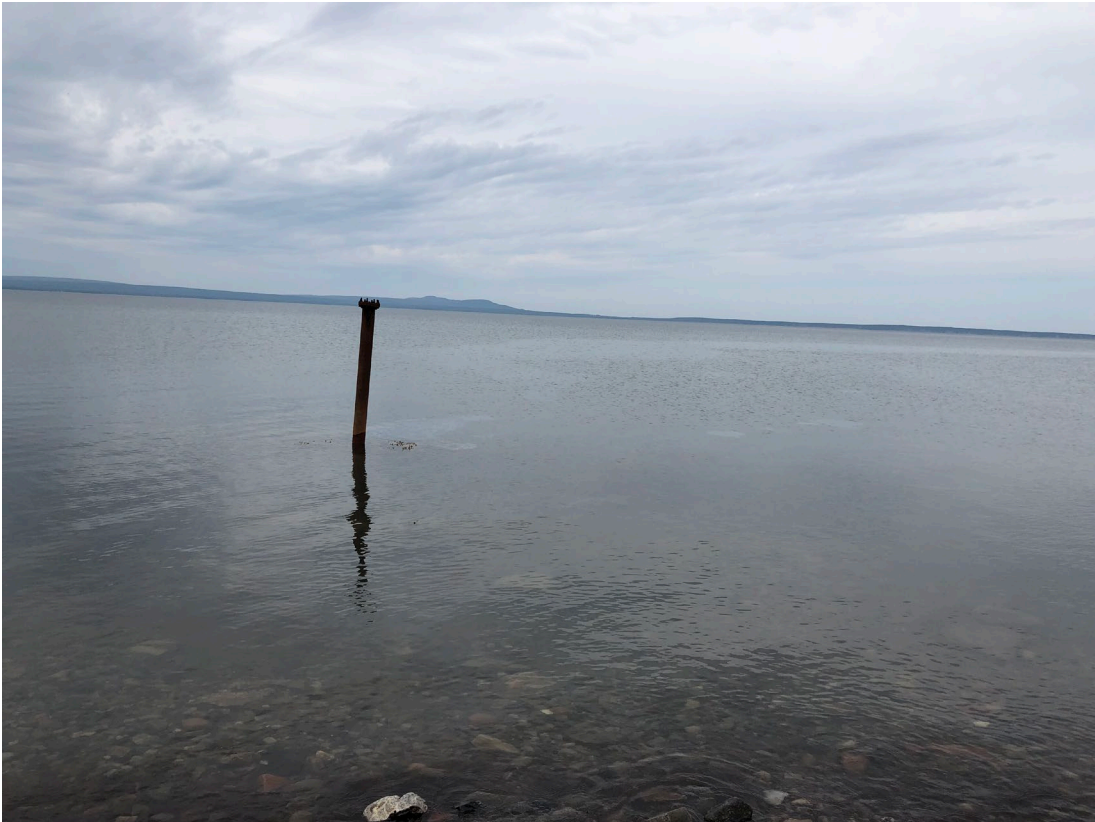
- The water level was relatively low with the wells situated in the water only a short distance from the shore.
- Oil sheening was observed in the vicinity of Well Repair #1. Sheening was predominant in the area around the well base. However, oil sheens were observed originating at random locations within the general well area.
- Tidal and wave action were minimal.
- Sheens formed as oil drops rose to the surface and expanded. Oil remained on the water surface for considerable time creating large sheen areas.
- Oil seepage was not observed from any of the other well locations.
- Monitoring of the area for oil seepage will continue.

Photo 1 – Abandoned Well Repair #1

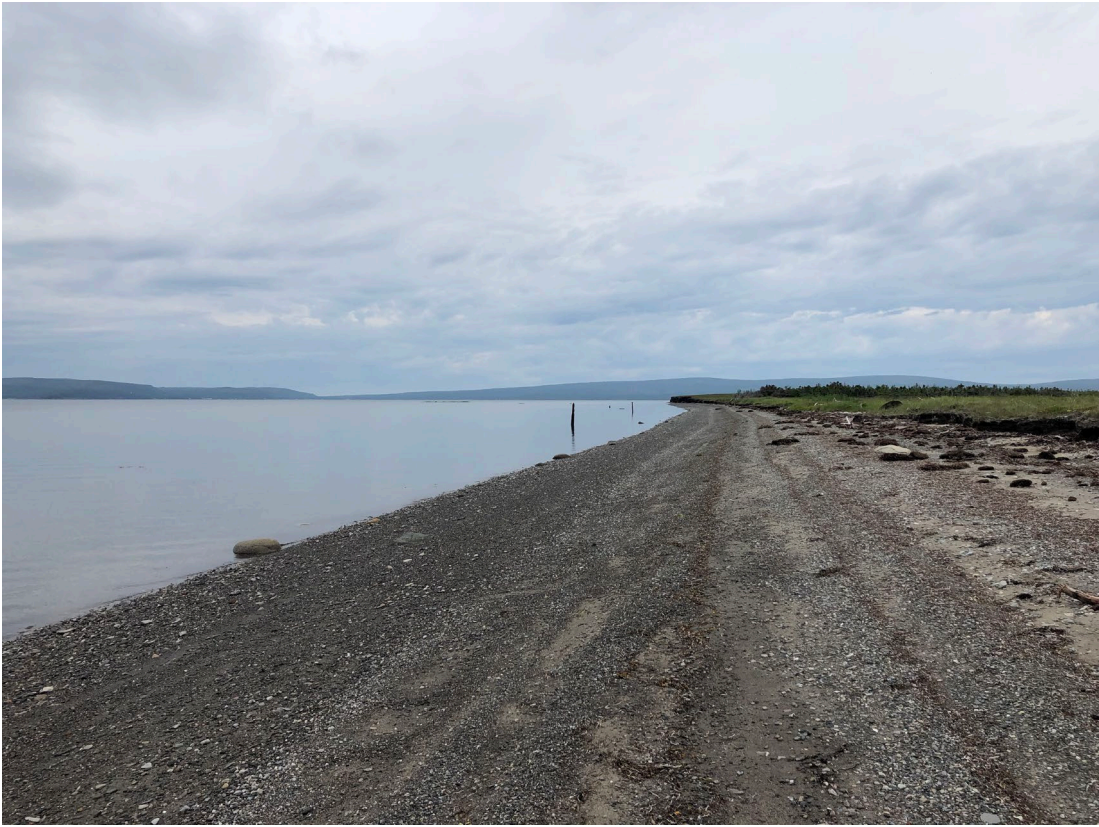
Photo 4 – Abandoned Well(s) Area

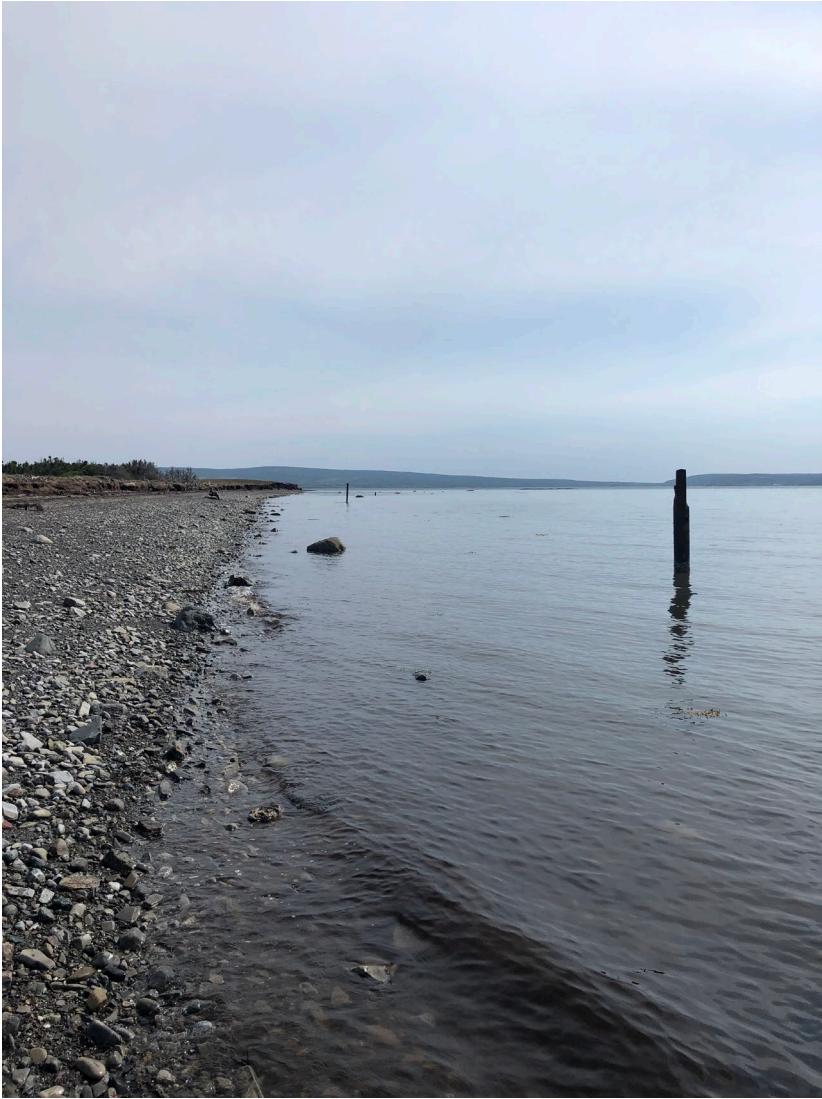
Photo 2 – Abandoned Well(s) Area

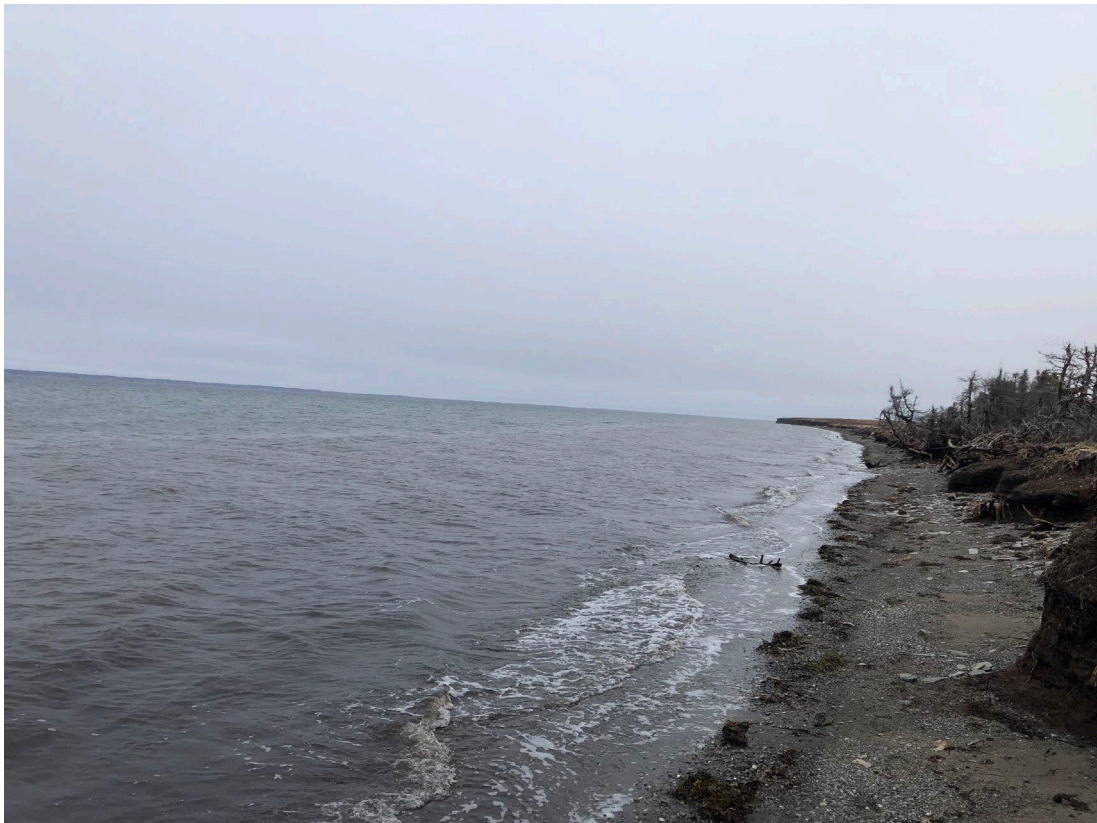
Photo 1 – Shoal Point Abandoned Oil Exploration Area (High Tide)

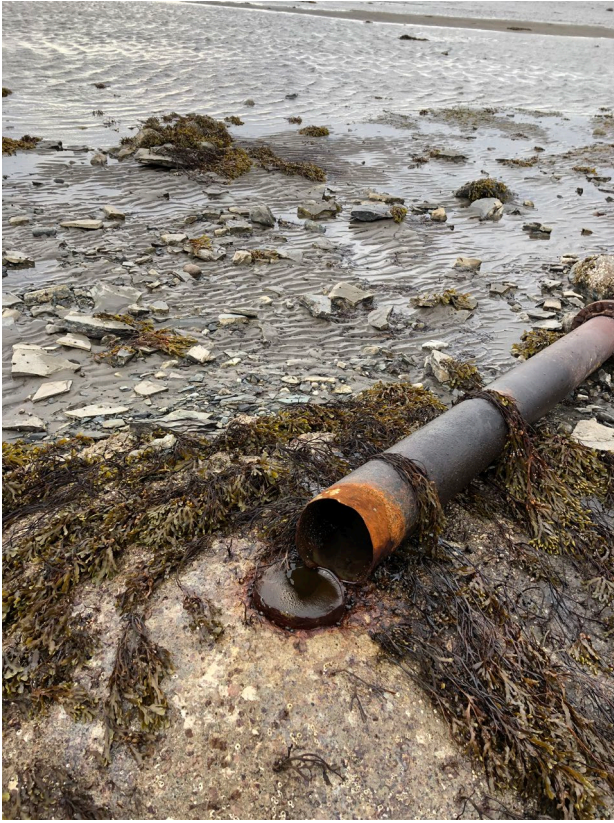
- The repair for Well #1 is no longer intact. The pipe has been sheared off at the concrete base. An oil/water mixture was present in the remaining section of pipe.

Photo 2 – Abandoned Oil Well #1

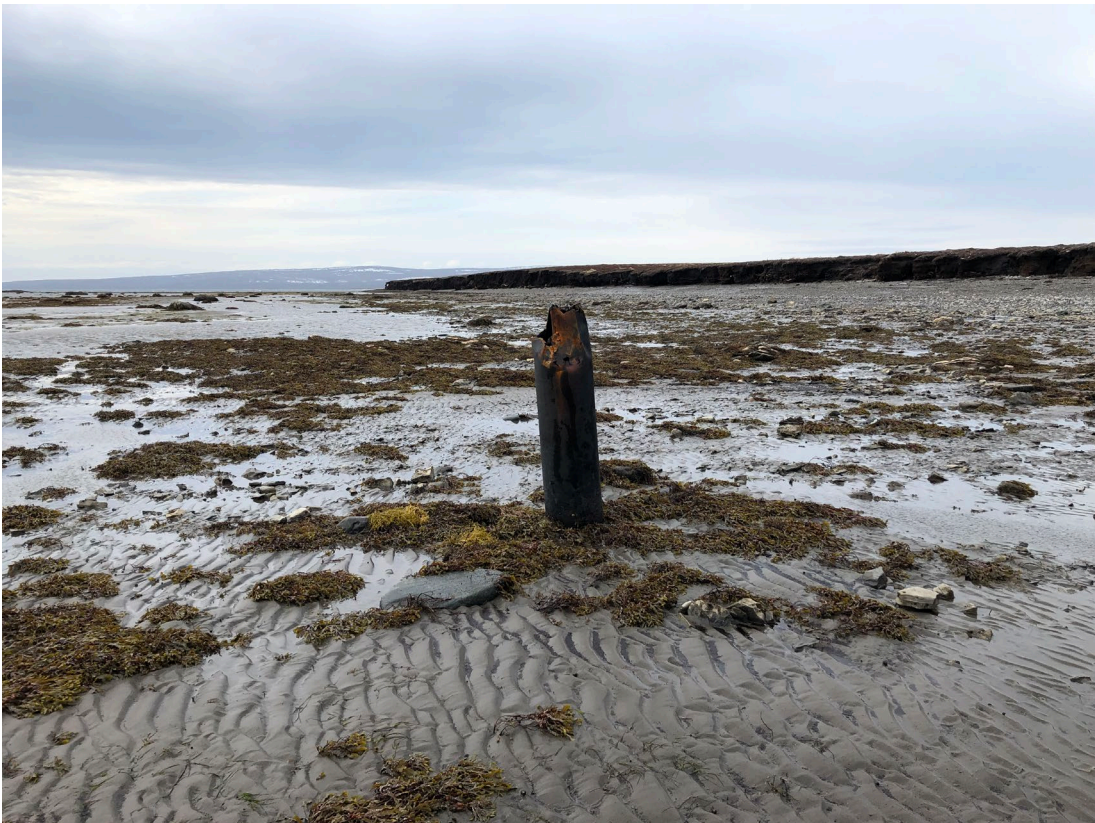
- The casing for abandoned Well #4 (well farthest from Shoal Point Tip) remains intact. There was no oil seepage/sheening observed in the general vicinity of this well.

Photo 5 – Abandoned Oil Well #4 (Farthest from Shoal Point Tip)

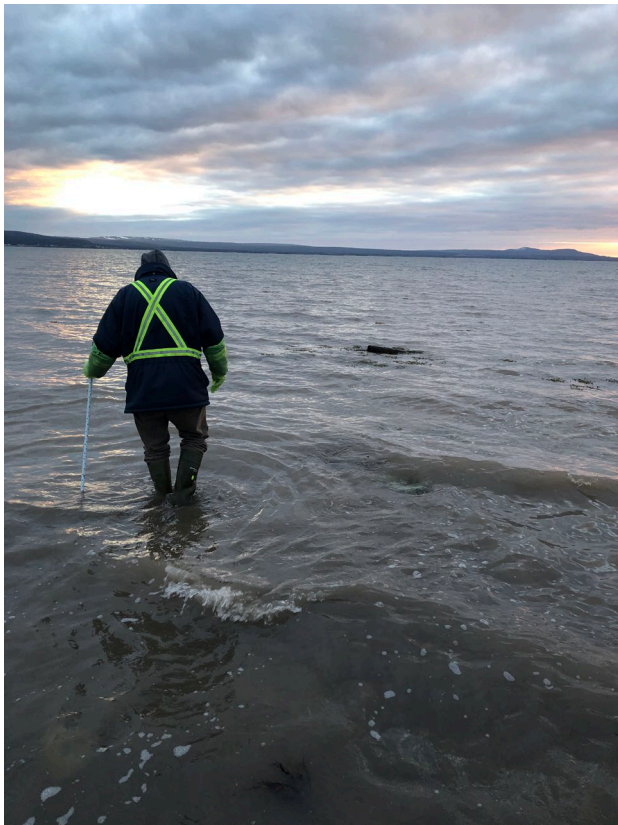
- The purpose of the visit was to gather information to help determine appropriate action(s) to address ongoing oil seepage related to the legacy oil wells in the area. Unfortunately, the tide was not sufficiently low to conduct a detailed assessment of the wells.
- Oil seepage/sheening was not observed in the bay. Winds were estimated to be >25 km/h resulting in significant wave action.
- A slight oil odor was evident from several locations along the shore.
- Monitoring of the area will continue.

Photo 1 – Area of Well Repair #1

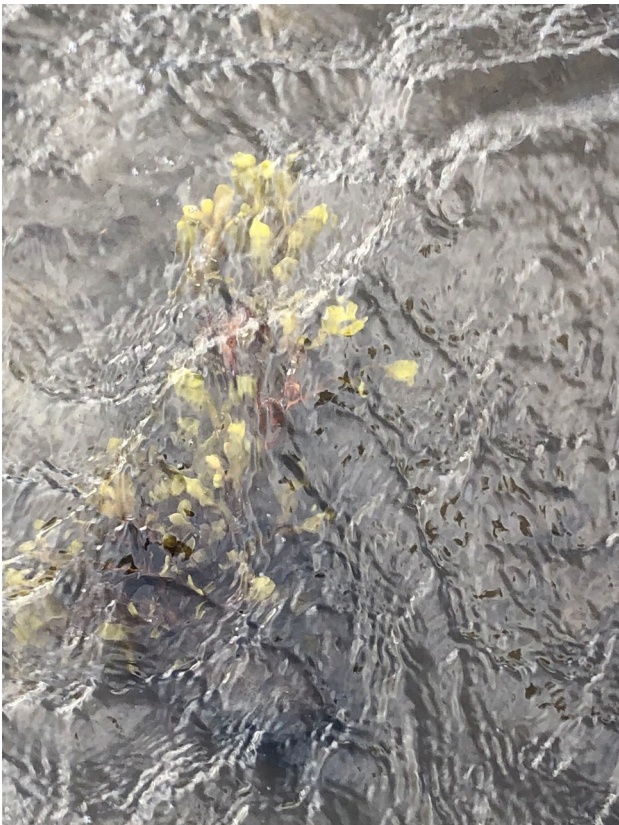
Photo 3 – Abandoned Oil Well #6

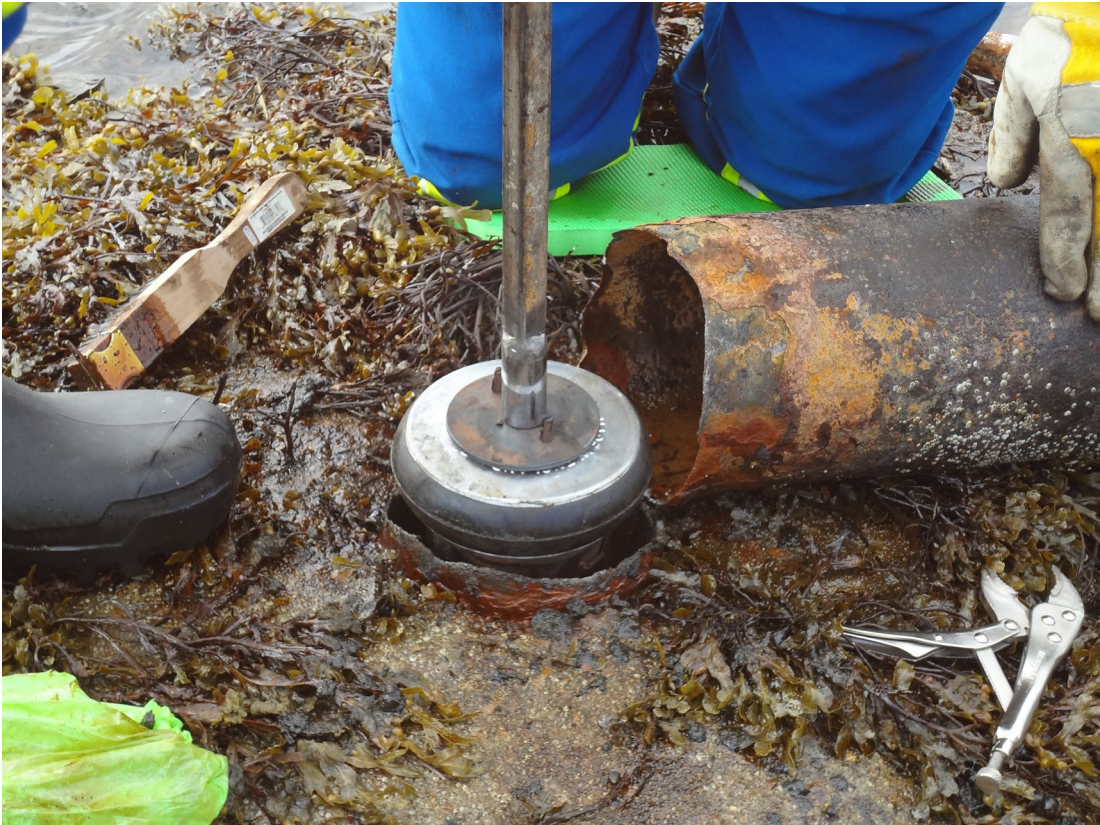
Photo 2 – Plug Installation Well #1

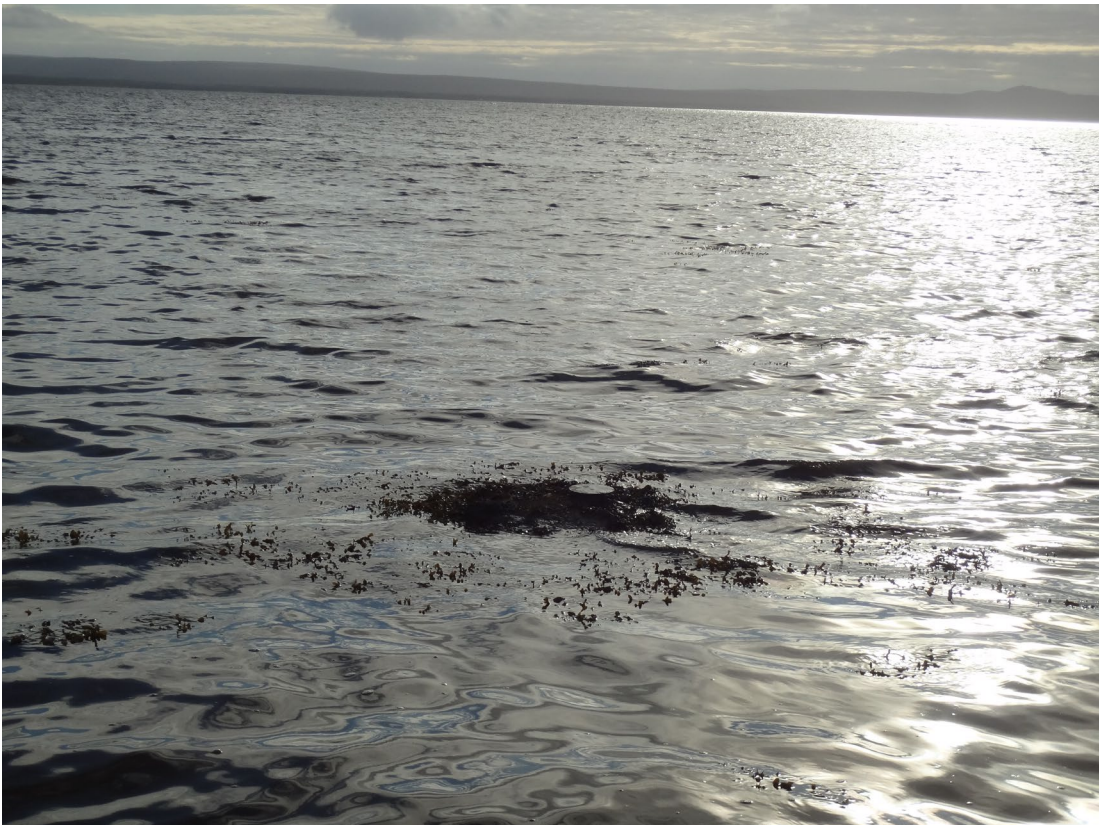
Photo 5 – Installed Cap and Plug for Well #1

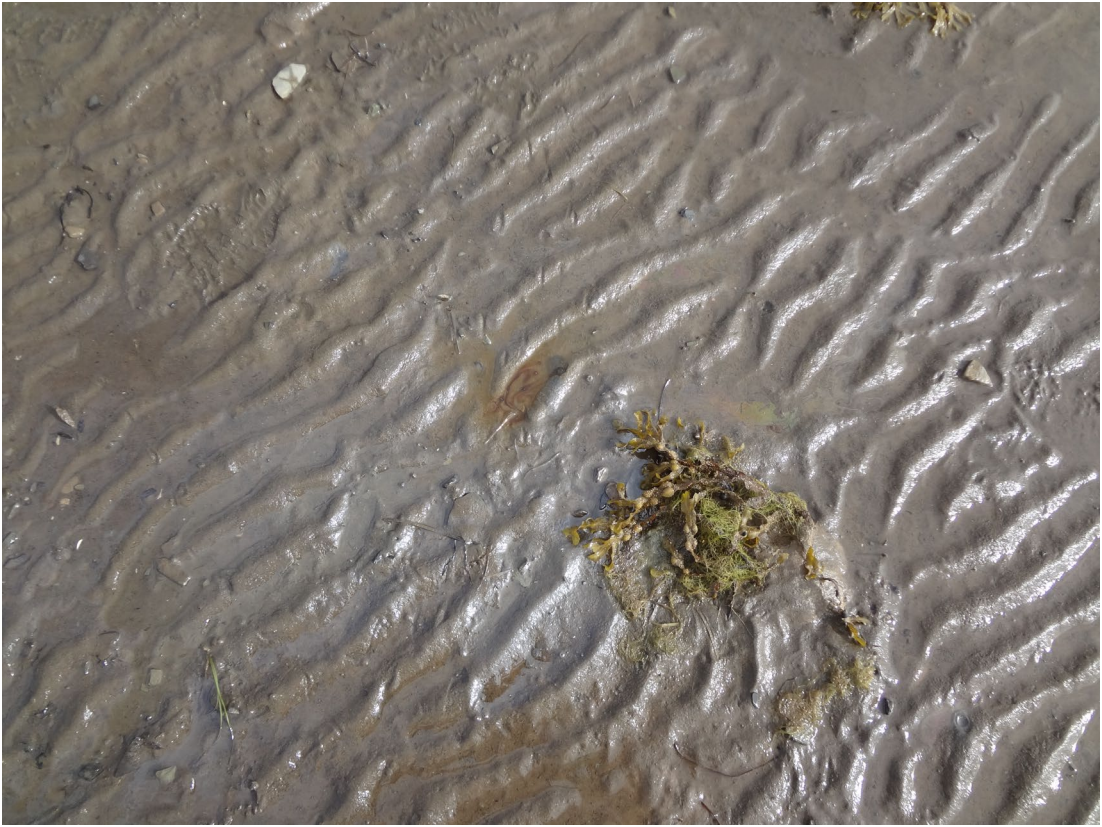
- The active formation of small oil seeps, originating from the sea floor, was observed at several locations.
- Oil sheening was observed in the vicinity of Well #5 and Well #6.

Photo 6 – Active Oil Seepage at Sea Floor
