# **Site Inspection Summary**

## **Abandoned Oil Wells - Shoal Point**

### **Purpose of Inspection** Ongoing Monitoring of Abandoned Oil Wells at Shoal Point

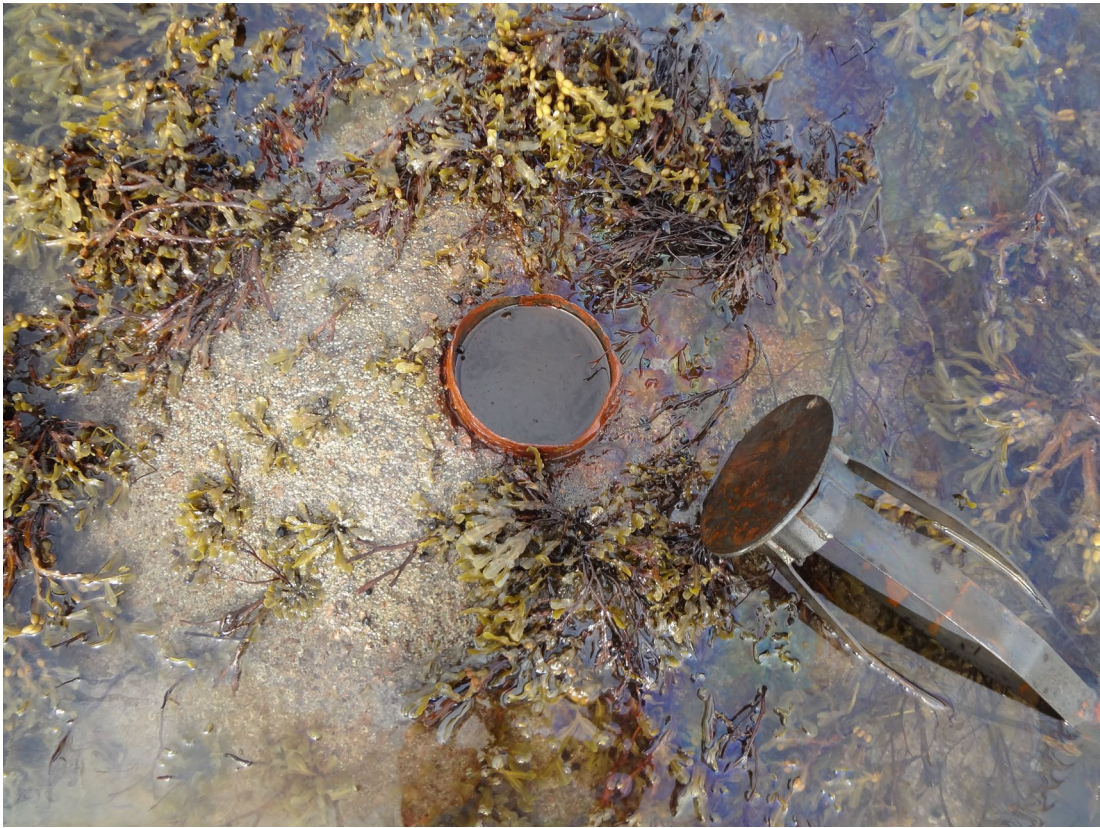
Photo 4 – Oil/Water Accumulation Well #1 (Cap Removed)

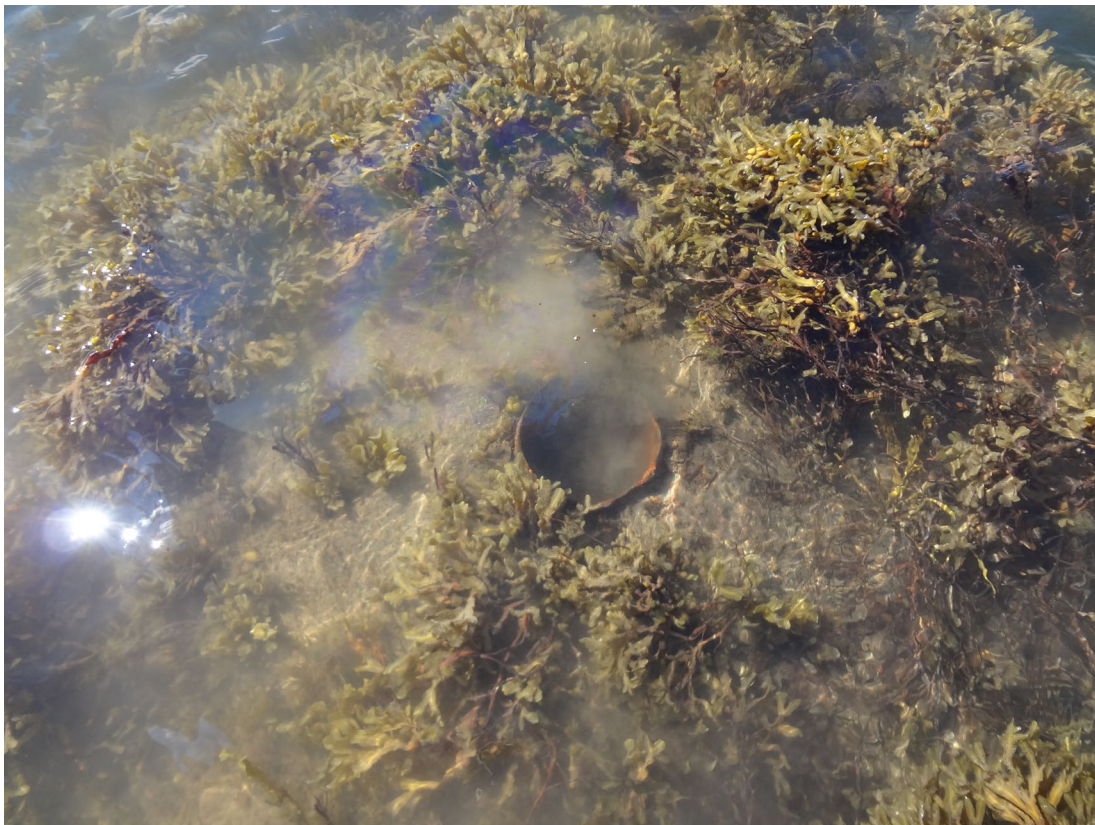
- Significant oil sheening was not observed in the bay.
- Bubbles and slight oil sheening were observed in the immediate area of the capped well (Well #1).
- The cap for Well #1 was removed. Oil bubbles were observed originating from within the pipe. Bubbles formed for a few seconds then ceased for 30 seconds to a minute.
- The plug has not eliminated oil release from Well #1. It could not be determined if a reduction in the amount of oil being released was achieved.
- Monitoring of the area will continue.

Photo 3 – Oil sheening and Bubbles at Well #1 (Cap Removed)

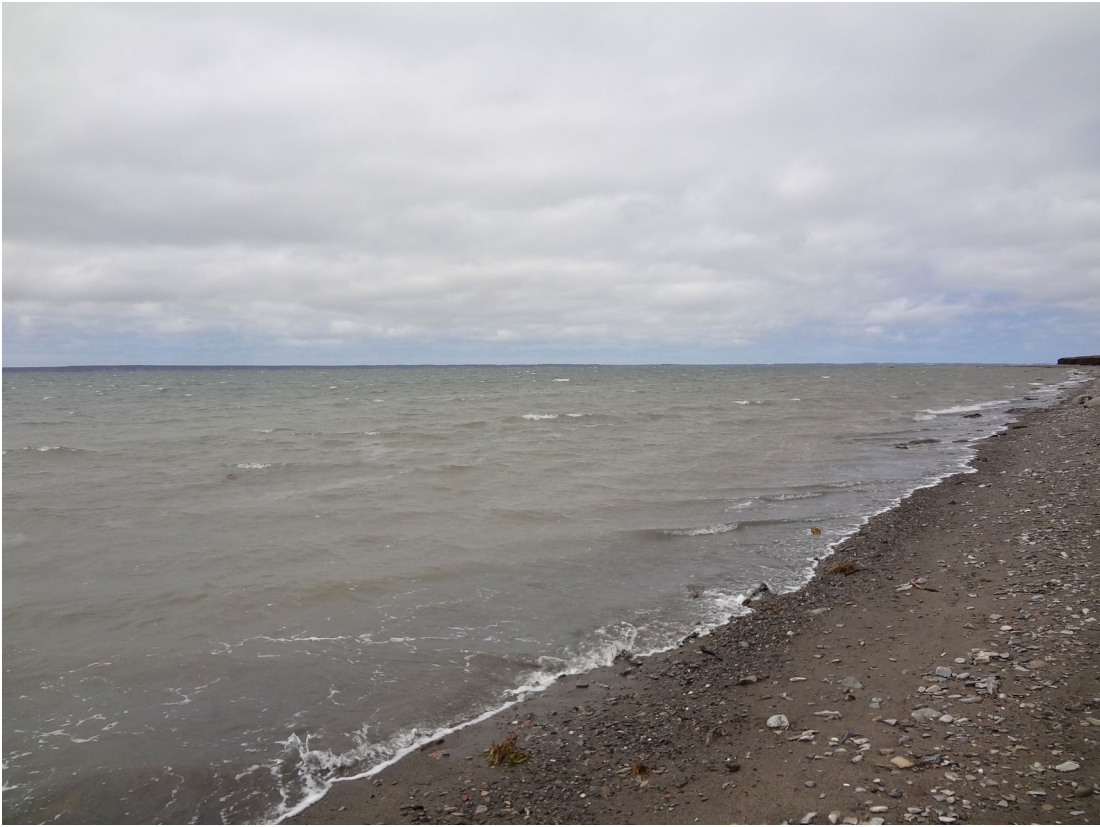
- Oil sheening was observed in the bay originating from the general area of Well #1.
- An oil odor was noted from the shore in the abandoned well(s) area.
- Monitoring of the area will continue.

Photo 2 – Oil Sheening in Area of Capped Well #1
