# **Site Inspection Summary**

## **Abandoned Oil Wells - Shoal Point**

### **Purpose of Inspection** Ongoing Monitoring of Abandoned Oil Wells at Shoal Point

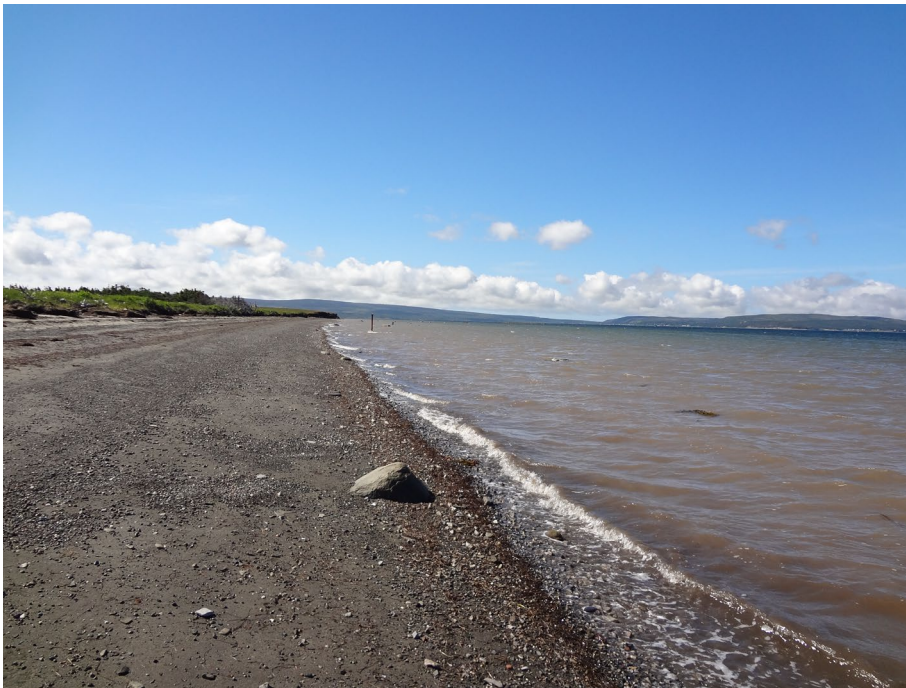
- The tide was not particularly low (0.4 m) and as such the bases of the well casings were submerged.
- The wind was noted as 10 km/h SW (towards the shore). I did not observe any signs of oil seepage in the area. I also did not detect any oil odor along the shore or in the vicinity of the wells. The water was relatively turbid and there was some wave action.

Photo 1 – Beach in vicinity of abandoned wells

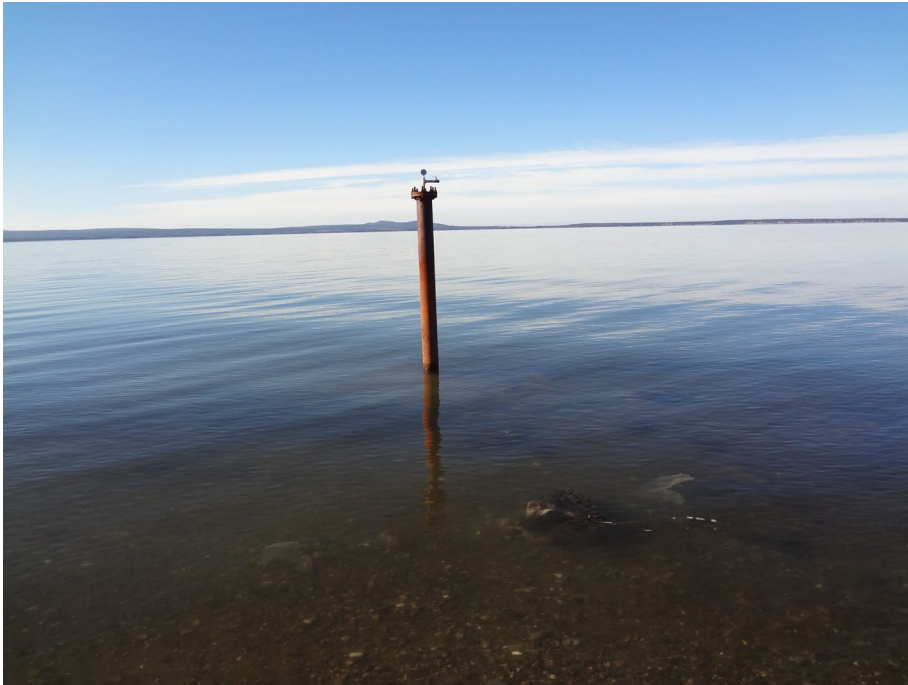
- The well casings were in the water and as such inaccessible by foot. The wind was minimal and the water was calm.
- No visible sign of oil was detected at any of the other well locations.
- Oil odor was not detected at the site.
- Three seals were observed in the bay a couple of hundred feet offshore.

Photo 1 – Well Repair #1

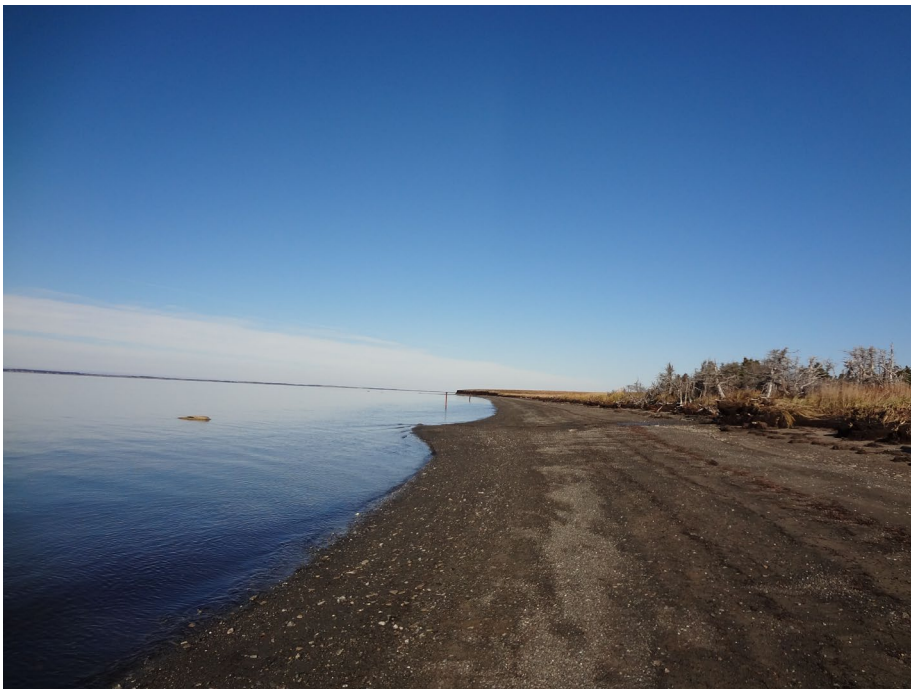
Photo 3 – General Area of Abandoned Wells

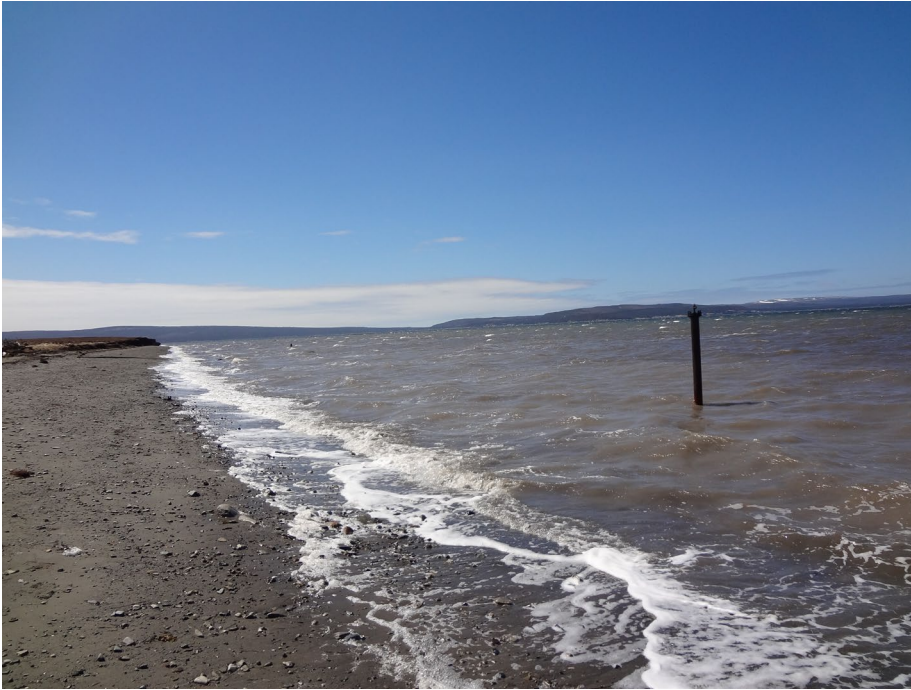
- Well Repair #1 was in the water. The pipe extension remains intact. The pressure gauge on top of the extension pipe is gone. Oil residue is present at the top of the pipe and along the exterior. No active oil seepage was observed from the well.
- No visible sign of oil was detected at any of the other well locations. The presence of oil in the water would not be evident as the wave action was significant and would quickly dissipate any oil seepage.
- A faint oil odour was evident in the area.

Photo 4 – Abandoned Wells Area

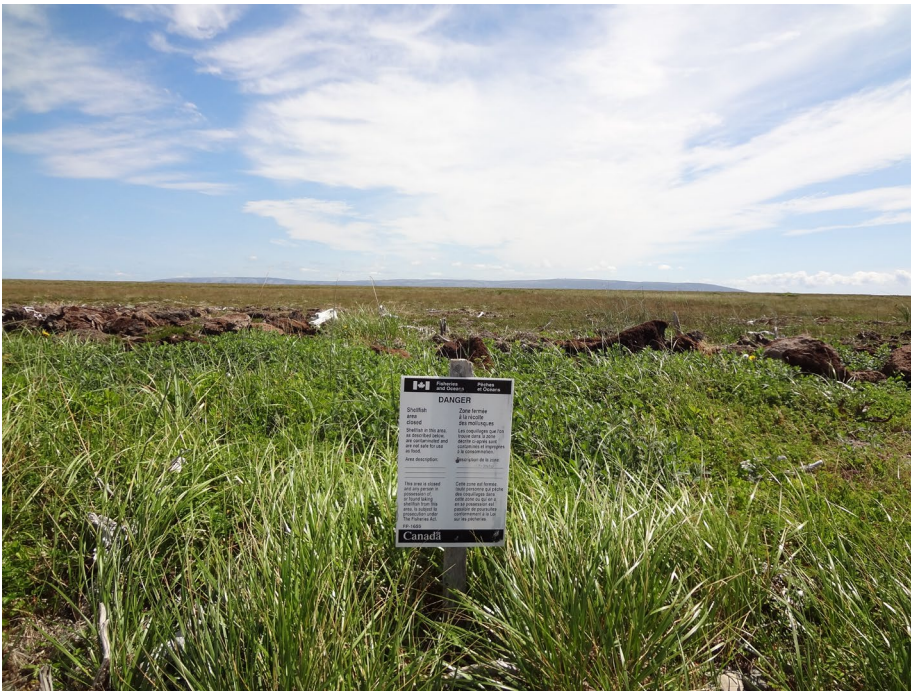
- The three visible well casings are in the water.
- The pipe extension associated with Well Repair #1 remains intact. Oil is observed leaking from the top of the pipe extension where the pressure gauge had previously been located. Oil release is intermittent but somewhat consistent.
- A strong oil odor is evident near the leaking well and along the shore.
- Slight oil sheening is evident on the sand/water interface along the beach downwind from the leaking well.
- No visible sign of oil or odor was detected at the other well locations.
- There is a posted DFO notice on the shore identifying the area as closed to shellfish. It is noted that shellfish are contaminated and unsafe for use as food.

Photo 3 – DFO Signage Restricting Shellfish Retention in Area

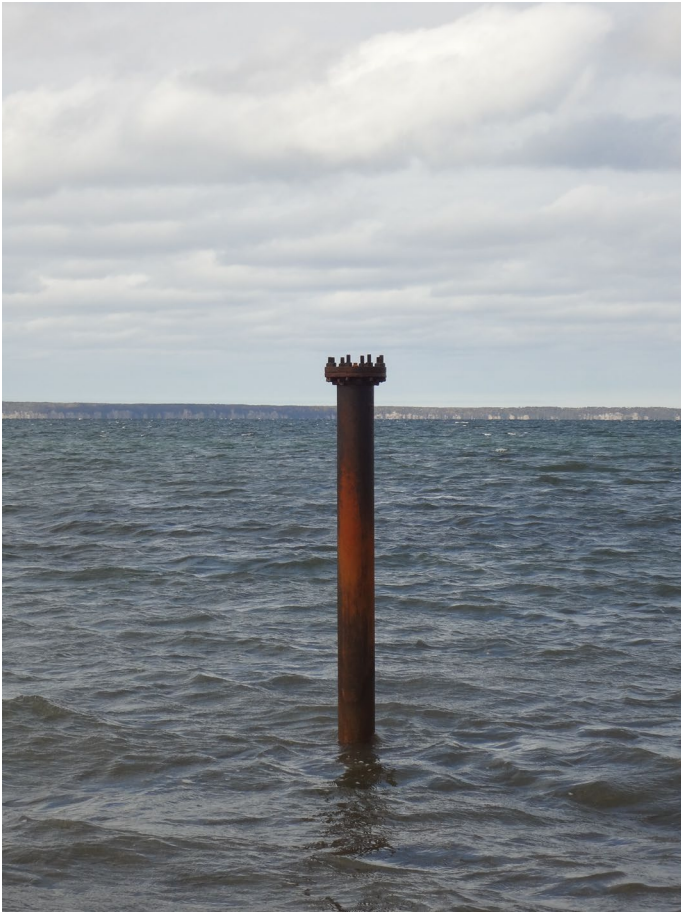
Photo 2 – Well Repair #1

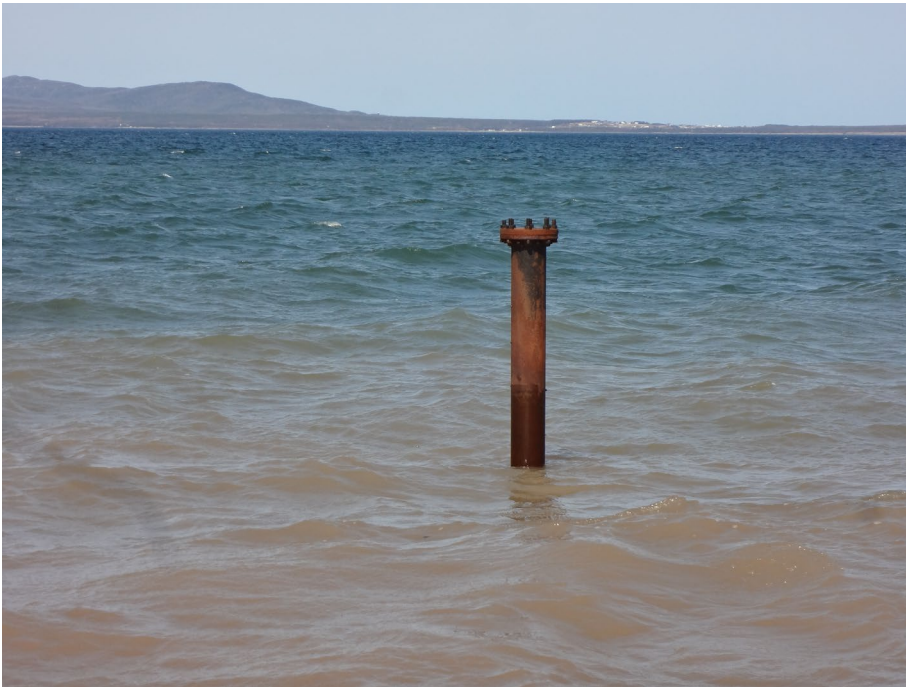
- Well Repair #1 casing and one of the abandoned wells (closest to the tip of Shoal Point) remain intact. The other abandoned well is not visible and is suspected to be underwater.
- There is no visible sign of oil in the vicinity of Well Repair #1. The plug placed in the top plate of the extension pipe has stopped the seepage of oil that had been occurring at this location. The casing is rust coloured and does not show any visible sign of oil staining.
- The wind is estimated to be 15-20 km/h in a west to east direction. The water is turbid/discoloured from the shore and continuing out for about 75 feet. Wave action is relatively strong.
- There was no visible sign of oil or oil odor detected in the area.
- Monitoring of the area for oil seepage will continue.

Photo 1 – Well Repair #1

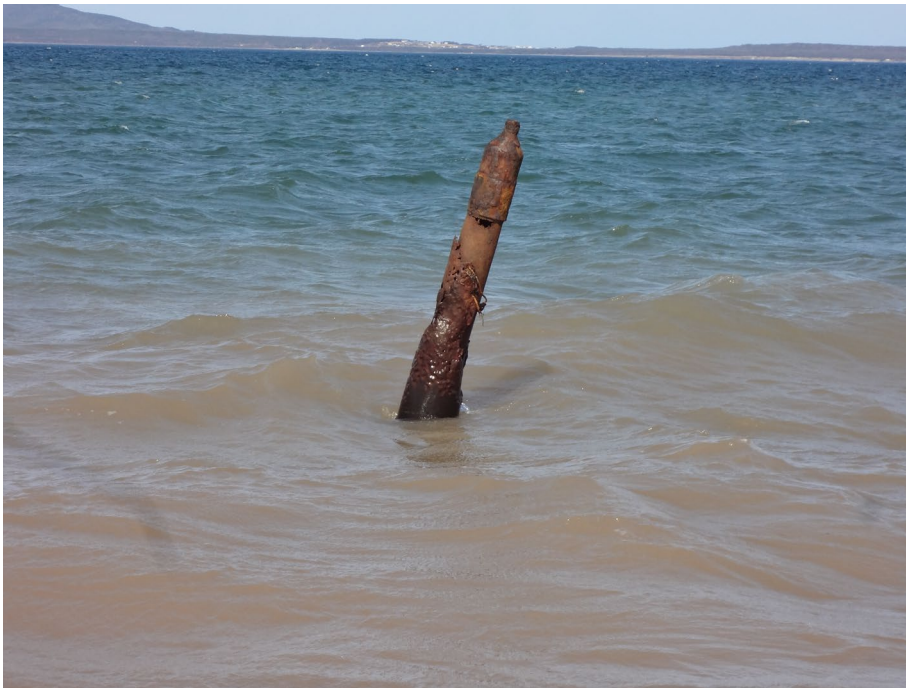
Photo 3 – Abandoned Oil Well Casing (Closest to the Shoal Point Tip)

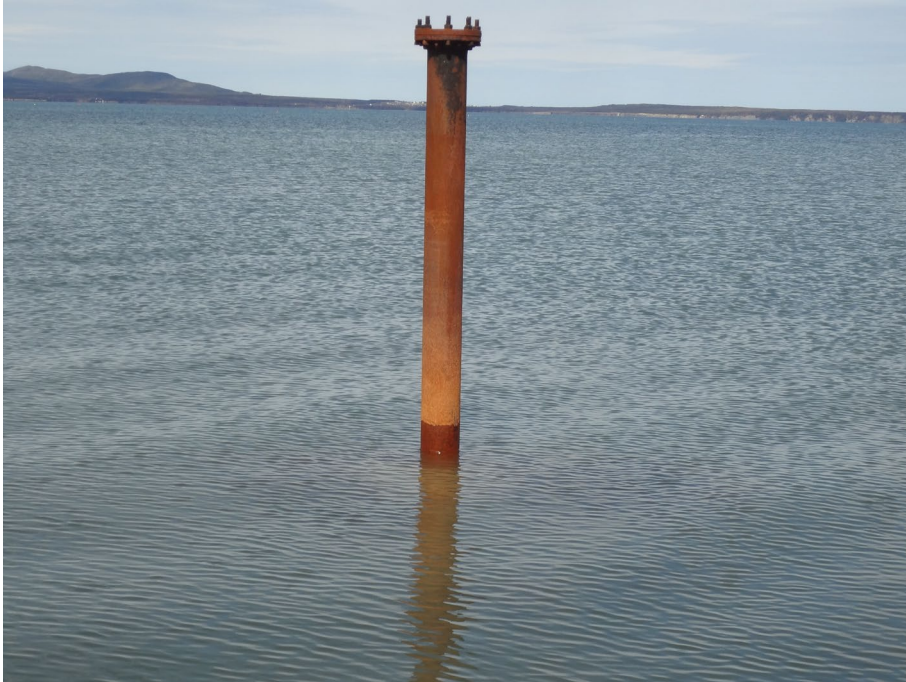
- There was no obvious sign of oil release/seepage associated with Well Repair #1 or with any of the other abandoned wells in the area.
- There was no oil odor detected from the shore area.
- Monitoring of the area for oil seepage will continue.

Photo 1 – Well Repair #1

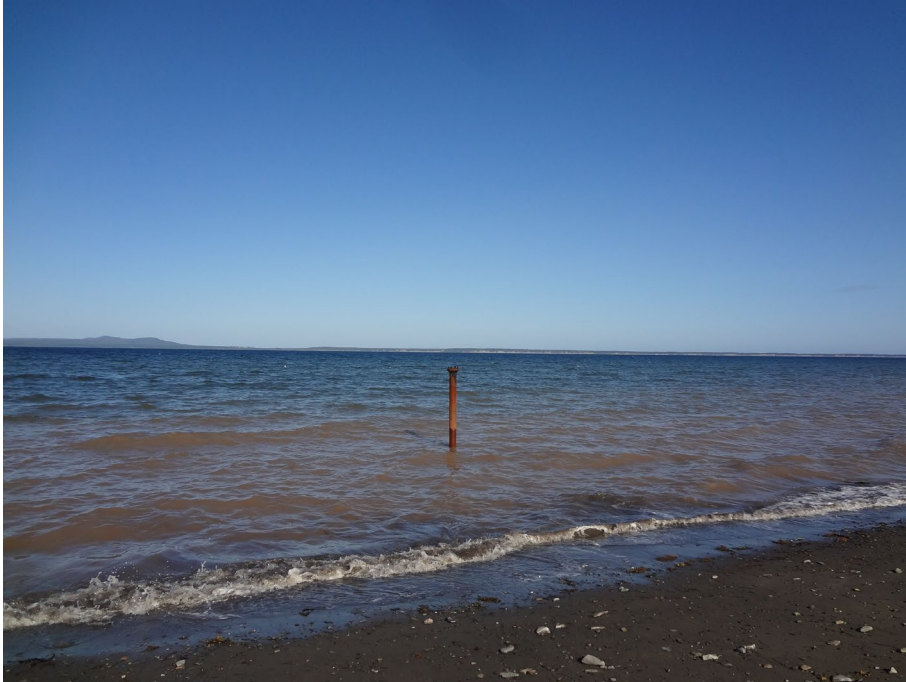
- There was no obvious sign of oil release/seepage associated with Well Repair #1 or with any of the other abandoned wells in the area.
- There was a faint oil odor noted upon arrival to the site.
- Monitoring of the area for oil seepage will continue.

Photo 1 – Well Repair #1

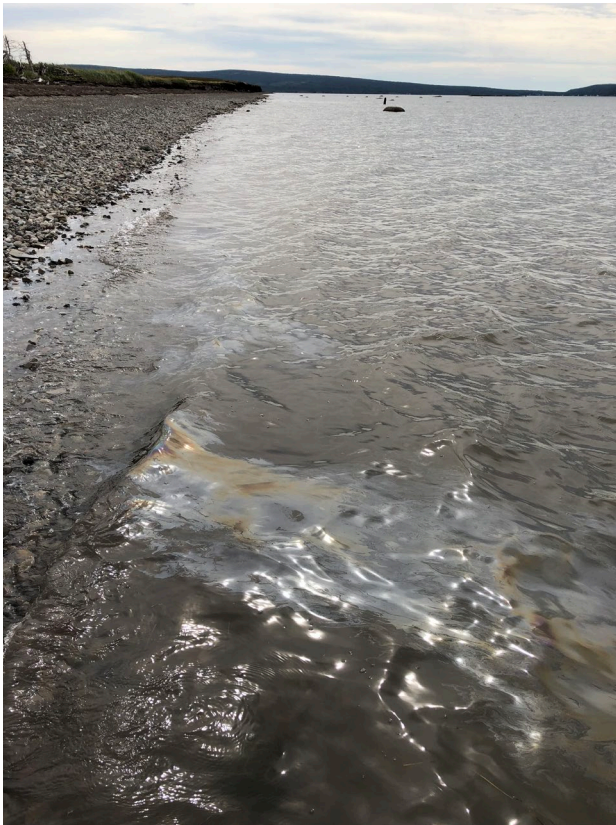
- The water level was relatively low with two of the three wells situated in the water only a short distance from the shore.
- Oil sheening was observed in the vicinity of Well Repair #1. The sheening originated from small oil releases (drops) at random locations in the water around the perimeter of the well base. The rate of release varied, but on average, is estimated to be one drop every 20-30 seconds.
- The direction of flow of the oil sheens was towards the shore.
- Oil seepage was not observed from any of the other well locations.
- Monitoring of the area for oil seepage will continue.

Photo 3 – Oil Sheening near Shore

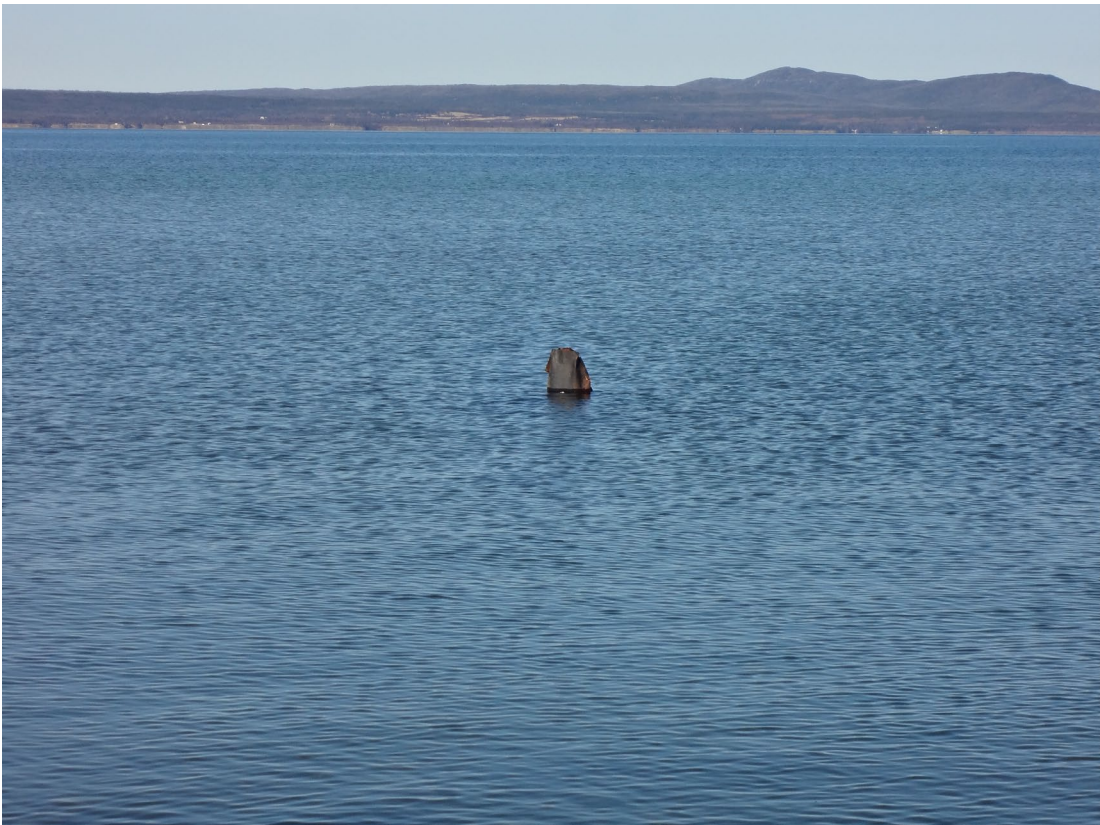
Photo 3 – Abandoned Oil Well Casing (Furthest from the Shoal Point Tip)

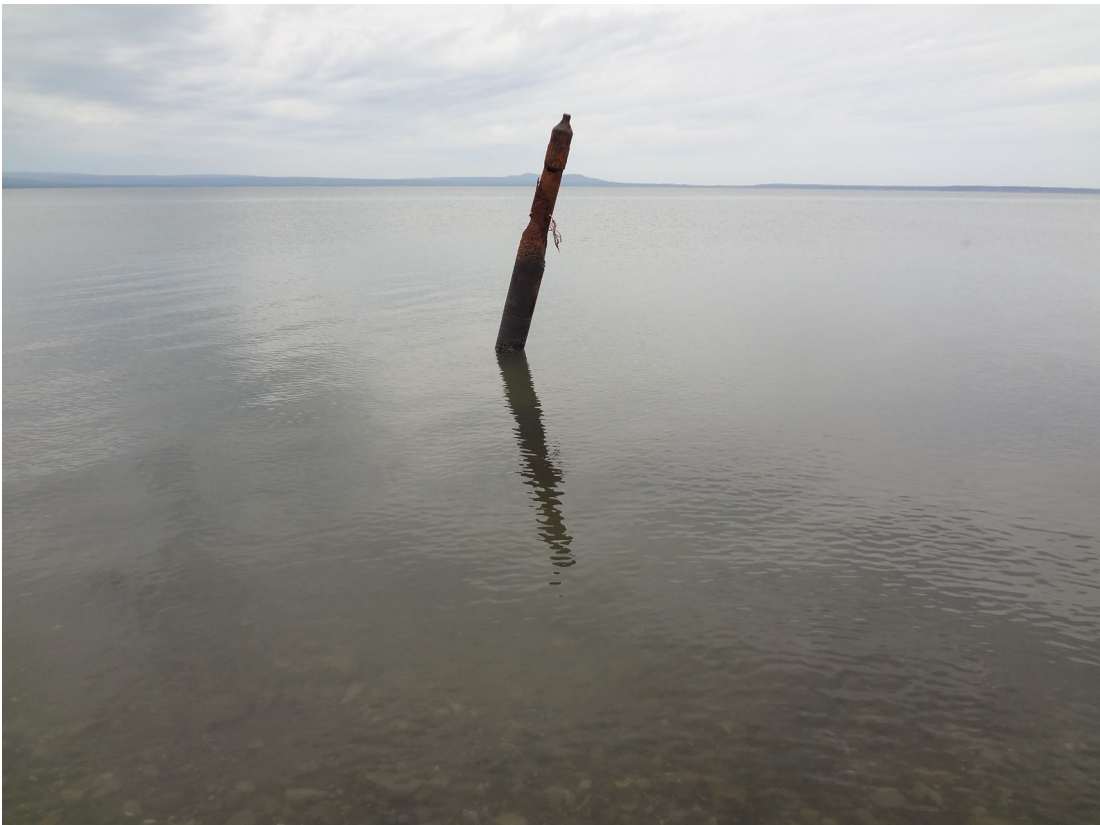
Photo 3 – Abandoned Oil Well Casing (Closest to the Shoal Point Tip)

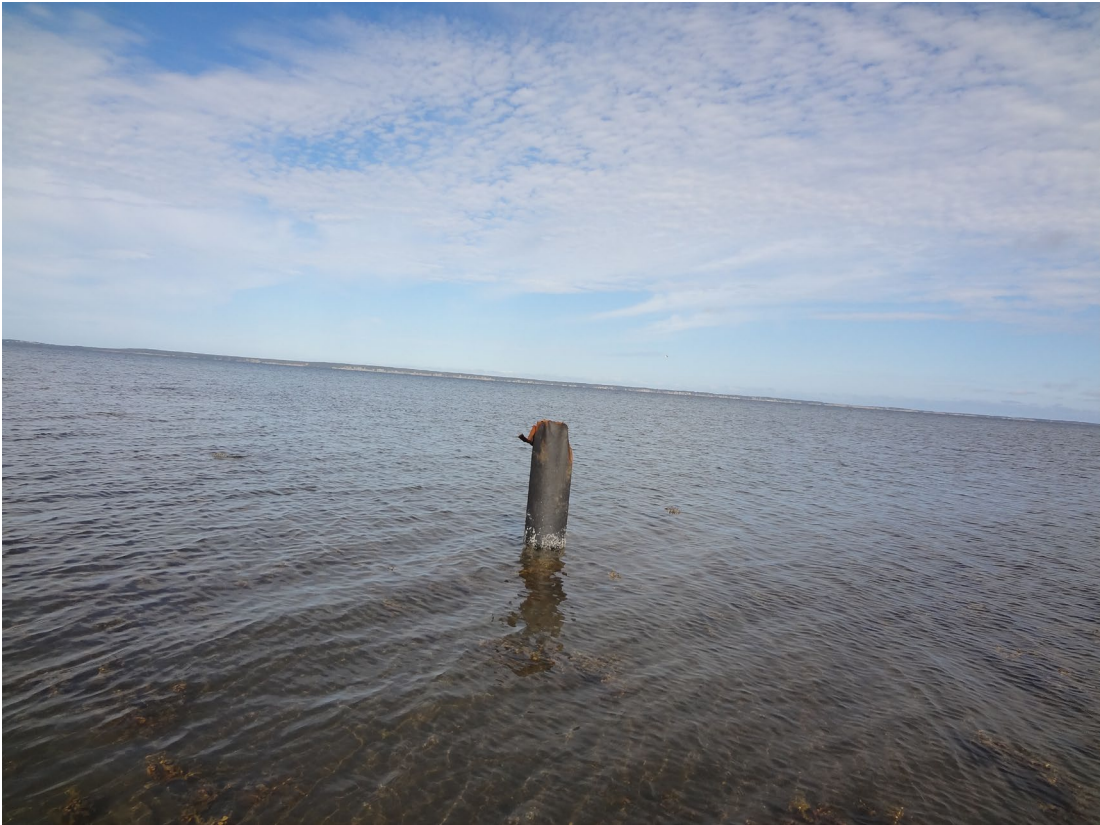
Photo 4 – Abandoned Oil Well Casing (Farthest from the Shoal Point Tip)

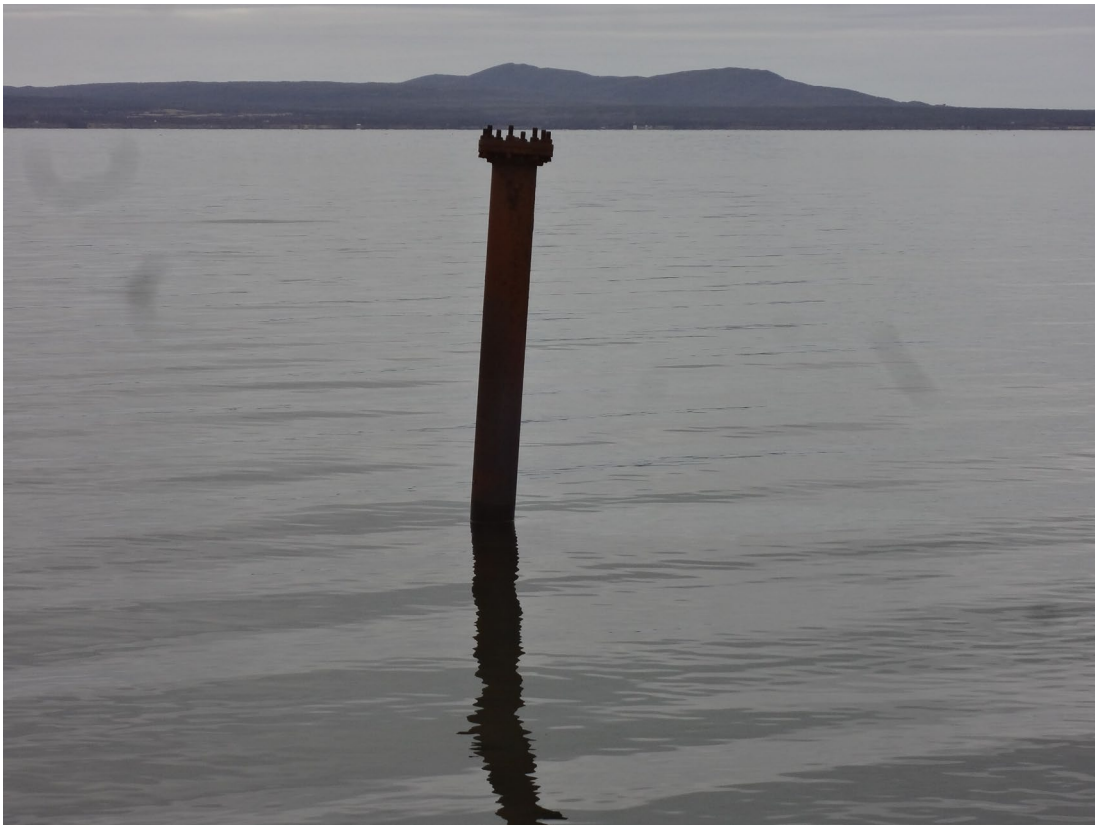
- The three oil casings remain intact and are in similar condition as observed last year.
- Oil sheening was observed in the vicinity of Well Repair #1 consistent with previous inspections.
- Oil seepage was not observed at any of the other well locations.
- An oil odour was detected from the shore in the general vicinity of Well Repair #1.
- 8-10 seals were observed in the bay.
- Monitoring of the area will continue.

Photo 1 – Well Repair #1

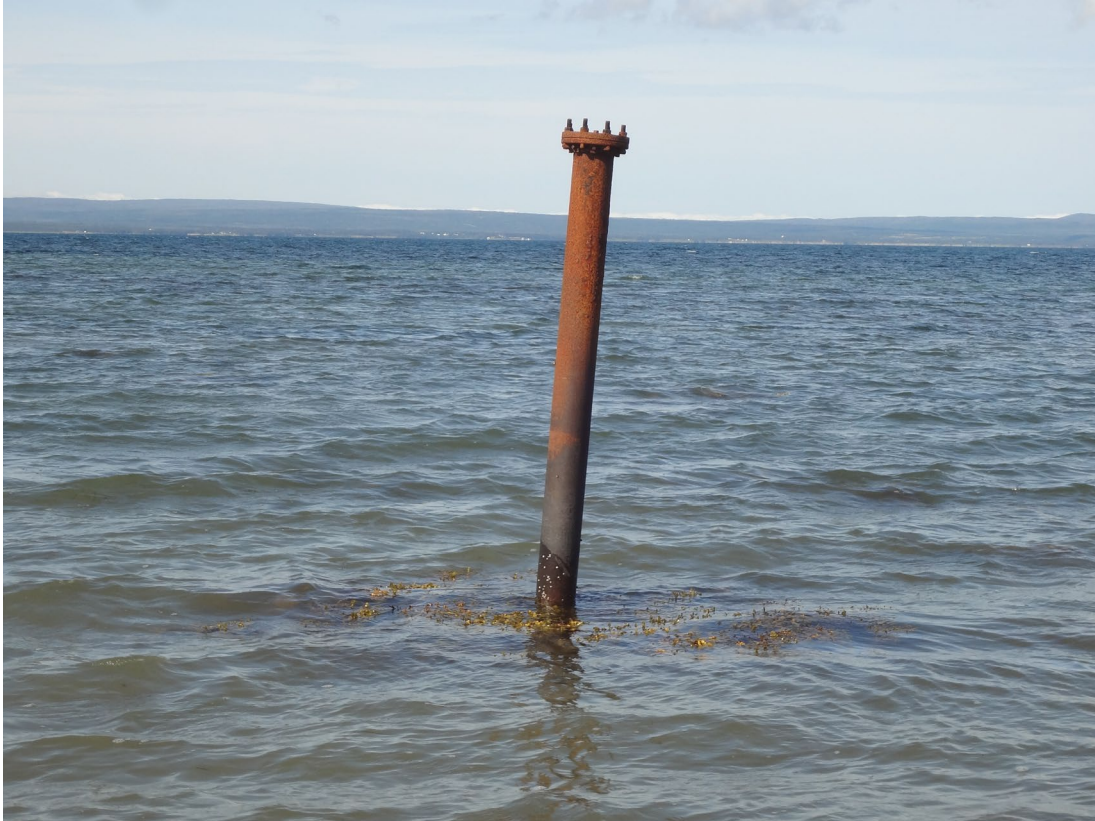
- Wave action was moderate.
- Oil seepage/sheening was not observed at any of the well locations or elsewhere in the bay.
- An oil odour was detected from the shore downwind of Well Repair #1.
- Monitoring of the area will continue.

Photo 1 – Well Repair #1

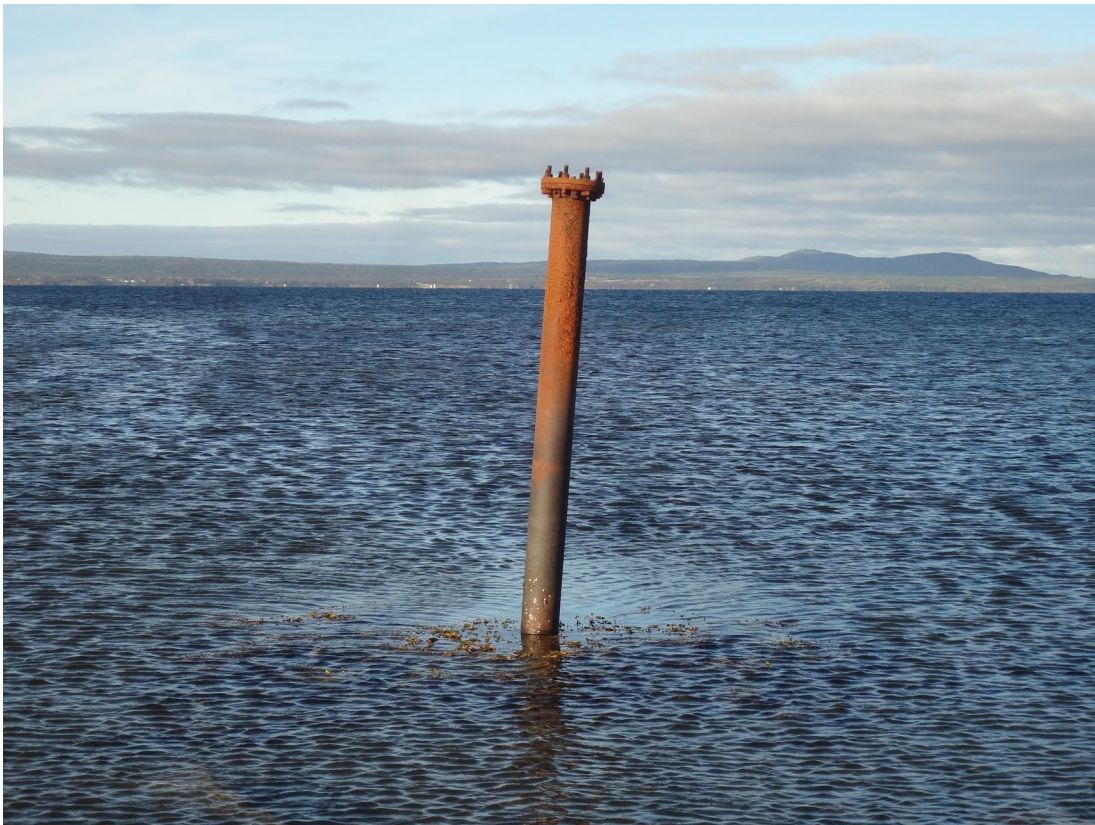
Photo 1 – Well Repair #1

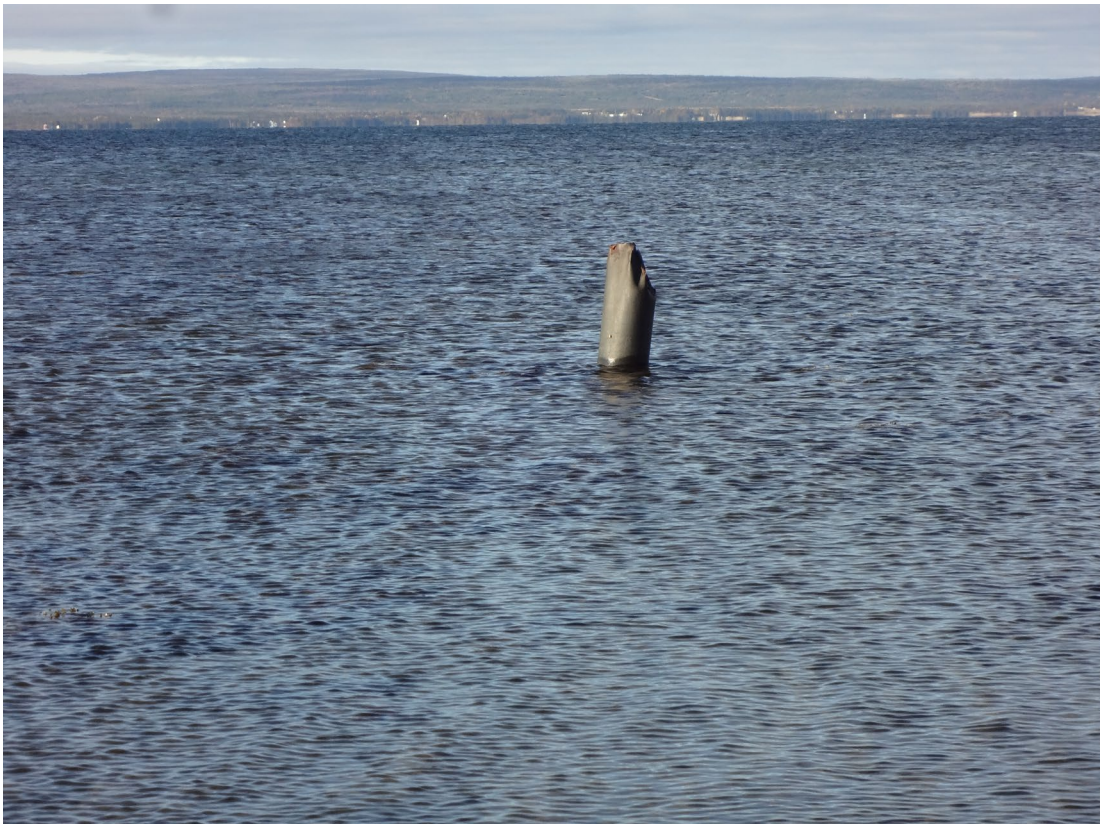
Photo 3 – Abandoned Oil Well Casing (Farthest from Shoal Point Tip)

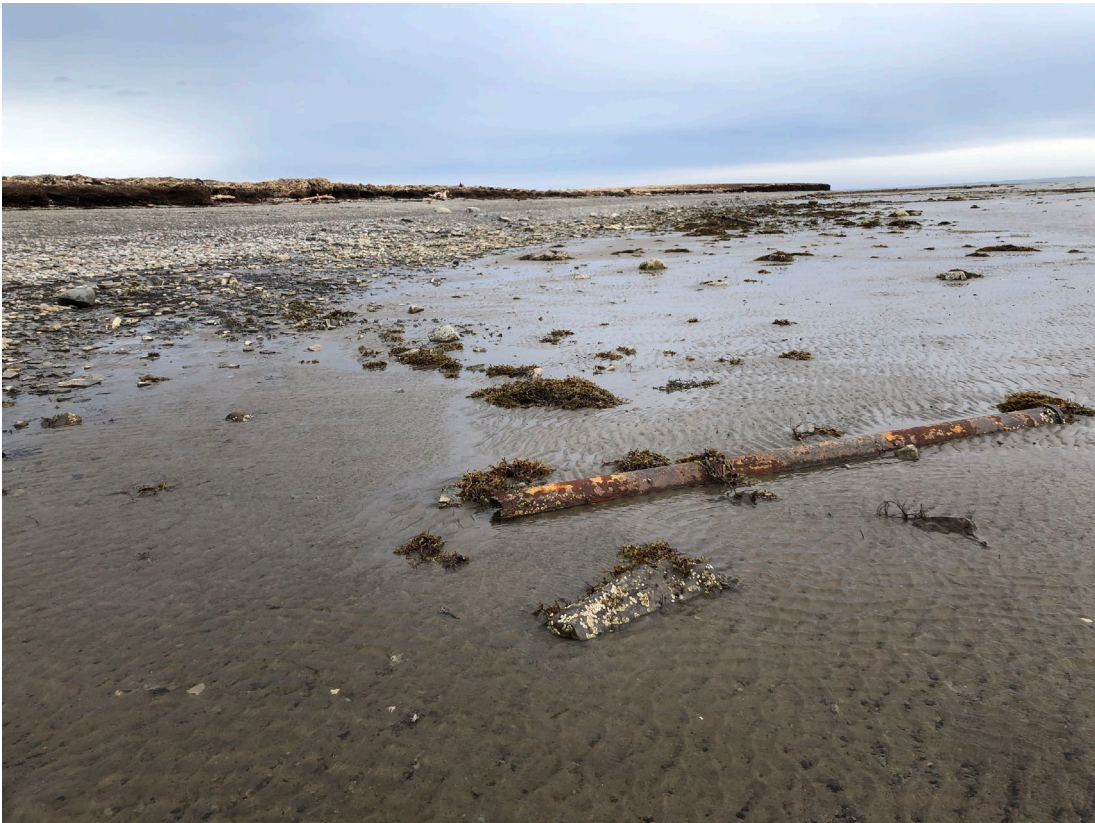
- There was no oil seepage/sheening observed in general vicinity of well repair #2 (Well #2).
- The casing for abandoned Well #3 (well located closest to the tip of Shoal Point) has been sheared off at ground level. There was no oil seepage/sheening observed in general vicinity of this well.

Photo 3 – Abandoned Oil Well #2 Area

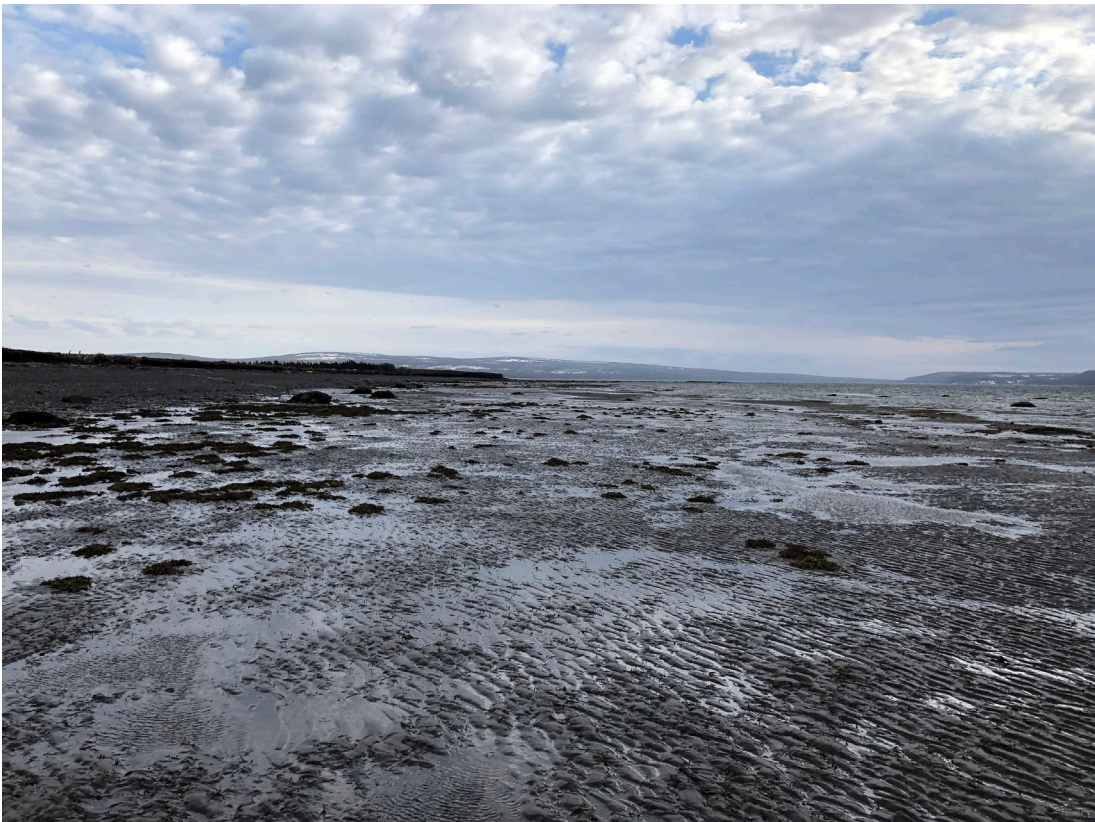
Photo 7 – Shoal Point Abandoned Oil Exploration Area (Low Tide)

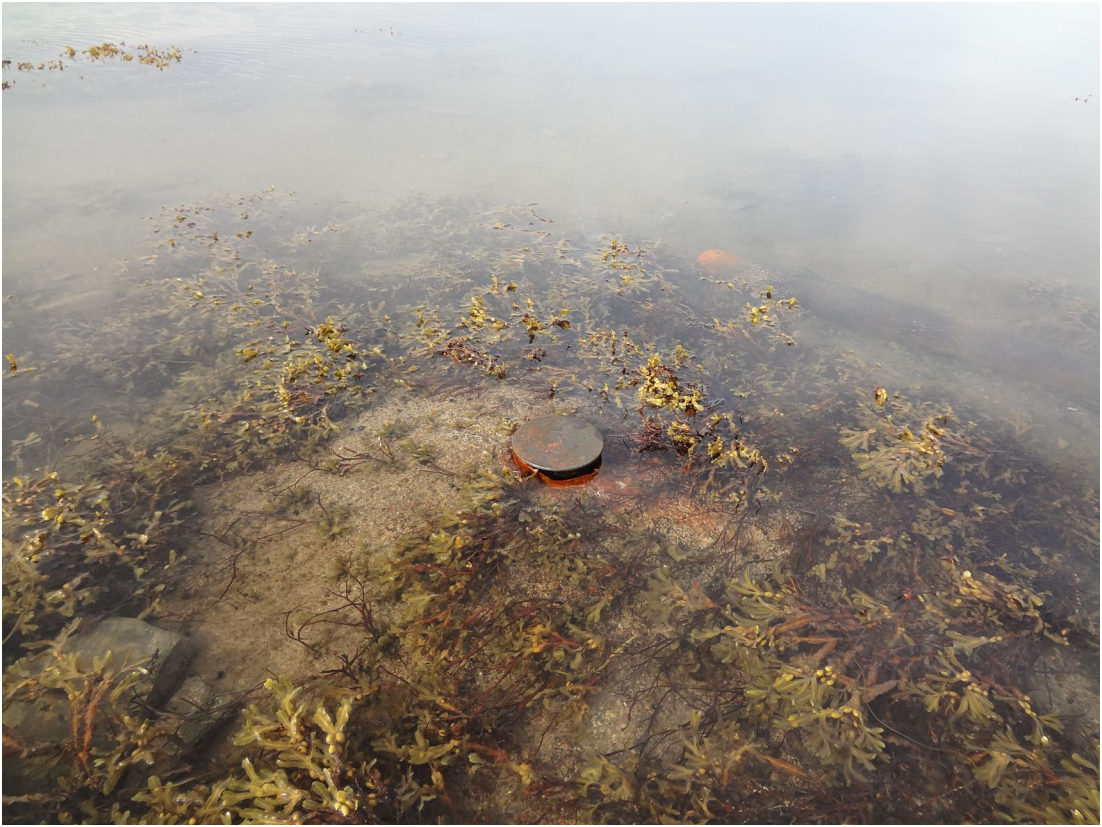
Photo 2 – Capped Well #1

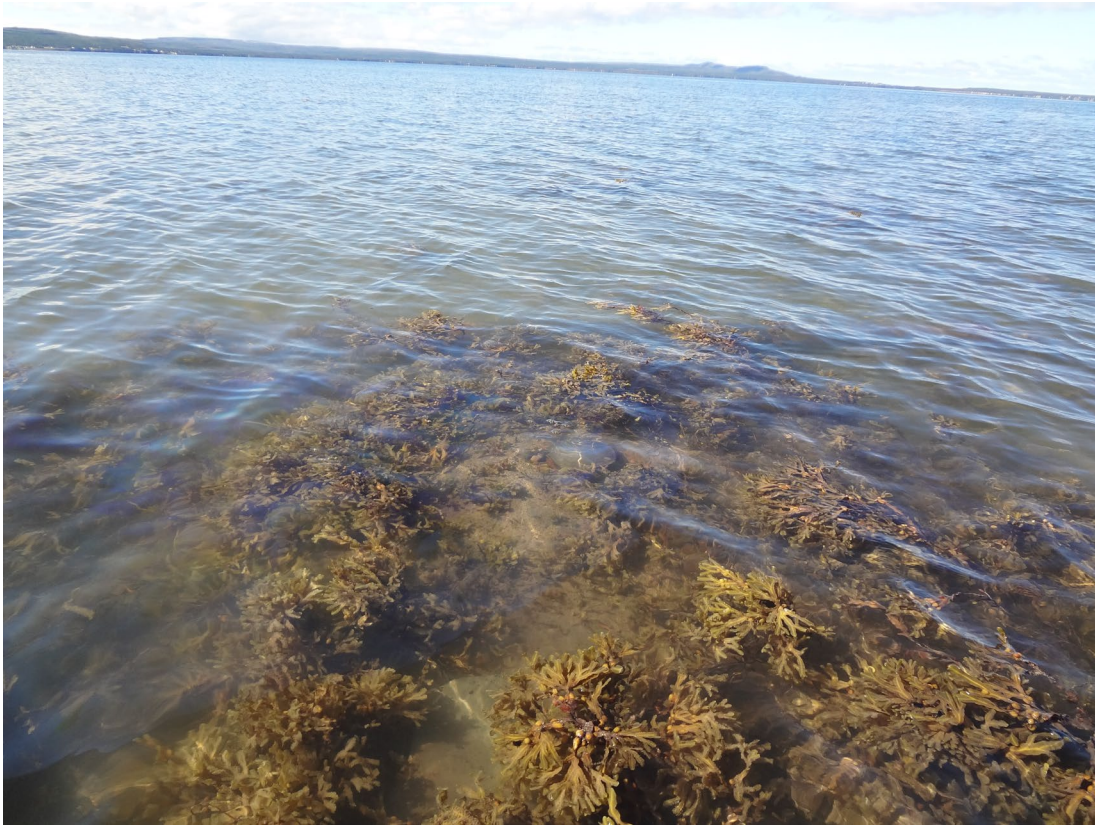
Photo 2 – Capped Well #1

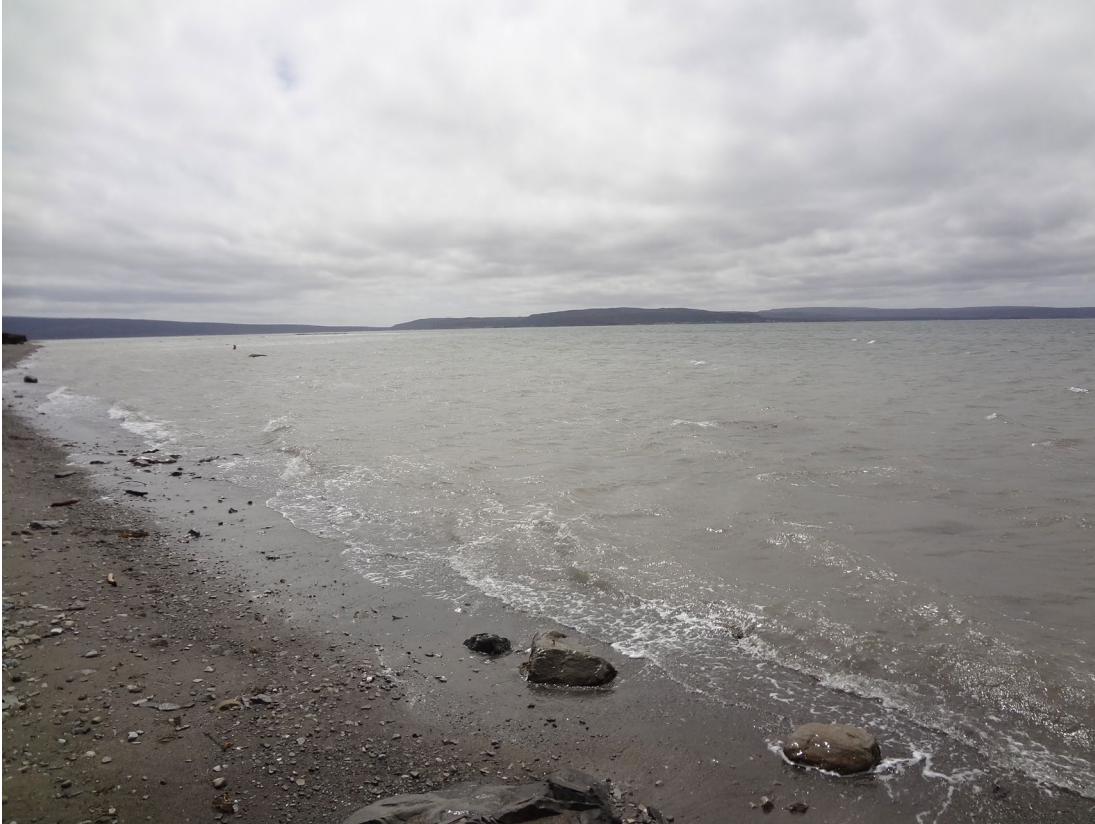
Photo 1 – Abandoned Well(s) Area View from Shore
