Investigation and Mitigation of Leaking Abandoned Underground Oil Well Casing Completion Report (Final)

Shoal Point, NL – ENVC-SP-2015-1

## Investigation and Mitigation of Leaking Abandoned Underground Oil Well Casing, Shoal Point, NL Completion Report

18 December 2015 Amec Foster Wheeler Project #: TF1512740

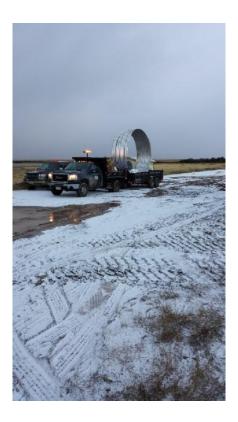
Photo 1 – Arrival of culvert at site in Shoal Point.

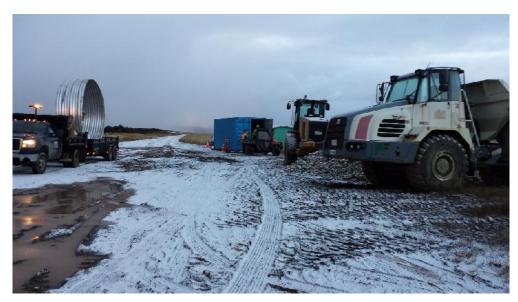
Photo 2 – View of mobilized contractor equipment at the lay down area.

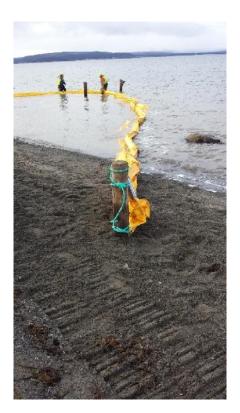
Photo 3 - Contractor installing turbidity curtain in water around well casing No. 1 work area.

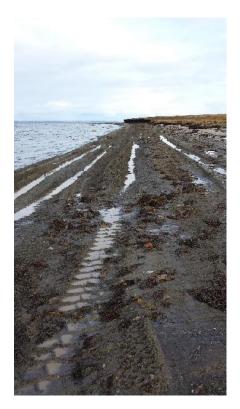
Photo 5 – Note soft beach conditions.

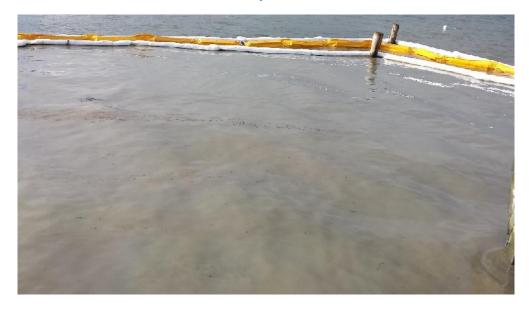
Photo 6 – Oil booms and turbidity curtain installed and anchored in position.

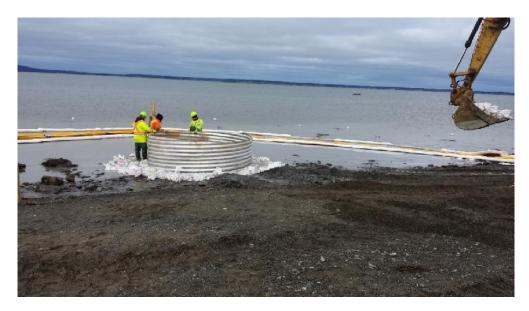
Photo 1 – Contractor installing culvert and sand bags at well casing No. 1 location.

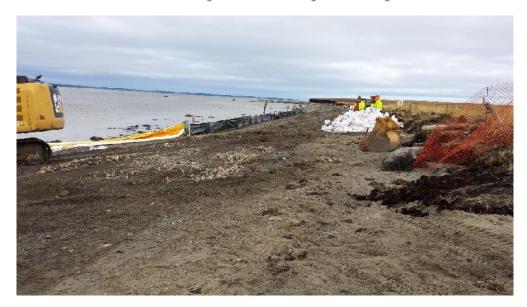
Photo 2 - View of silt fence in position along beach access.

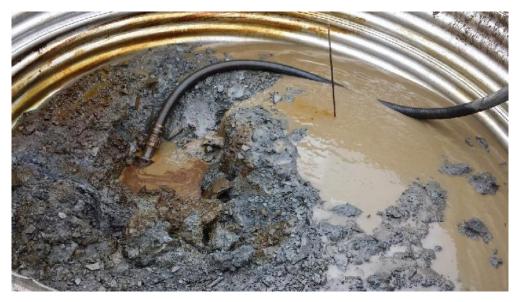
Photo 4 – Pumping the water out of the installed culvert.

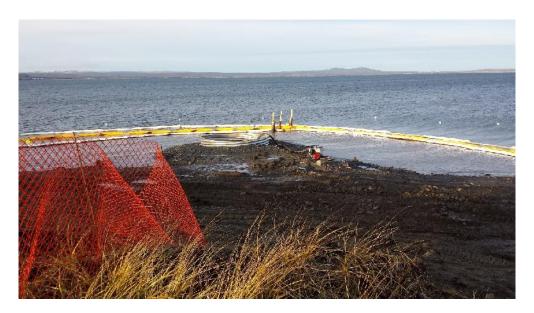
Photo 1 – View of work site at beginning of second day of construction (Well Casing No. 1).

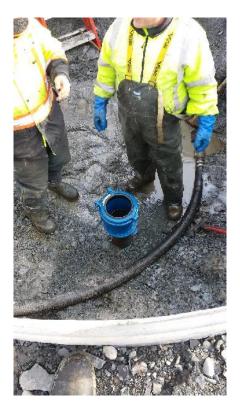
Photo 3 – Well casing No. 1 with adapter coupling in position.

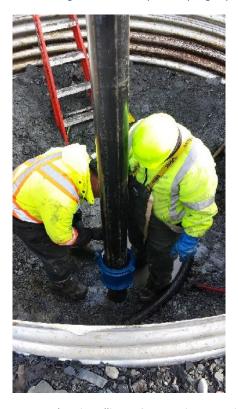
Photo 4 – Workers installing 150 mm ø pipe extension.

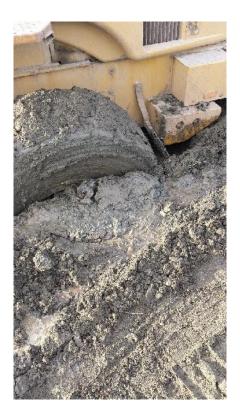
${\it Photo}~5-{\it Contractor}~encountered~challenging~conditions~along~beach~access.$

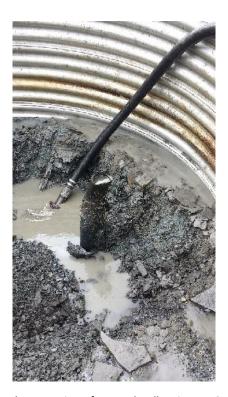
Photo 1 – View of exposed well casing No. 2

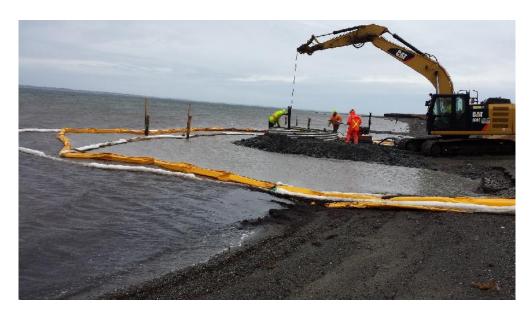
Photo 3 – View of work site at well casing No. 2.

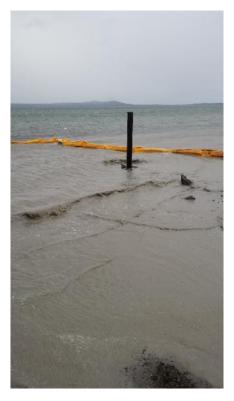
Photo 6 – View of completed well casing No. 2 prior to installation of pressure gauge and lockable outlet valve.

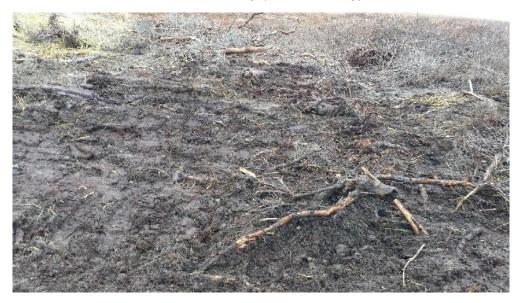
Photo 2 – View of reclaimed bog laydown area near work site.

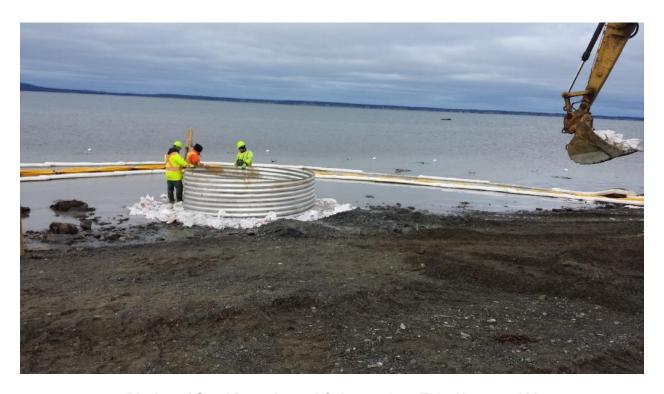
Placing of Sand Bags Around Culvert at Low Tide About 10 AM

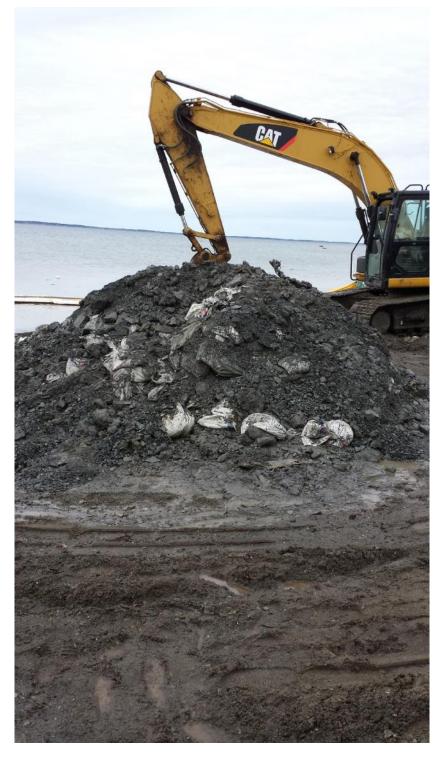
Contaminated Soil that was sent to the Remediation Center

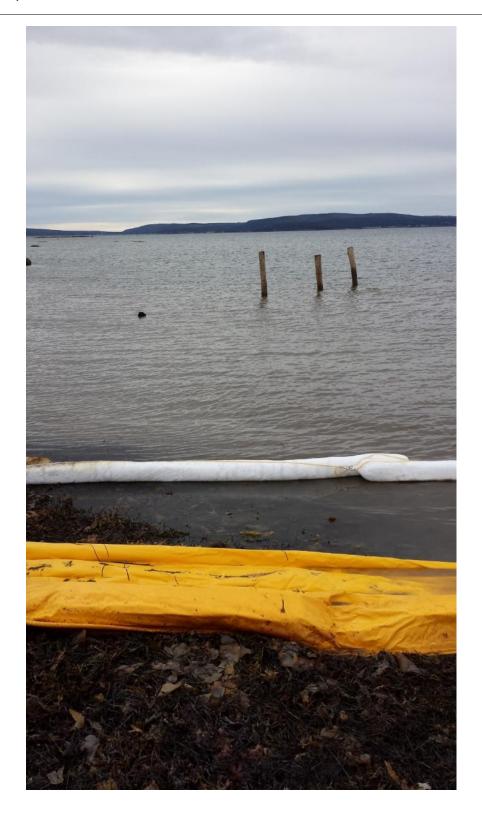
Well #2 with posts used to stabilize Oil Booms and Turbidity Curtain
